**“TPM APPROACH FOR ANALYSIS AND REDUCTION IN
ENGINE LEAKAGE FROM STATOR PLATE”**

**MASTER OF TECHNOLOGY
(PRODUCTION & INDUSTRIAL ENGINEERING)**

Submitted by:
ASHISH VASHISTHA
UNIVERSITY ROLL NO: 2K11/PIE/02

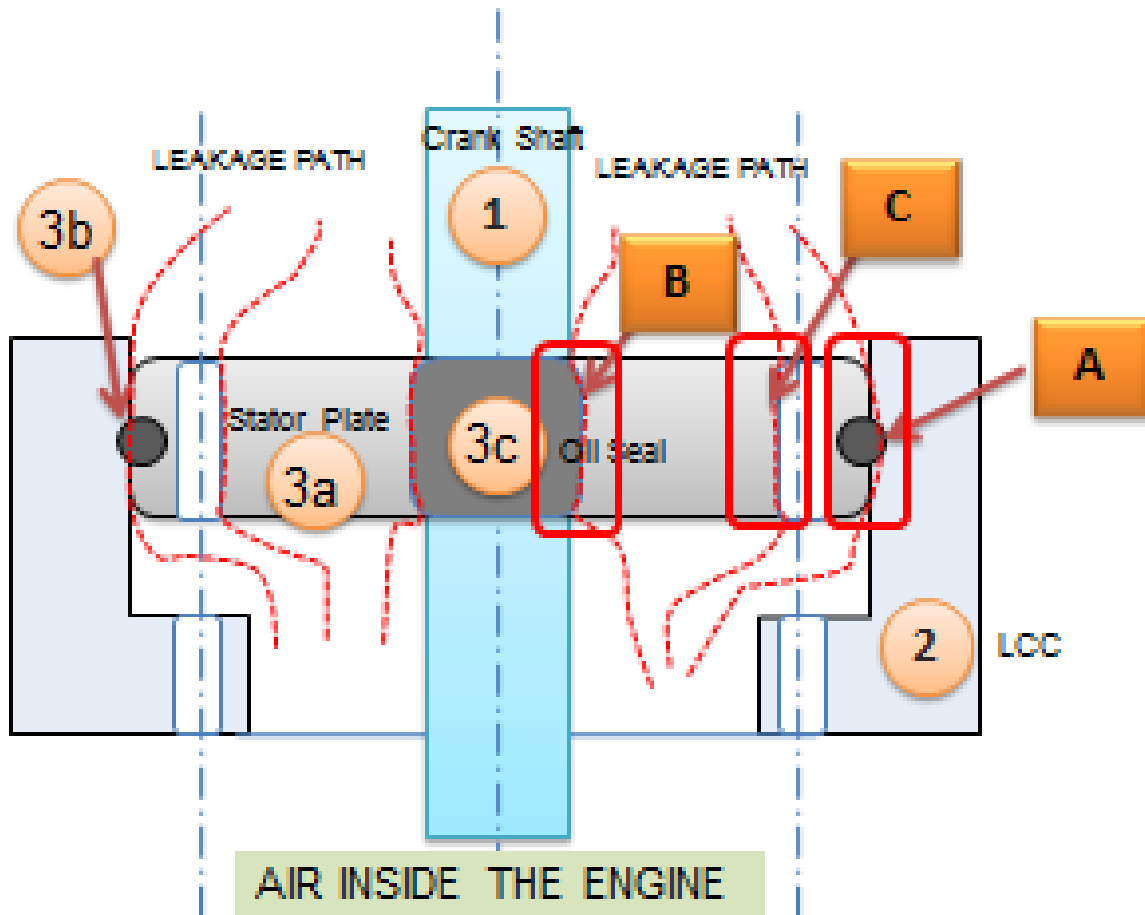
BREAK UP OF 1069 Nos. (0.68%) LEAKGAE ENGINE IN SUPPLIER M/s NIPPON BASED ON SEALING SURFACES

- A** O ring and LCC interface
- B** Oil seal and crank shaft left interface
- C** Mounting and LCC interface

C represents the sealing surface between mounting bolt of stator plate and LCC interface.

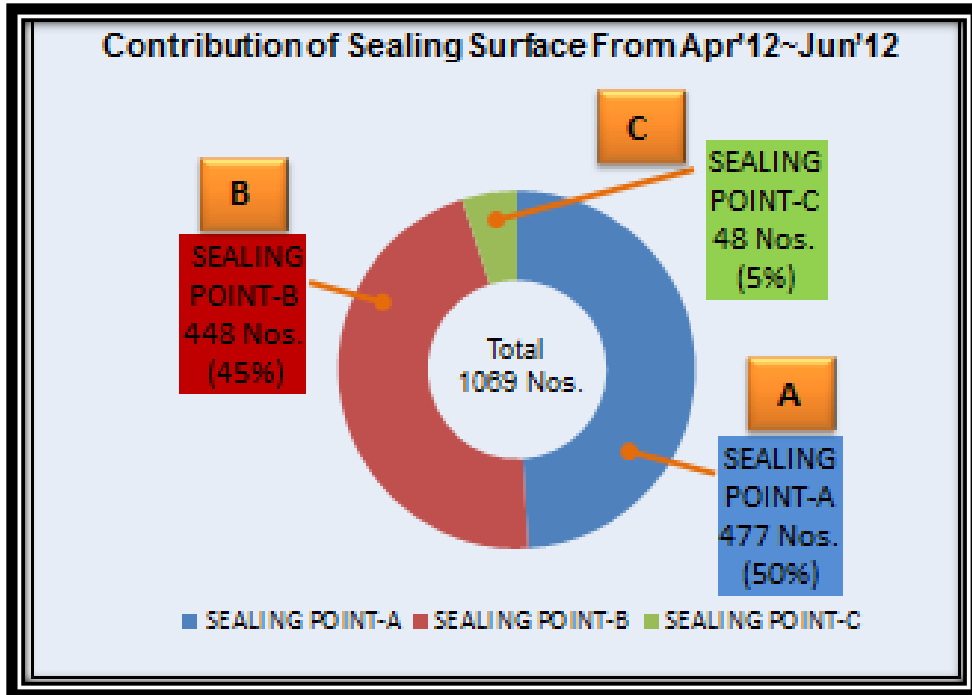
BREAKUP OF LEAKAGE FROM THE VARIOUS SEALING SURFACE

FROM THE SEALING POINT A 50 % OF LEAKAGE OBSERVED.

FROM THE SEALING POINT B 45 % OF LEAKAGE OBSERVED.

FROM THE SEALING POINT C 05 % OF LEAKAGE OBSERVED.

THIS DATA SHOWS THAT THE MAXIMUM LEAKAGE OBSERVED FROM THE O'RING AND LCC INTERFACE.

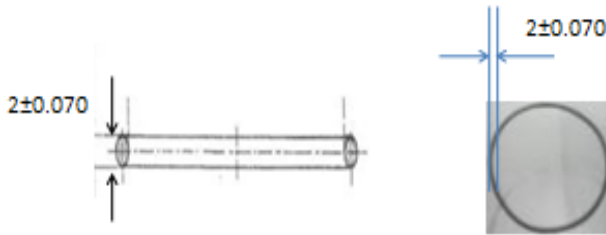
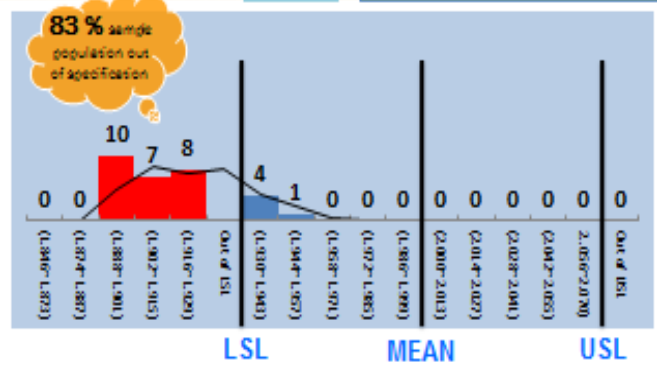
O-Ring thickness (t)

O ring thickness is found lower than LSL

By measuring the o ring thickness of 30 nos we observed that out of 30, total 25 o ring diameter are out of specification. Lower than the lower limit.

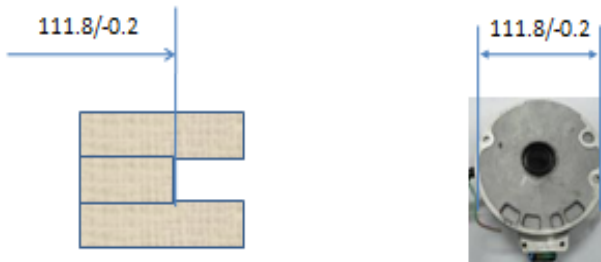
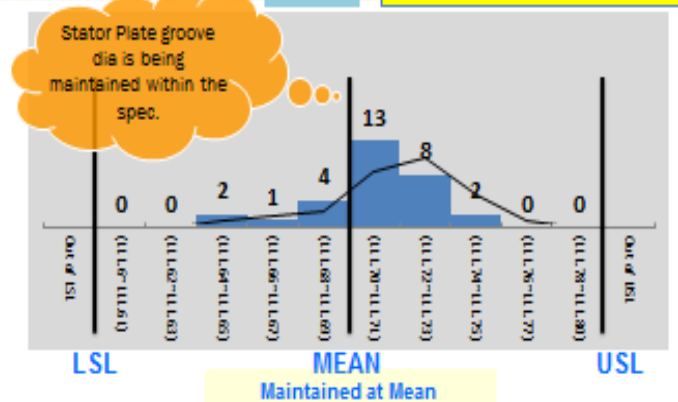
Stator Plate O ring groove dia(d)

Maintained at Mean

83% of O ring found out of specification and Stator Plate O ring groove dia found with in specification

We also checked the stator plate o ring groove dia by take the sample population of 30 nos. all the 30 nos found within the specification.

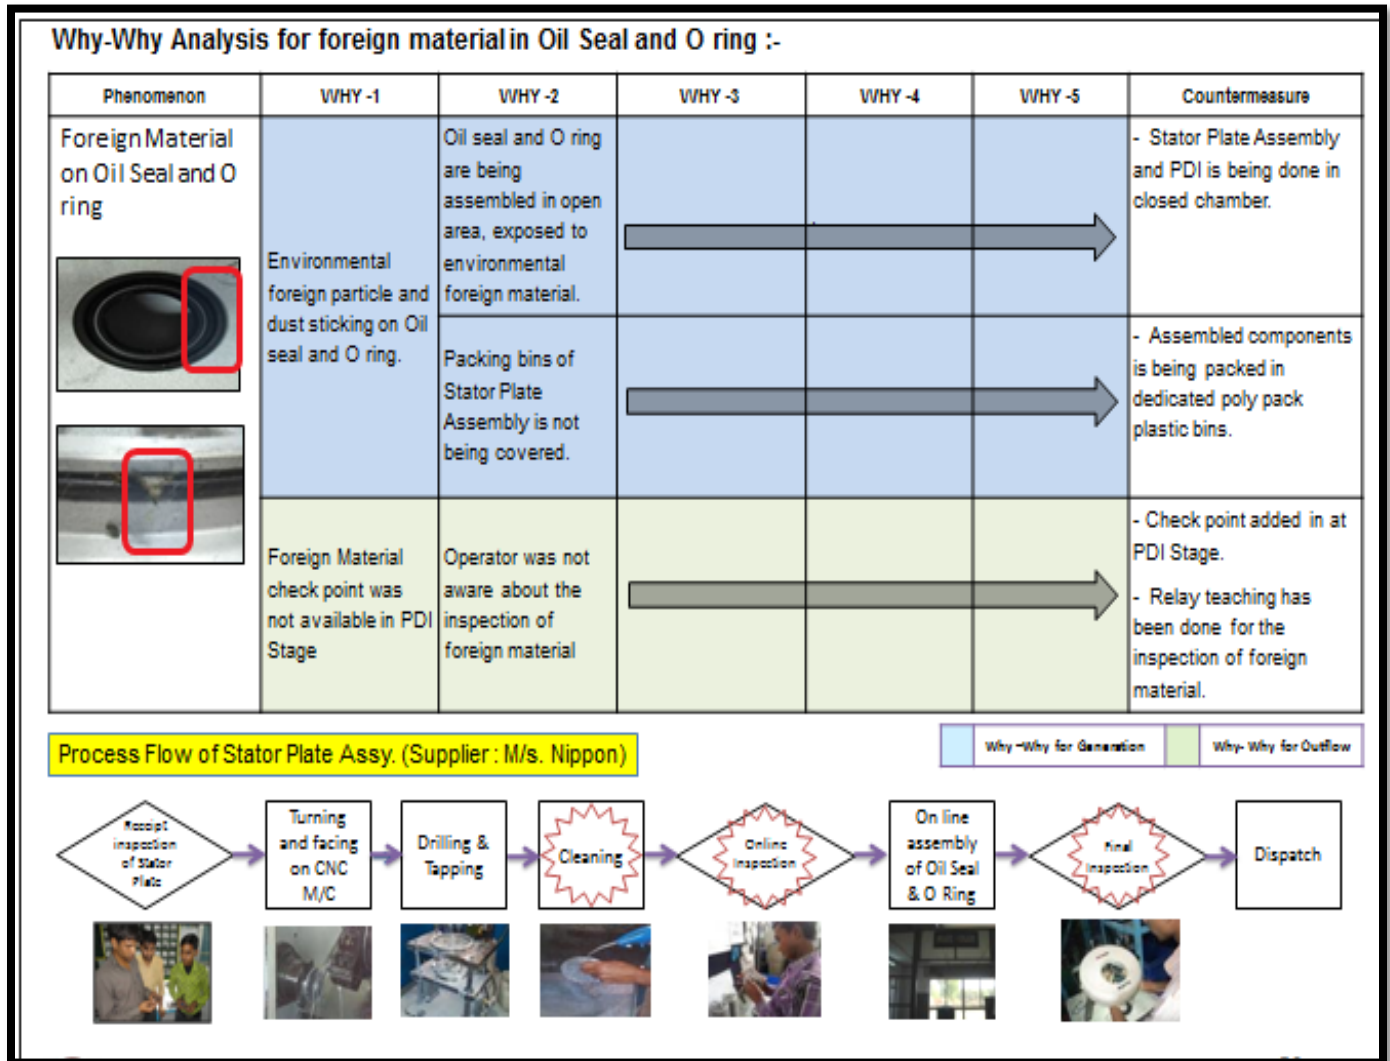
ANALYSING THE FACTOR :

For the foreign material in oil seal and o ring, we have done why why analysis and found that oil seal and o ring are being assembled in open area, exposed to environmental foreign material.

The second thing is packing bins of stator plate assembly is not being covered.

As a countermeasure of all these 3 reasons we have started stator plate assembly and inspection in closed chamber. Assembled component started packing in closed plastic bins. Check point for inspection is added in PDI Stage. Relay teaching has been started for the inspection of foreign material.

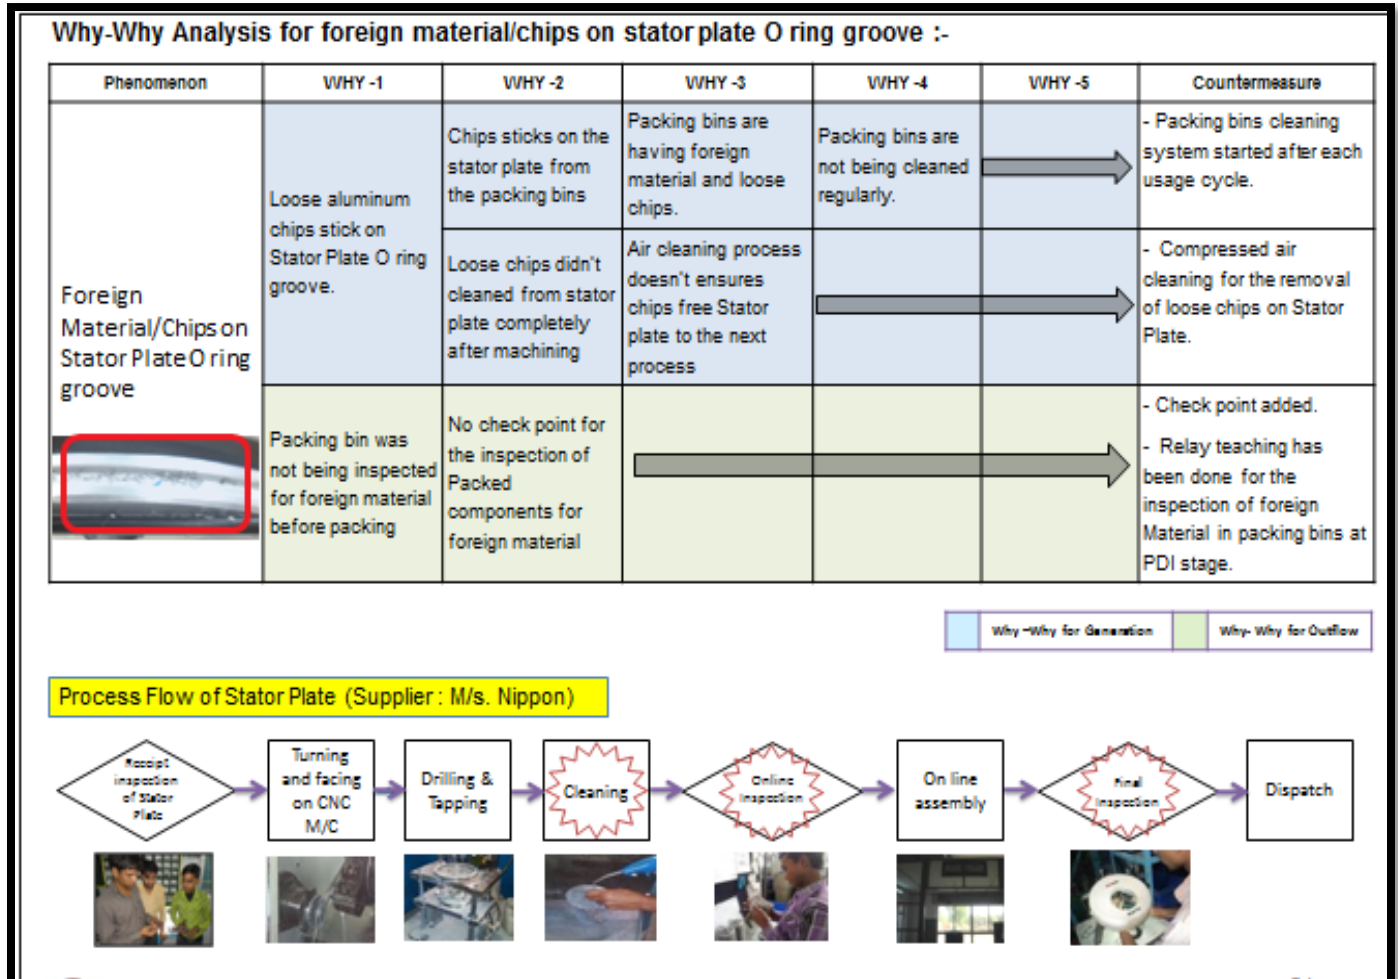
Foreign Material/Chips on stator plate o ring groove is the another observation. After doing analysis we found that packing bins are not being cleaned regularly. Air cleaning processes doesn't ensures chips free stator plate to the next process.no check point fot the inspection of packed component for foreign material.

As a countermeasure of all these , packing bins cleaning system started after each usage cycle. Compressed air used for cleaning/removal of loose chips on stator plate. Relay teaching has been done for the inspection of foreign material in packing bins at PDI stage.

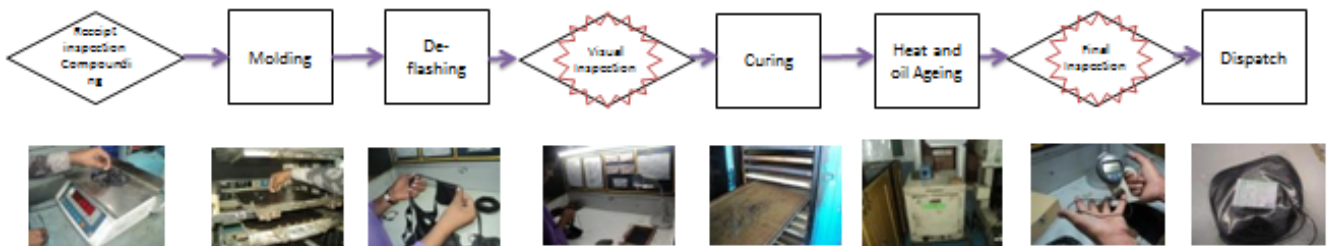
Process Flow of O Ring (Supplier : M/s. Nippon)

Against the phenomenon of O ring thickness less, when we have done why why analysis, we found that mould cleaning and polishing is not being done regularly. The second thing is Mould/cavity wise inspection was missing. As a countermeasure polishing/cleaning done and frequency of cleaning fixed and being adhered.

Mould /cavity, batch wise inspection started.

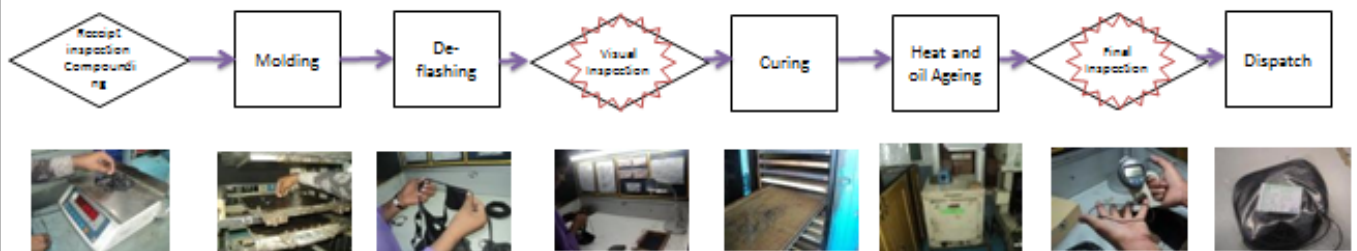
Process Flow of O Ring (Supplier : M/s. Nippon)

Now we have done why why for flashes on o ring. We found that notch and tool maintenance frequency not fixed. Operator was not able to detected minor flashes by naked eyes.

The first countermeasure is tool notches reshaped and its maintenance schedule fixed.

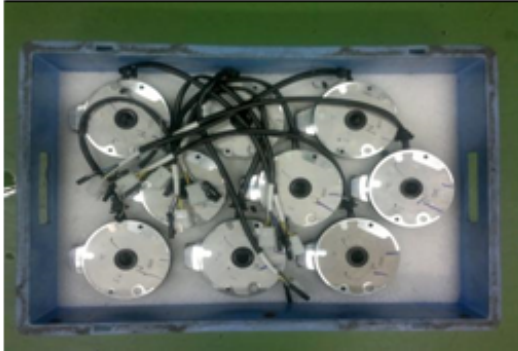
BEFORE

Packing bins are not Poly Packed

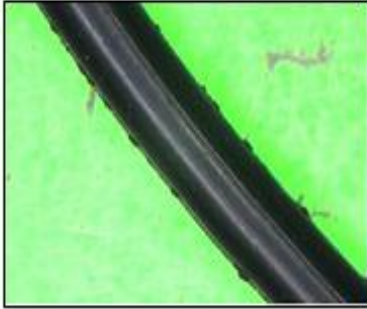
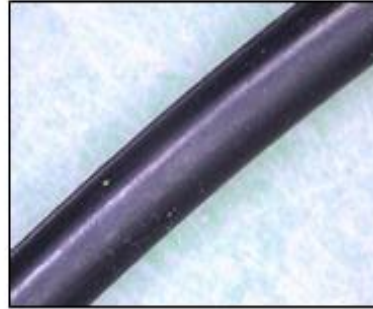
O Ring- **BEFORE**

FLASHES ON O RING

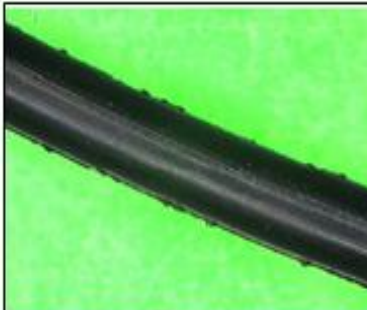
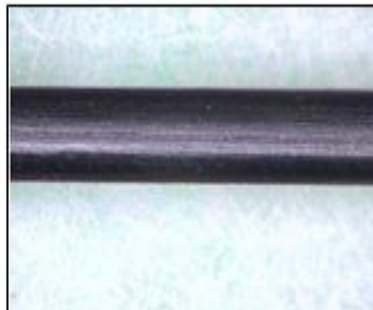
O Ring- **AFTER**

NO FLASHES ON O RING

Tool Life and its maintenance schedule has been made to control the process condition. In this figure we can easily understand that after sharpening the tool the generation of flashes is completely removed.

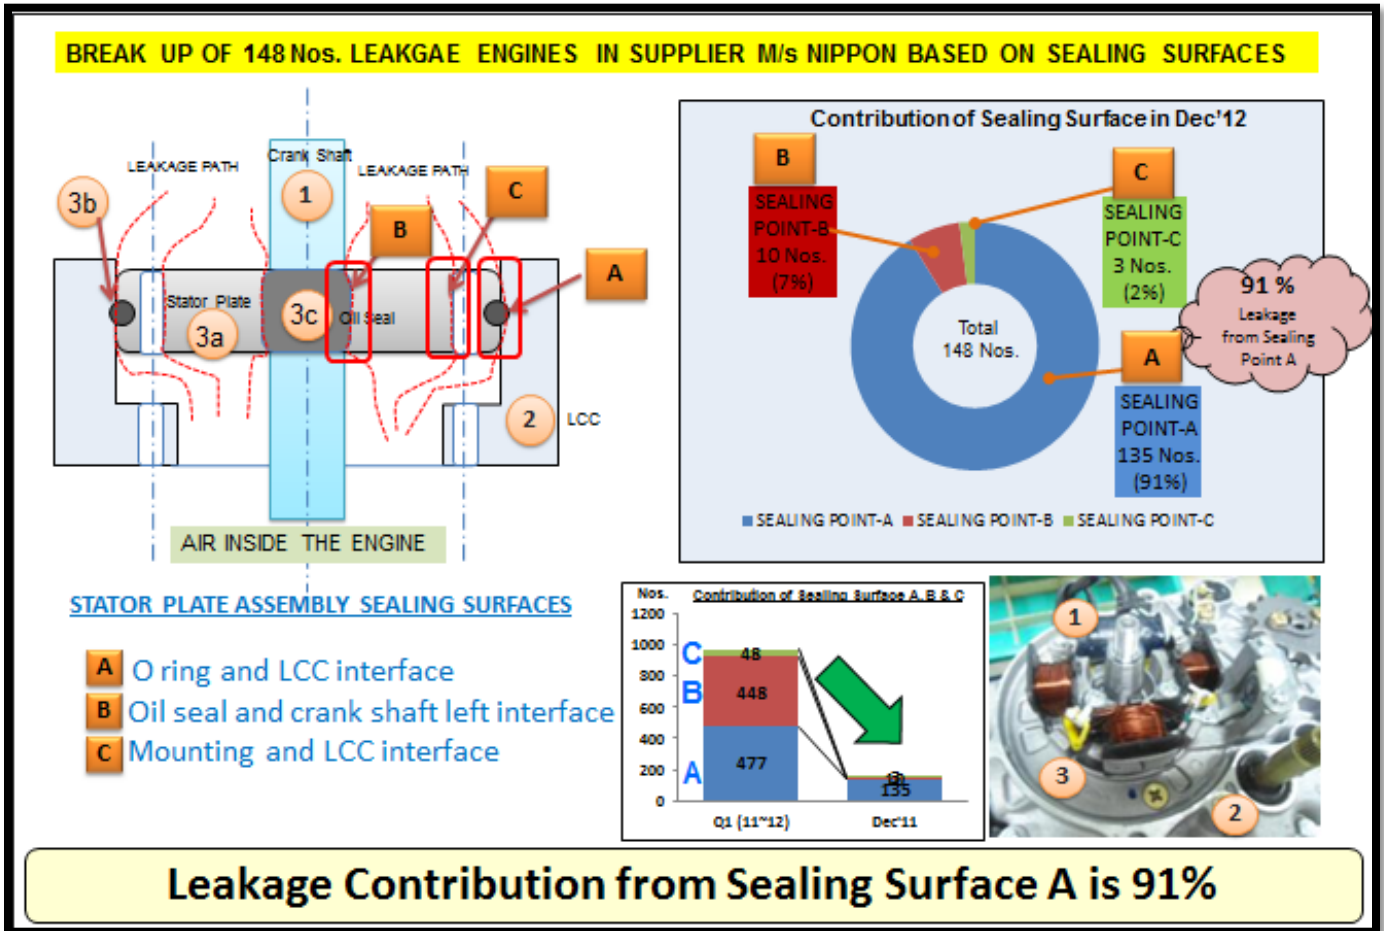
ANALYSING THE FACTOR:

After doing further analysis of total 148 nos of defect, we found that leakage contribution from the sealing surface A is the highest which is 91%. Point C is having 2% of leakage which is from mounting and LCC interface. And 7% leakage is found from oil seal and crankshaft interface.

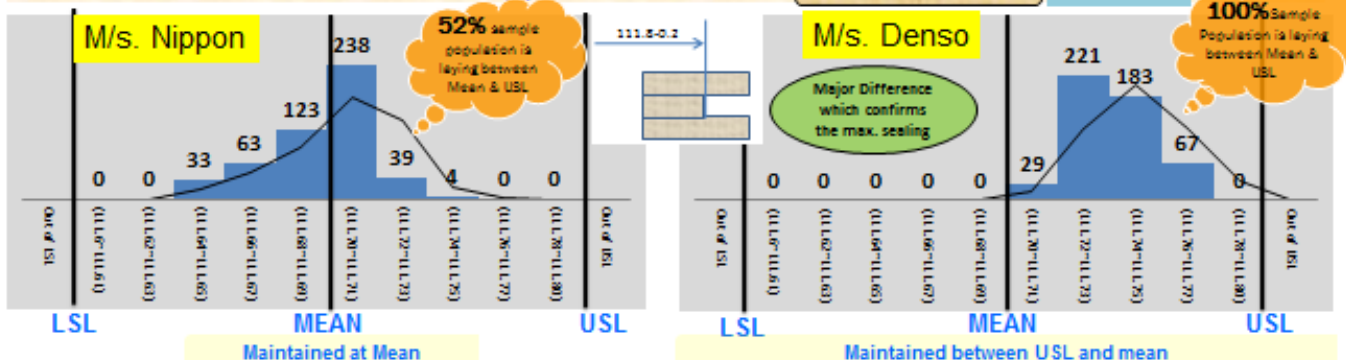
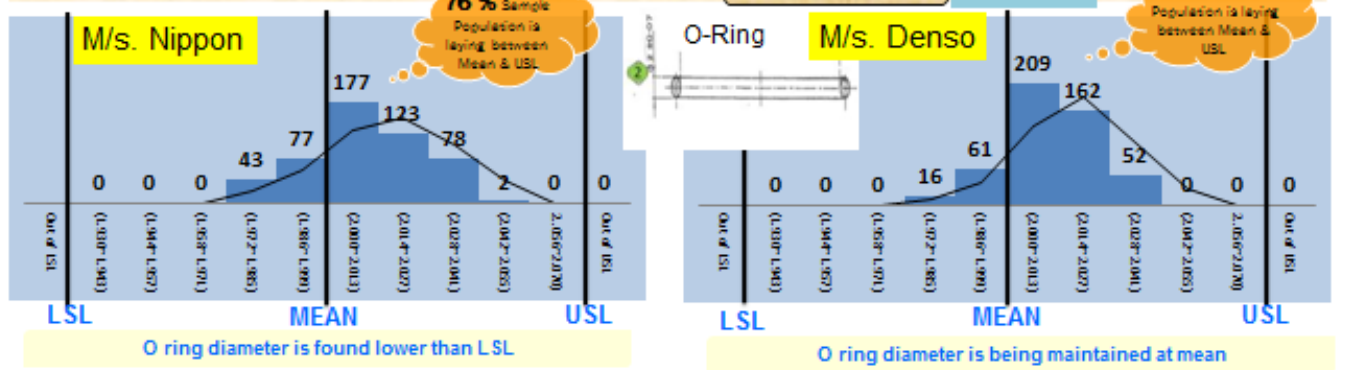
STATOR PLATE O RING GROOVE DIAMETER (d) SAMPLE POPULATION Dim 111.800/-0.200 N=500x3

No Major Observation in O Ring Thickness in both the supplier
 In Stator Plate O ring Groove Dia. 52% Population of M/s Nippon Lying between Mean & USL

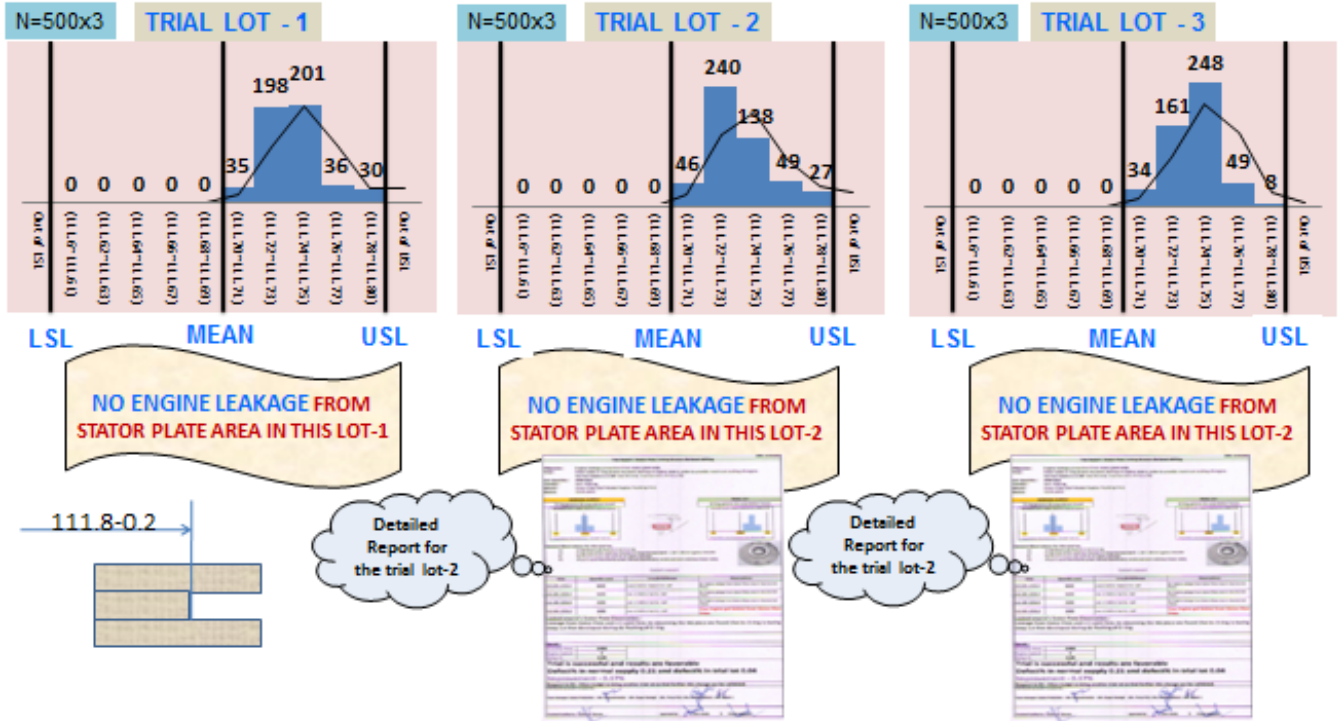
This trial confirms that keeping Stator Plate O ring groove dia(d) at upper side (between mean and USL) confirms maximum sealing in engine from stator plate area.

Further actions : 3 Lots of 10,000 Pieces was demanded from M/s. Nippon having groove dia between Mean and USL
