STUDY ON RESPONSE OF CONCRETE BRIDGE DUE TO CONSTRUCTION DEFECTS

A DISSERTATION

In this study, the field survey has been done to identify the defects and elaborate on the codal provisions. The method used for assessing the behaviour of the structure due to defect is modelling and analysis of the bridge in STAAD pro software. With the consideration of defect, additional unexpected moments are generated in the girder and diaphragm for which the structure was not originally designed. In general, steel reinforcement is provided for required moments in the structures. If additional unexpected moments are generated, then damage can occur in the structure and affect the service life of the structure. The present study highlights that the collection of data can provide information about the possible defects with their causes for a meaningful conclusion about the service life of the structure.

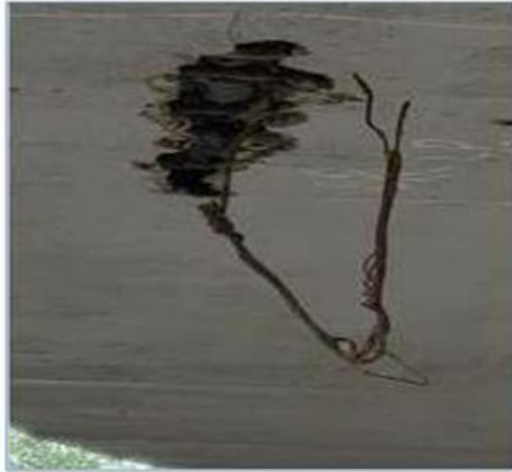
Fig 3.1 Exposed Reinforcement and also seen unwanted material in deck slab

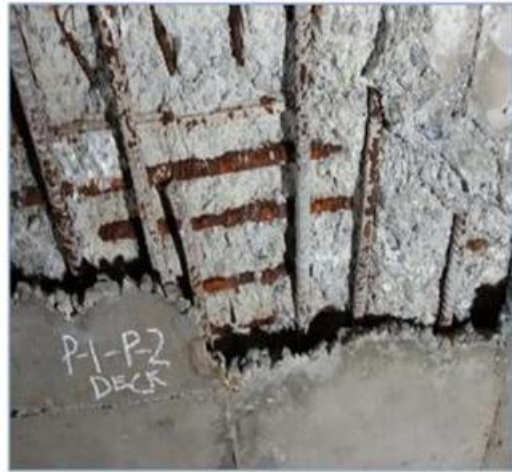
Fig 3.2 Exposed Reinforcement Observed in deck slab

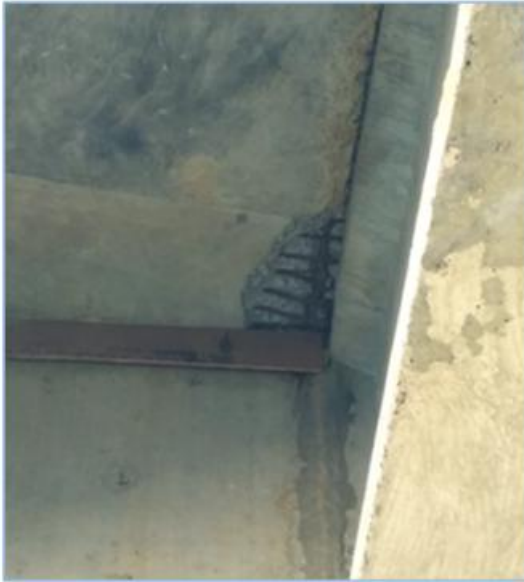
Fig 3.3 Exposed Reinforcement Observed in deck slab

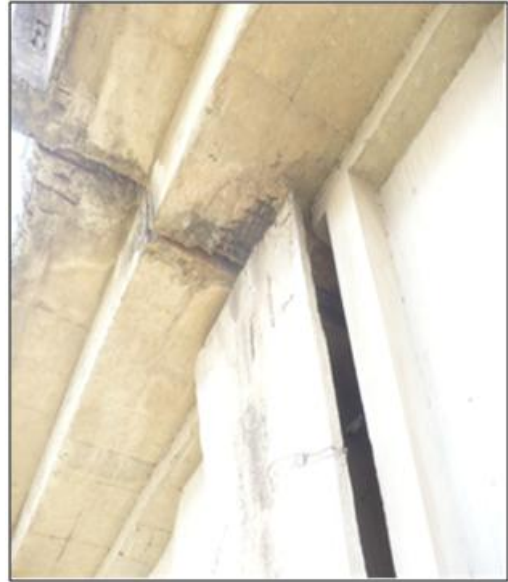
Fig 3.4 Exposed Reinforcement Observed in cantilever portion

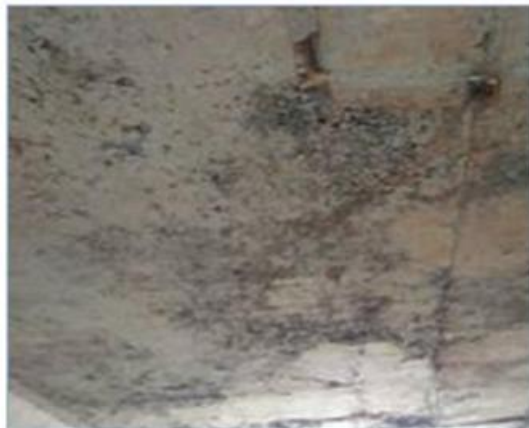
Fig 3.5 Honeycombing observed in soffit Slab

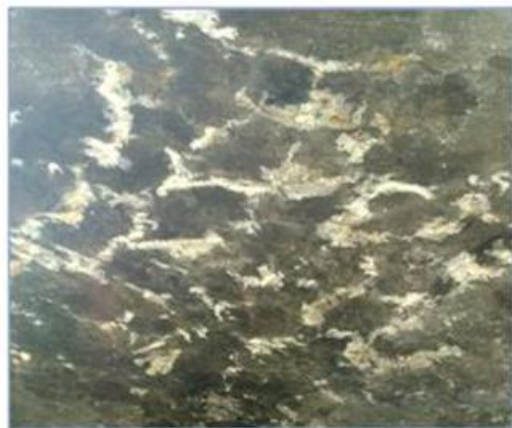
Fig 3.6 Leaching observed in soffit slab

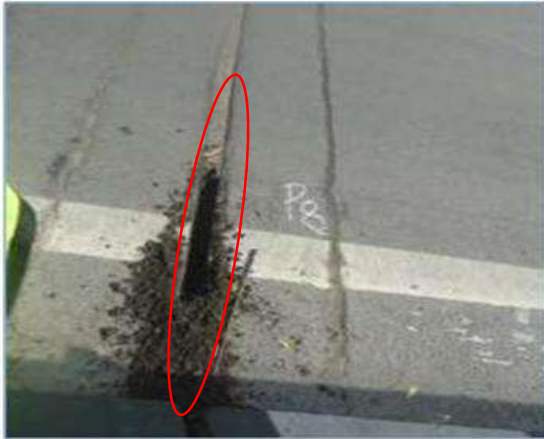
Fig 3.7 Debris accumulated in expansion joint

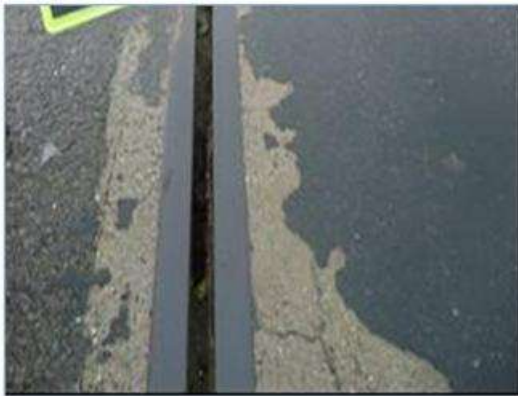
Fig 3.9 Neoprene seal missing in expansion joint due to movement affected

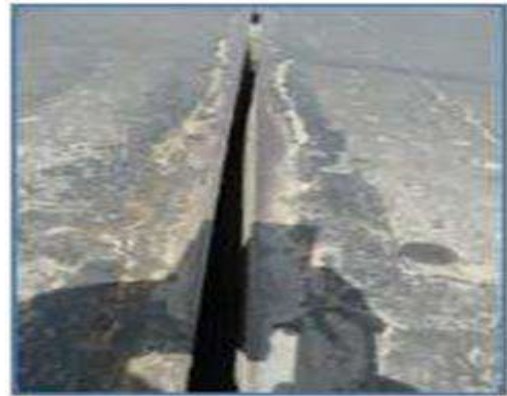
Fig 3.10 Neoprene seal missing in expansion joint due to movement affected

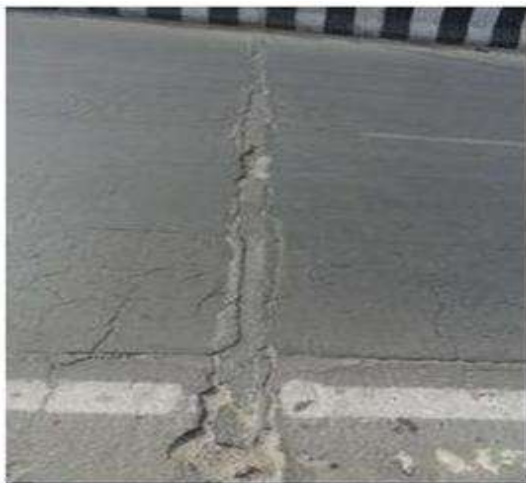
It has been also observed that during the laying of wearing course, expansion joint gap filled with the wearing course material (refer Fig 3.11) leading to restriction in

Fig 3.11 wearing course material filled in expansion joint

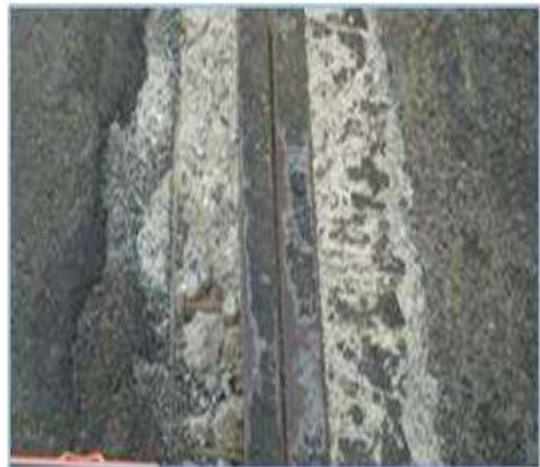
movement and causing additional stresses in the structure. Edge beam of expansion joint is also damaged as shown in Fig 3.12. Due to the strip seal missing water leakage through expansion joints observed at several locations (refer Fig 3.13 to 3.14). Underside portion of expansion joint is also observed damaged (refer Fig 3.15)

Fig 3.12 Exposed reinforcement in edge beam of expansion joint

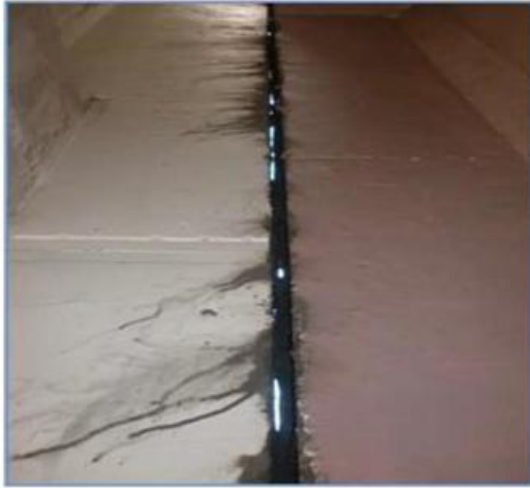
Fig 3.13 Neoprene seal missing in expansion joint and water leakage observed

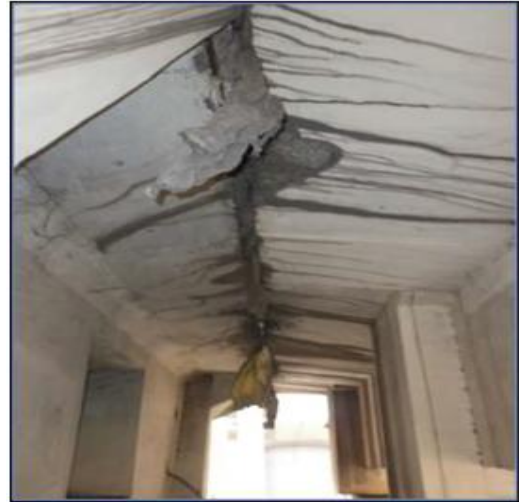
Fig 3.14 Underside portion of expansion joint damaged

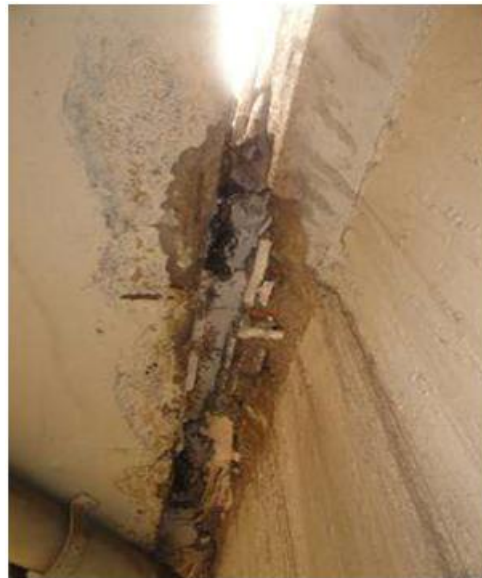
Fig 3.15 Underside portion of expansion joint severely damaged

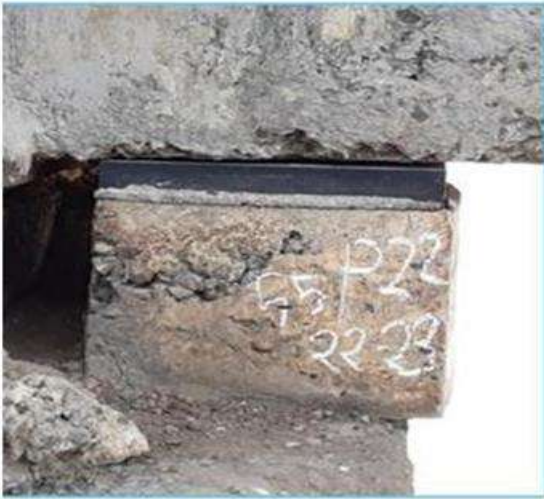
Pedestal is a monolithic component with Pier cap in the bridge which provides the base to placing the bearing. Pedestal should be cast appropriately for resting the bearing for functioning properly, while in the field it is observed that pedestals are not casted as per standard and honeycombing are observed at many locations as seen in Fig 3.16. Negligence in proper concreting of pedestals are observed as shown in Fig 3.17, there is a cavity observed in the pedestal while it should be properly compacted concrete. Due to the debris accumulated at the pier cap, moisture retention and water seepage are observed near the pedestal. If seepage continues it will lead to initiating the corrosion in the structure.

Fig 3.16 Pedestal not casted properly

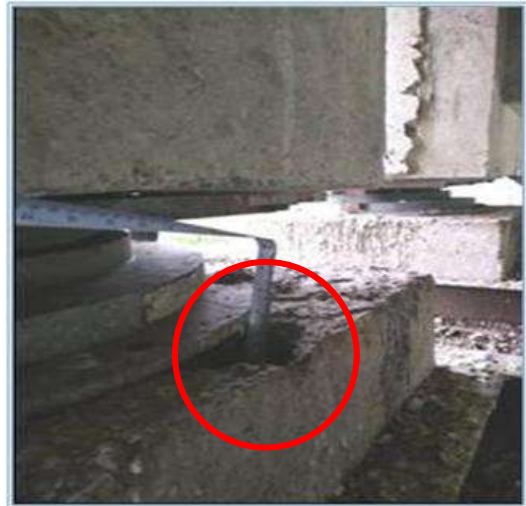
Fig 3.17 Cavity observed under the bearing plate at pedestal

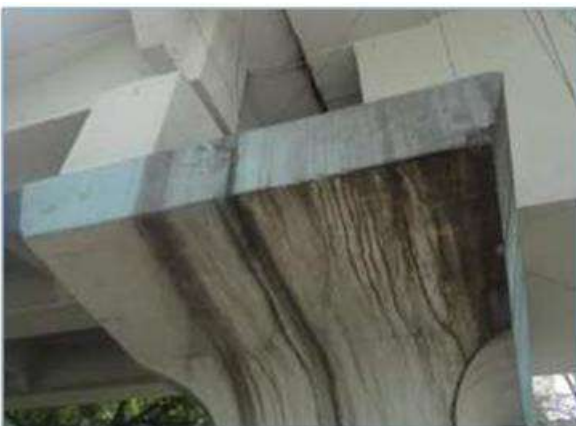
Fig 3.18 Seepage on pier cap

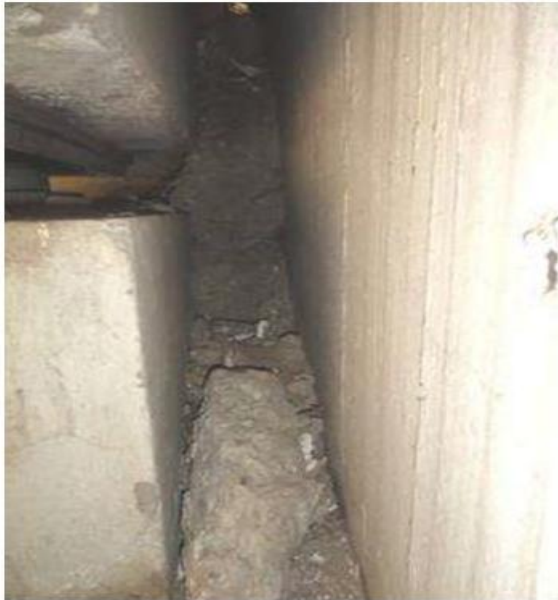
Pier cap is a horizontal component over the pier which transfers the superstructure load to the substructure. Dampness is major problem which has been observed at many locations during the field observations. One of the main reasons of dampness was due to poor installation practice & maintenance of expansion joint which leads to leakage from the expansion joint (refer Fig 3.18 to 3.19). If the dampness continues then the chances of reinforcement corrosion increase and the structure begin to corrode severely. Another common defect observed in the field is the vegetation growth over the pier cap (refer Fig 3.20 to 3.21) Due to the vegetation growth cracks are initiated in individual component. Debris accumulation over the pier cap (Fig 3.22 to 3.23). It is also observed that hardened concrete was accumulated around the bearing at pier cap which was a sign of poor workmanship negligence (Fig 3.24 to 3.25).

Fig 3.24 Concrete accumulated at pier cap due to negligence during the construction

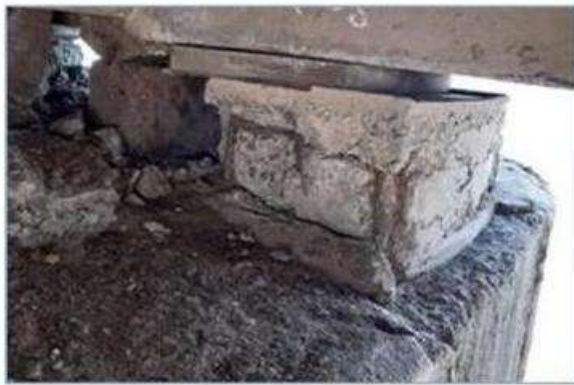
Fig 3.26 Bearings not placed properly

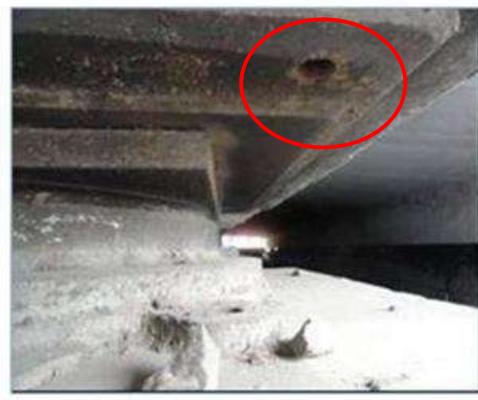
Fig 3.29 bolts are missing in bearing plate

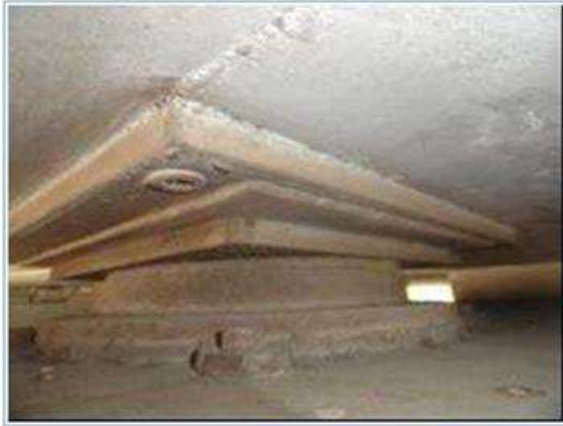
Fig 3.30 bolts are missing in bearing plate

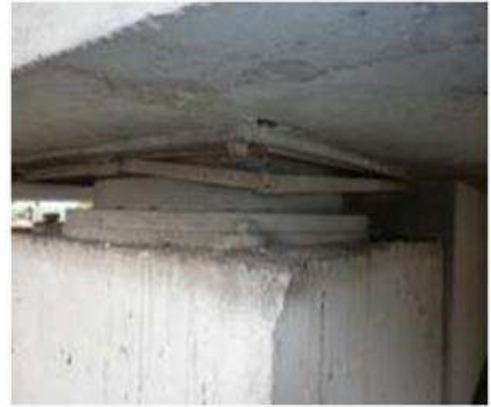
Fig 3.31 Bearing steel plate damaged

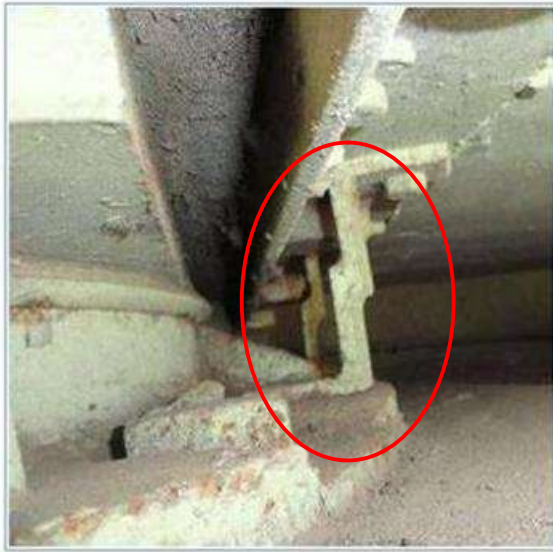
Fig 3.32 Locked bearing is observed as sleeves are not opened for free movement

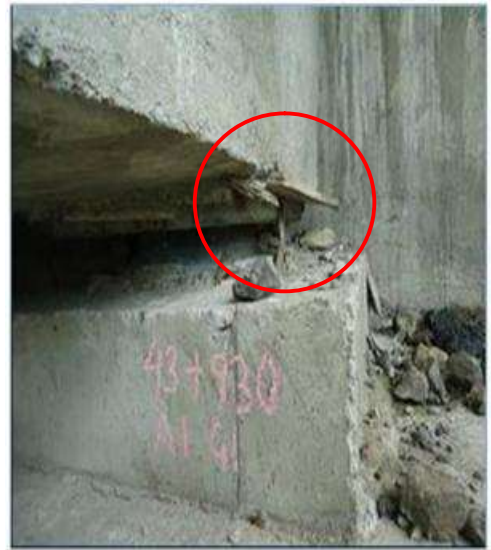
Fig 3.33 Locked bearing is observed as sleeves are not opened for free movement

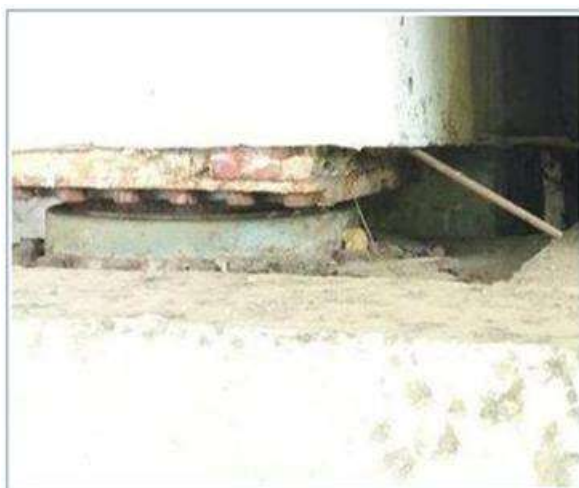
Fig 3.34 Unwanted R/F bar exposed

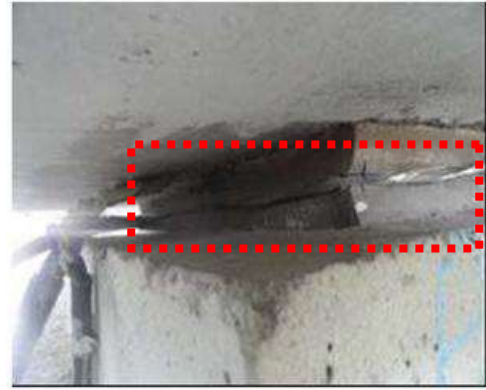
At few locations it is observed that MS binding wire is seen around the elastomeric bearing leading cuts on bearing rubber as shown in Fig 3.36 to 3.37.

Fig 3.37 cuts on bearing is observed

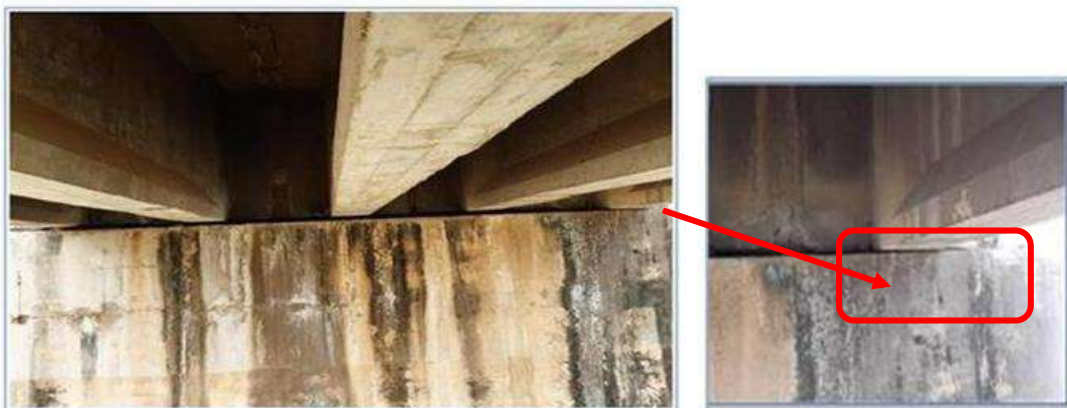
Girder is a component of bridge structure which used to support the deck slab and takes load. In the field it is observed that girder not seated on the bearing appropriately, at few locations, it is even observed that Bearings are missing end the girders are seated directly on pier cap (refer Fig 3.38). As shown in Fig 3.39 to 3.40 the end portion of prestressing cables are exposed, it can be a cause to initiation of corrosion in the structure. Such type of problems occurs due to the negligence of field engineer. As per the standards, after completion of stressing activity, the wire shall be cut and two coats of epoxy paint shall be applied and entire portion filled with the non-shrink epoxy mortar [3] In Fig 3.41 to 3.42 shown that all prestressing cables are corroded and damaged. It seems that it is due to the improper drainage system and water continues to seep over the girder surface. Exposed sheathing as seen from the bottom of flange as shown in Fig 3.43 and exposed reinforcement also seen at the bottom of flange (refer Fig 3.44). A poor repair work also observed in the field as shown in Fig 3.45. In Fig 3.46 honeycombing observed at the bottom of flange.

Fig 3.38 Girder resting on pier cap without bearing

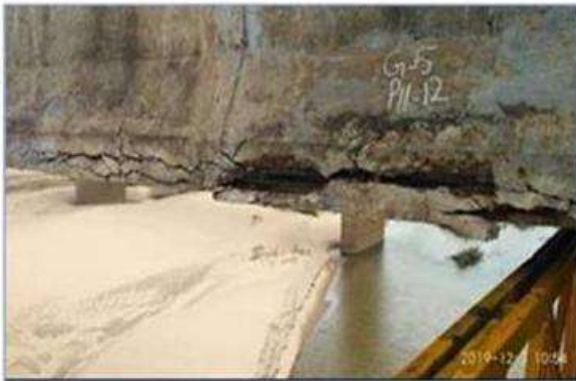
Fig 3.41 Prestressing cables corroded

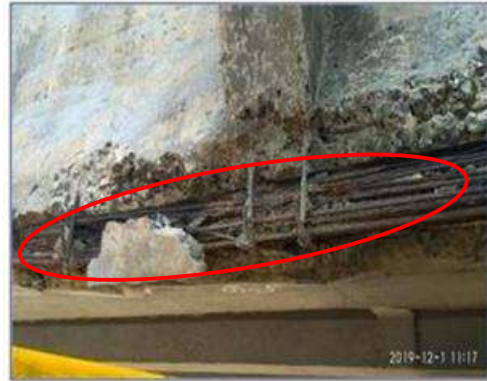
Fig 3.42 Prestressing cables corroded

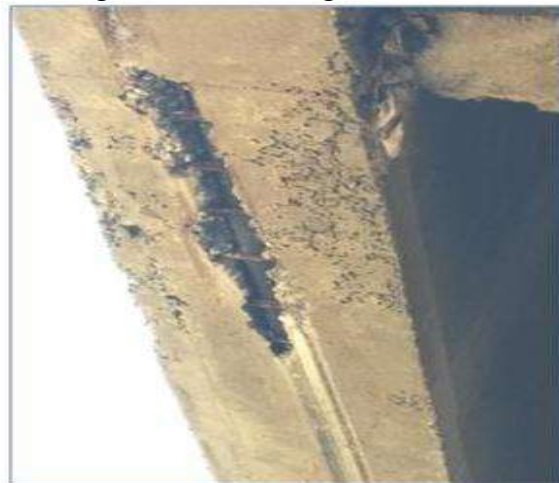
Fig 3.43 Exposed sheathing as seen from the bottom in the bottom flange of girder

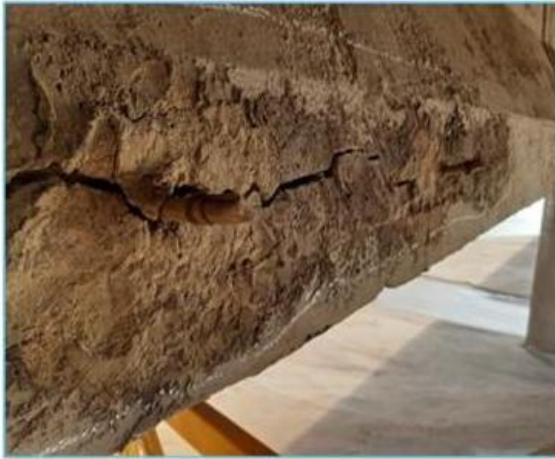
Fig 3.45 Poor repair work

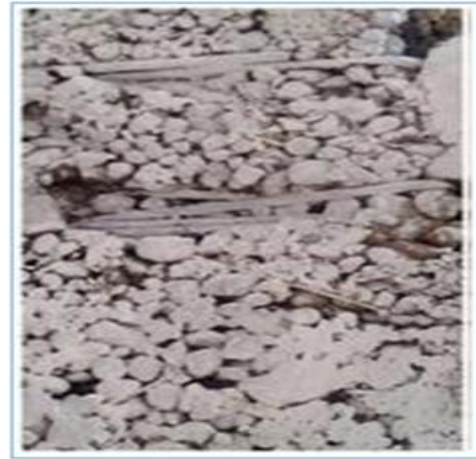
Fig 3.46 Honeycombing as seen at the bottom of the flange of girder

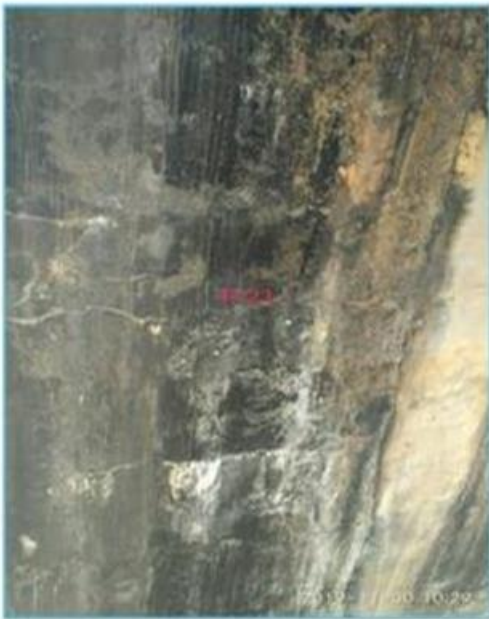
Bridge pier support the span and they transfer the load from superstructure to foundation. The problem of Leaching was observed on the surface of pier as shown in Fig 3.47 and localized exposed reinforcement was also observed as shown in Fig 3.48.

Fig 3.47 Leaching observed on pier

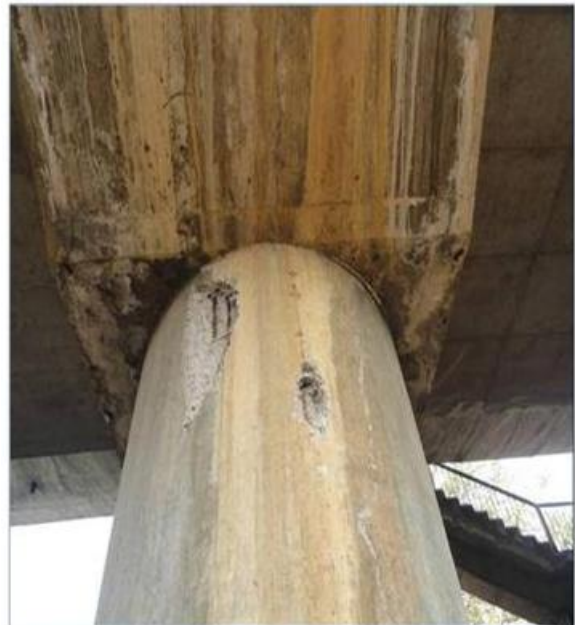
Fig 3.48 Exposed reinforcement observed on pier

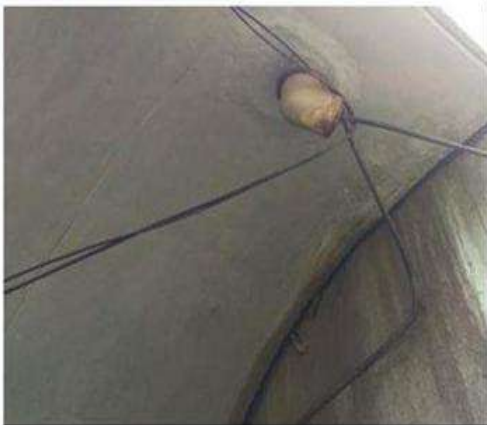
Fig 3.49 Improper down take pipe

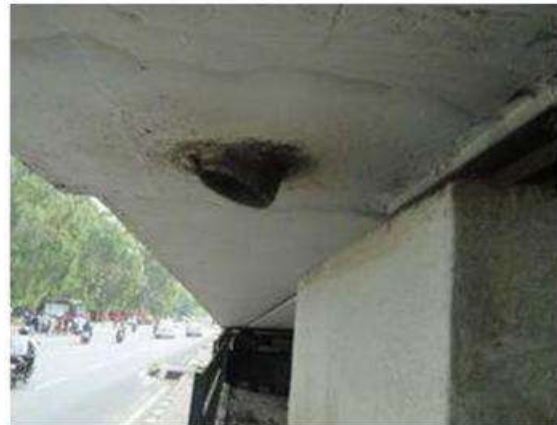
Fig 3.50 Improper down take pipe

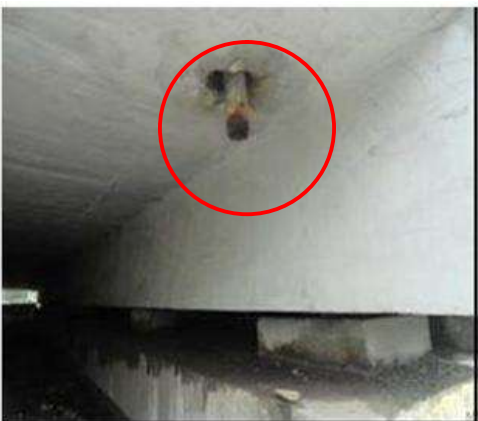
Fig 3.51 Improper down take pipe

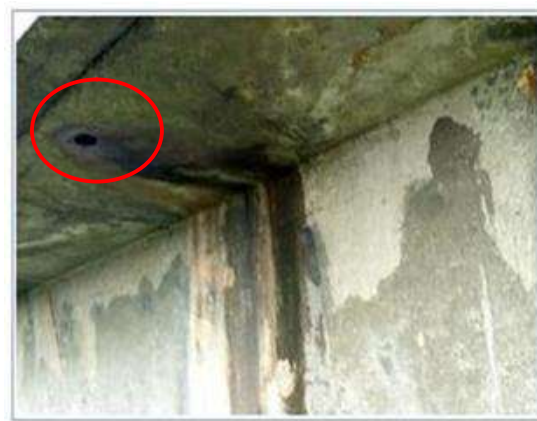
Fig 3.52 Seepage observed on structure surface due to improper drainage system

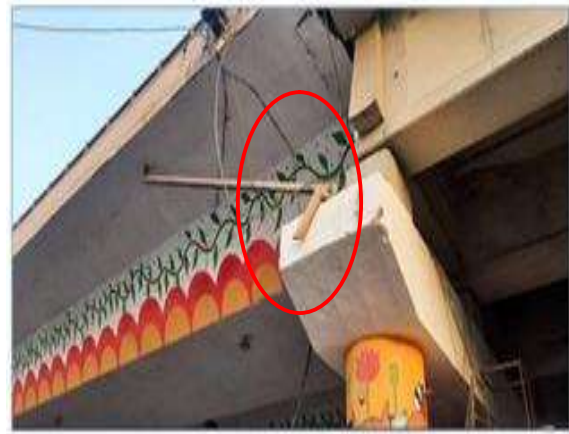
Fig 3.56 Improper down take pipe provided

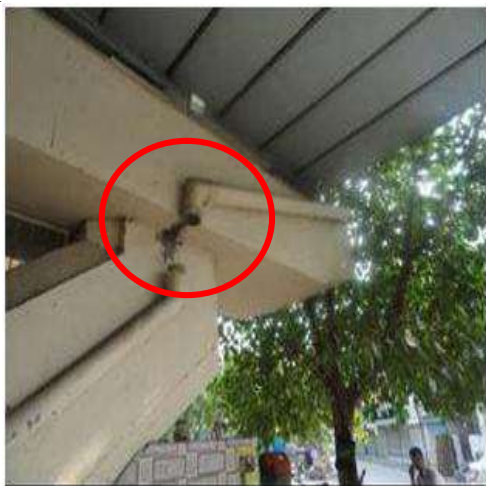
Fig 3.57 It shows Drainage pipe provided properly but got damaged and it has not been noticed due to lacking of inspection.

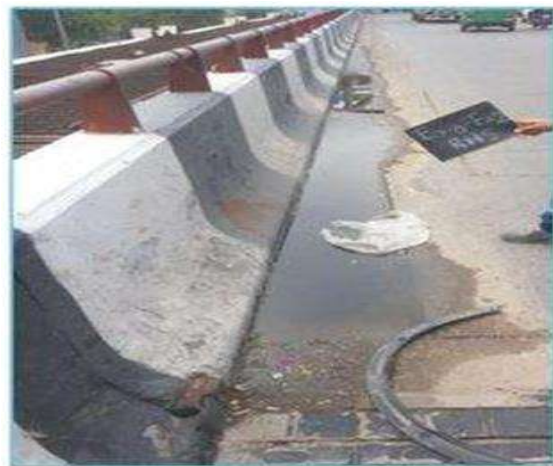
deterioration in the early age. Though guidelines are available on the drainage and its maintenance, but the same are not followed in the field religiously. Improper down take pipe observed in the field (refer Fig 3.49 to 3.51). Seepage was observed on the structure surface due to improper fixing of down take pipe as shown in Fig 3.52. IRC: SP: 42-2014 guidelines are laid for appropriate decision making in drainage the water shown in Fig 3.53. Drainage system should be maintain properly and regularly and ensure that all inlet should not be choked or clogged. In Fig 3.54 shown the proper down take pipe arrangement, it is a good construction practice. Both Fig. 3.55 & 3.56 are of the same structure but right work has been done on one pier (by providing the proper down take pipe) while not done on the other pier. It is called a negligence or careless. It has been observed that drainage pipe provided properly but got damaged and it has not been noticed due to lacking of inspection (refer Fig 3.57). Due to the choking / clogged the drainage spout water logging observed at road level (refer Fig 3.58)

Fig 3.58 Water logging observed at road level

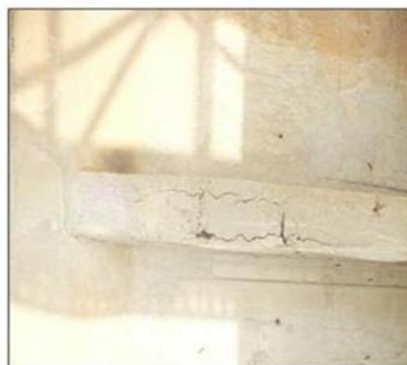
Fig 3.62 cracks observed at the bottom of diaphragm

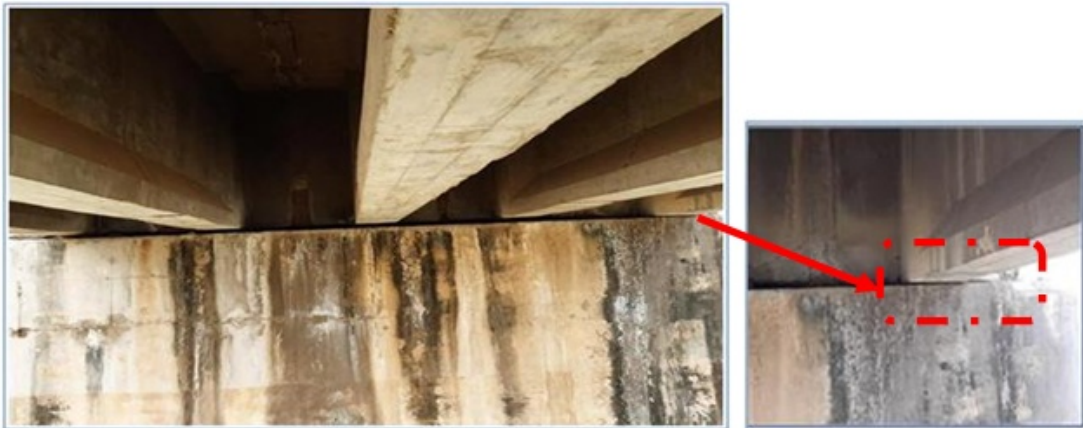
Fig.4.1 Out of five Girders one girder resting on pier cap without bearing
