CREEP-FATIGUE ANALYSIS FOR REMAINING LIFE ASSESSMENT OF STEAM TURBINE BLADE USING NUMERICAL SIMULATION AND EXPERIMENTAL TESTING

A Thesis

DOCTOR OF PHILOSOPHY

CHAPTER 3: Investigation of the Failure of Seventh Stage Low Pressure Steam Turbine Blade and Framework for Life Assessment

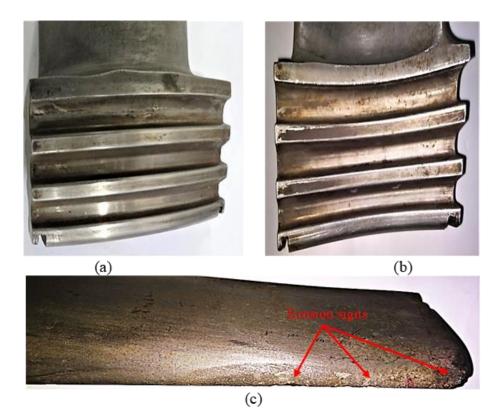
Figure 3.2. Blade root (a) back (b) front view with some dent marks (c) Erosion signs on blade's edges

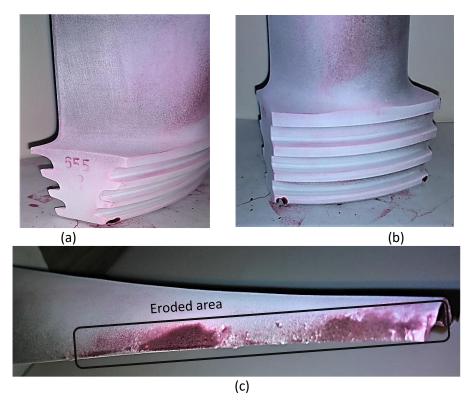
Figure 3.3 Blade root (a) side view (b) front view with no sign of a crack (c) Erosion pits on blade's trailing edge

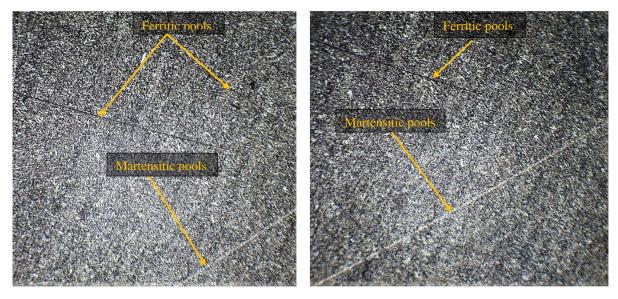
The damaged blade was also subjected to microstructural examinations. Standard metallographic sample preparation was followed by optical microscopy for this objective. Microstructures show uniform and homogeneous structures in the matrix. The hardened and tempered martensitic structure can be seen in the micrographs. Figure 3.4 shows the microstructure of the blade consisting of tempered martensitic and delta ferrite phases in the matrix.

Figure 3.4 Tempered martensite and ferritic pools can be seen in the microstructure (100x).

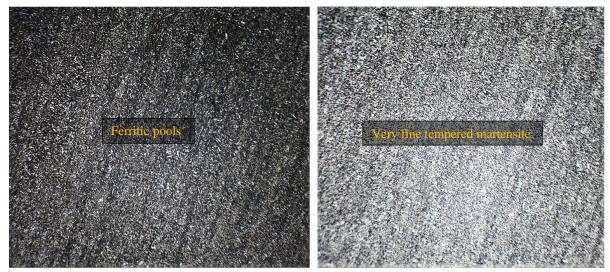
Figure 3.5 Optical micrographs at 100x of the root of damaged blade showing Very fine tempered martensite and ferritic pools.

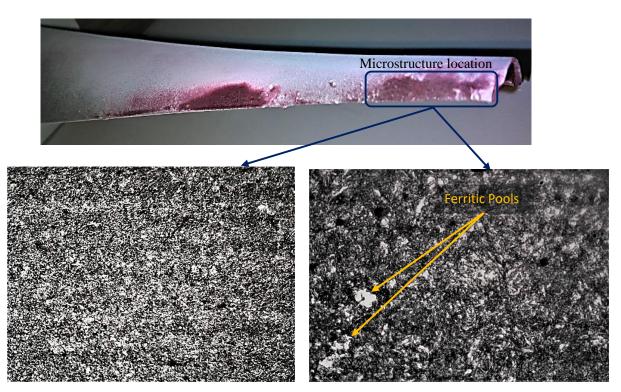
The eroded portion is further studied to know the changes in microstructure of blade due to erosion pits and the microstructure shows bainitic structure and retained austenite as shown in Figure 3.6. Delta ferritic pools has also been observed on the top eroded portion of blade. The bright white phase shows the presence of ferritic pools in microstructure shown in Figure 3.7. The grain boundary carbides were also observed as shown in Figure 3.8 was also observed. These grain boundaries will provide a path to crack propagation resulting in a faster rate of failure.

Figure 3.6 Microstructure shows bainitic and structure retained austenite (40x)

Figure 3.7 Microstructure shows delta ferrite pool (100x)

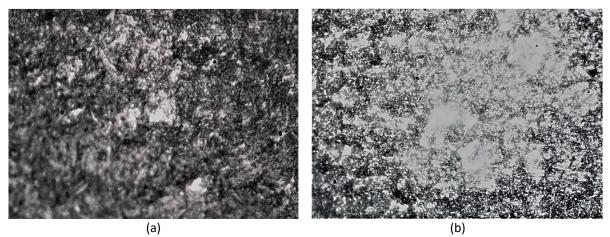
Figure 3.8 Microstructure showing grain boundary carbides (a) 200x (b) 400x

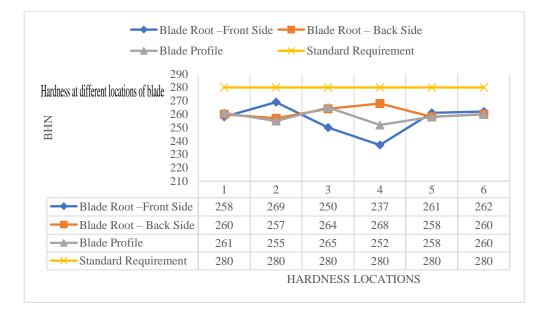
The average hardness value for blade root front side, blade root back side and blade profile are 256, 259 and 261 respectively.

Figure 3.11 Hardness at different locations of blade.

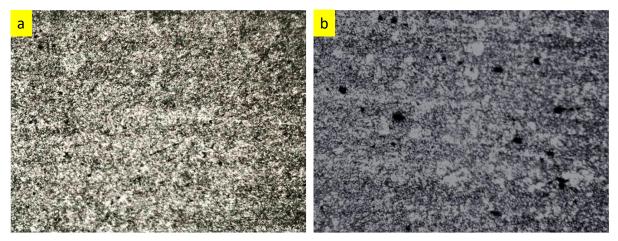
After visual inspection, the microstructure of the failing blade was studied in detail and compared to that of the original samples. Figure 4.3 shows a micrograph of a polished metallographic specimen cut from the blade airfoil region, illustrating a homogeneous microstructure composed of hardened and tempered martensitic grains. The airfoil of the failing blade showed no signs of microstructural degradation and was in line with the X20Cr13 specification (AISI 420).

Figure 4.3. Microstructure (100X) shows a) bainitic structure and retained austenite.b) Delta ferrite pool (Bright white phase) and grain boundary carbide are also observed.

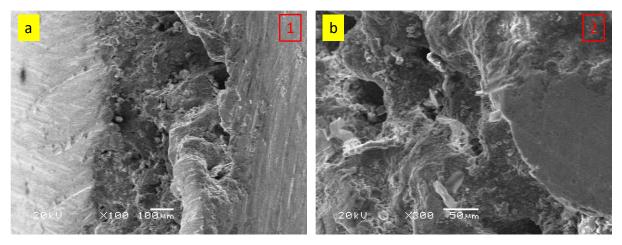
Fatigue striations are characteristic features that appear on the surface of a material that has undergone fatigue failure as shown in figure 4.5(a). These striations form perpendicular to the direction of the applied stress and are caused by the repeated loading and unloading of the material. Beach marks and ratchet marks are also visible. In SEM fractographs, erosion pits appear as circular depressions or craters on the surface of the material. Foreign particles shown in figure 4.5(b) are present at the edge of pits indicating that they were responsible for the erosion.

Figure 4.5 SEM fractographs of the eroded surface showing a) characteristic fatigue striations b) erosion pits with foreign particles at fractured edges.

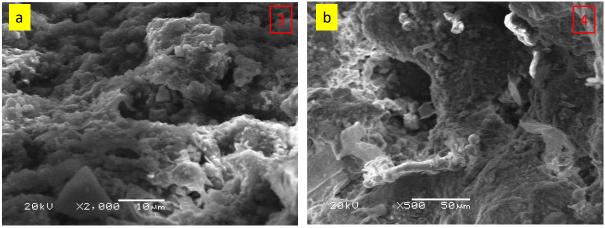
Figure 4.6 Fractographs showing a) micro void coalescence b) the presence of foreign particles in erosion pits.

These particles can also induce stress concentrations in the material, leading to crack initiation and propagation. In addition, the presence of foreign particles can also influence the corrosion resistance of a material.

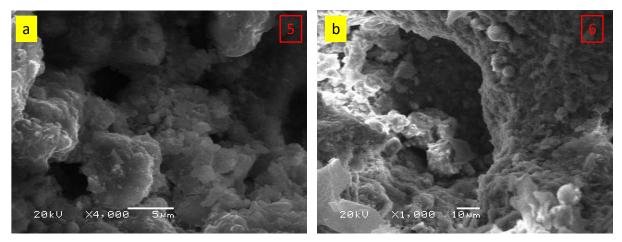
Figure 4.7 Fractographs of the fractured blade (a) indicating the presence of a substantial amount of Si (Silicon) in the grooves at 4000x b) Fractographs of the pit (region '6') at an enlarged scale1000x

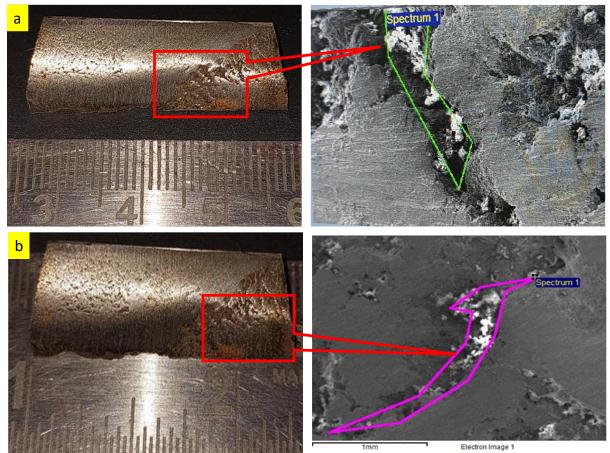
another impurity in steam that can cause erosion in turbine blades. It can react with the surface of the blade, leading to the formation of corrosive compounds that can cause material loss and pitting.

Figure 4.8 a) Evidence of Si was found using SEM-EDX. b) The EDS spectrum identifies the Silicon (Si) rich oxides with other alloying elements of Iron (Fe), Sodium (Na) and Manganese (Mn).

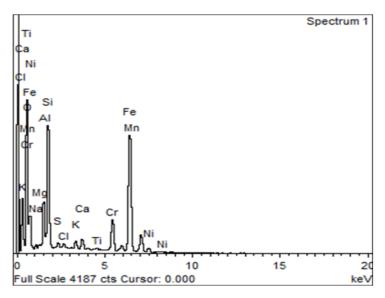
3. Formation of deposits: The impurities can deposit on the surface of the blade, leading to the formation of hard deposits that can cause abrasive wear and pitting.

Figure 4.9 The EDX analysis of the most eroded phases shows chlorine, titanium, iron chromium, and oxygen peaks.

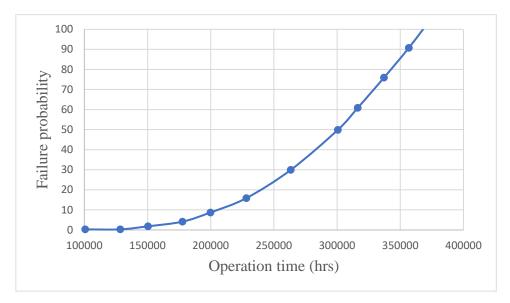
Figure 5.22 Failure probability at location 1

The probability of failure is 0.05% at location 1, where the damage level is currently around 0.7, which is very near to the critical value.

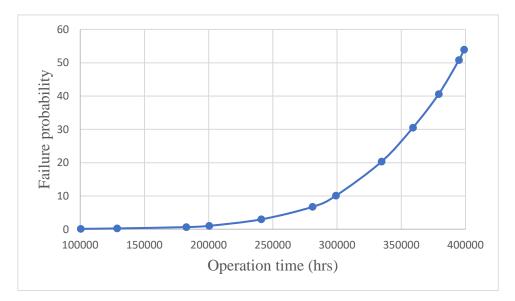
The failure probability is 0.05% at position 1, where the total damage value is approx. 0.7676 which is very near to critical damage, and 0.005% at place 2, where the damage is equal to 0.383.

Figure 5.23 Failure probability at location 2
