# **DAMAGE DISTRIBUTION AND BEHAVIOUR OF BUILDINGS IN BHUJ EARTHQUAKE -2001**

A DISSERTATION

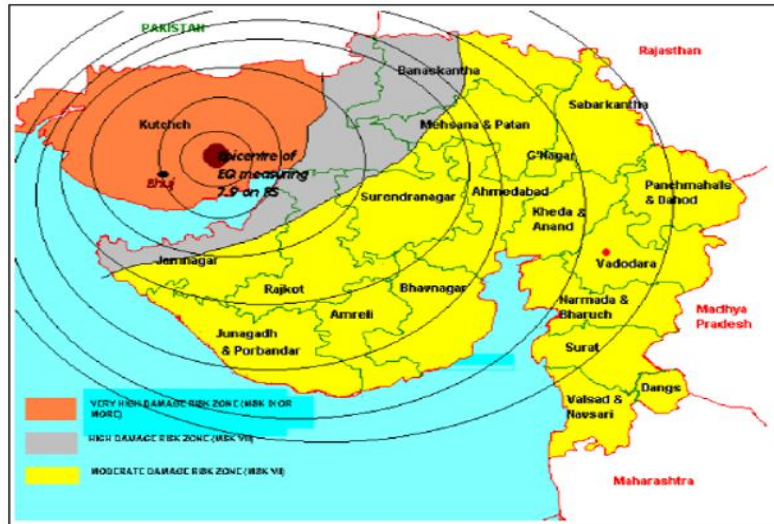
Map 1: Gujarat Earthquake Damage Zones (Source: United Nations, 2001)

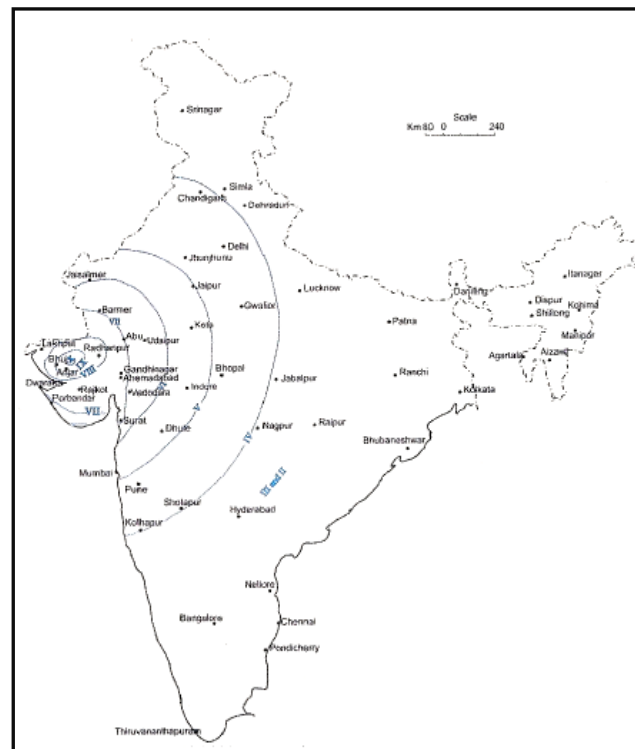
Map 2: Gujarat Earthquake Isoseismal map (Source: United Nations, 2001)

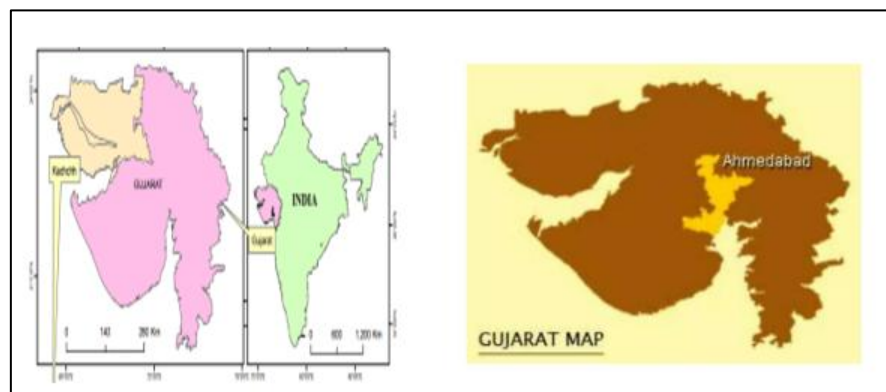
**Map 3:** Location map of the Study Area Kachchh and Ahmadabad district

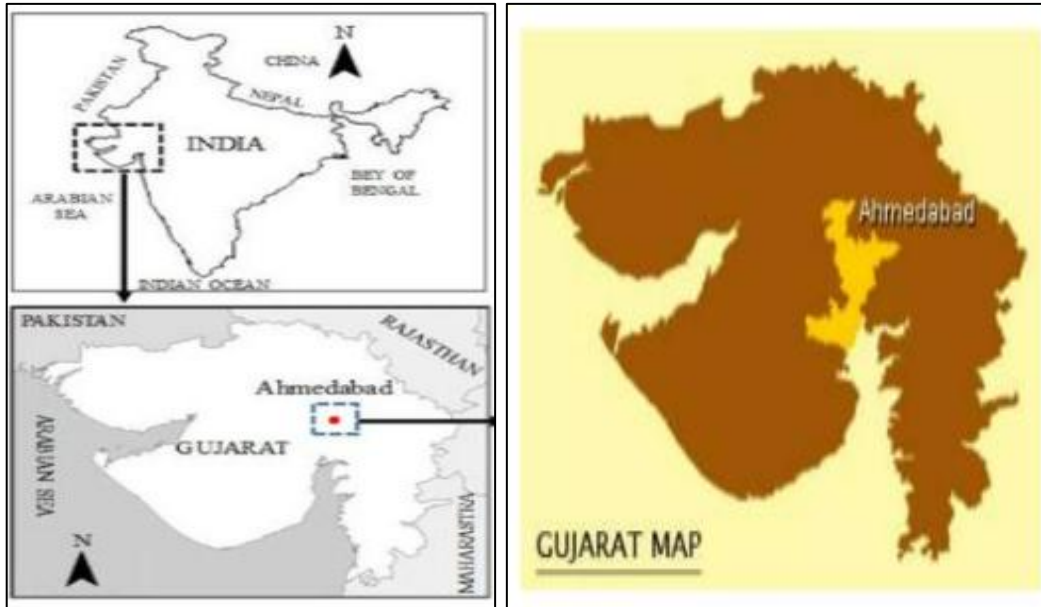
**Map 5:** Location map of the Ahmedabad district

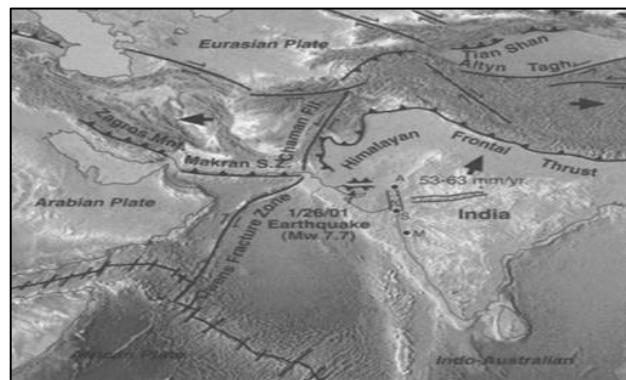
**Figure 1:** The Mw 7.7 Bhuj earthquake on January 26, 2001, occurred in northwestern India. The tectonic background of the earthquake was characterised by the displacement of crustal blocks, as represented by arrows representing large-scale motion.

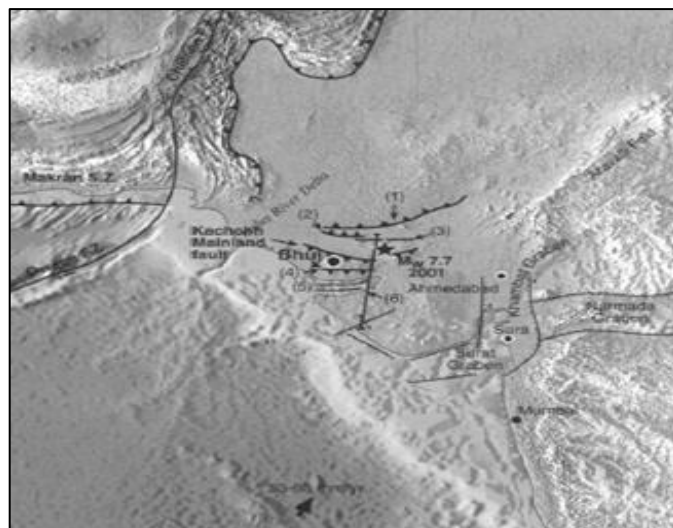
**Figure 2:** The Gujarat and adjoining regions exhibit significant tectonic features, including the Nagar Parker fault, Allah Bund, Island Belt, Katrol Hill fault, Gulf of Kachchh, Recently, an earthquake took place slightly north of the Kachchh Mainland fault.

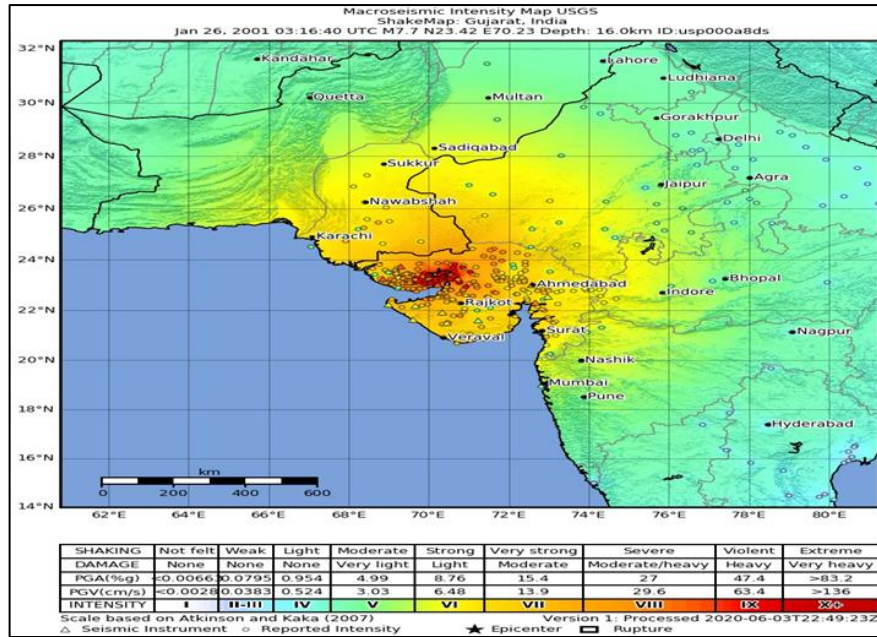
**Figure 5:** USGS SHAKEMAP (BHUJ EARTHQUAKE 2001)

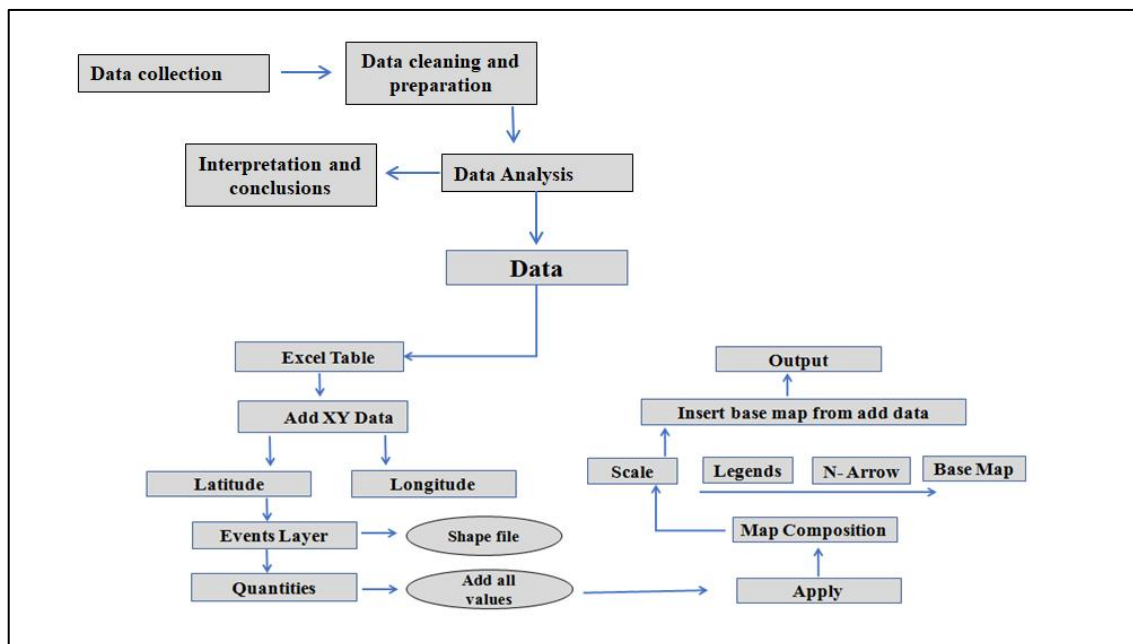
**Figure 6:** Flowchart of the Methodology

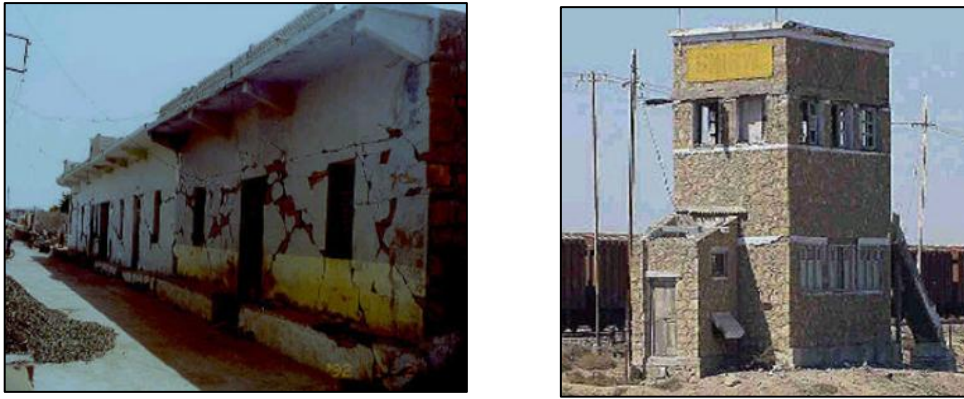
Figure 7: Rubble masonry with concrete roof and Seismic bands

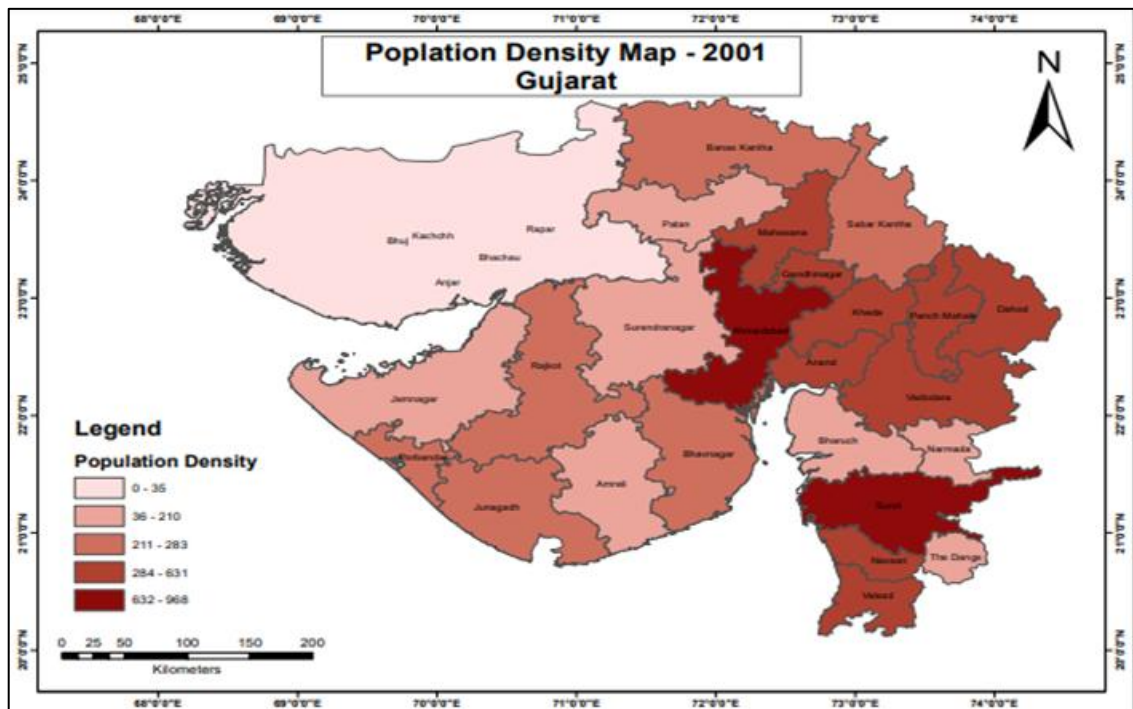
The map referred to is known as a population density map. It is a type of thematic map that focuses on the distribution of people over a specific geographical area, highlighting areas with higher or lower population densities. Population density is a measure of the number of people per unit of area, typically expressed as the number of individuals per square mile or kilometre. To create a population density map, the total population of a particular geographic area, such as a city, state, or country, is divided by the total land area of that region. The resulting value is then used to create a color-coded or shaded map that shows the population density of different areas. In population density maps, areas with higher population densities are typically represented using darker shades of colour, while areas with lower population densities are represented using lighter shades.

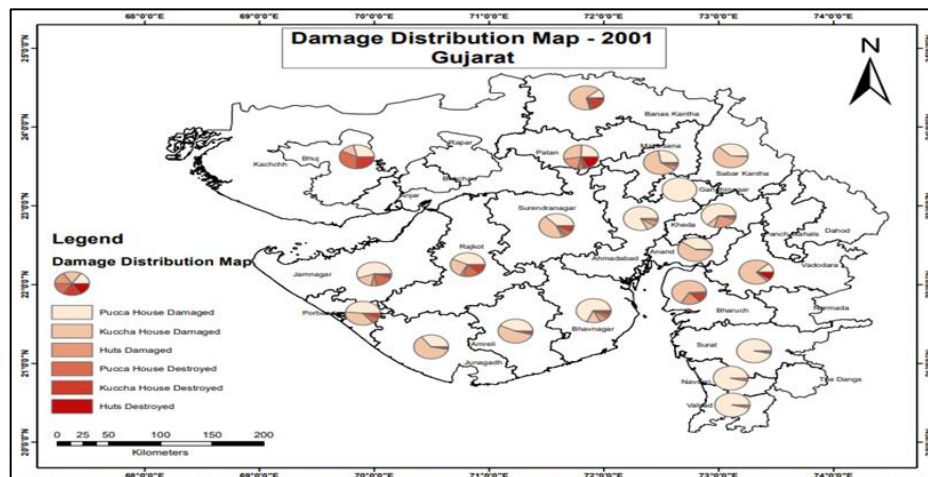
##### 4.6.1 Pucca house and % damage in Kutch -2001

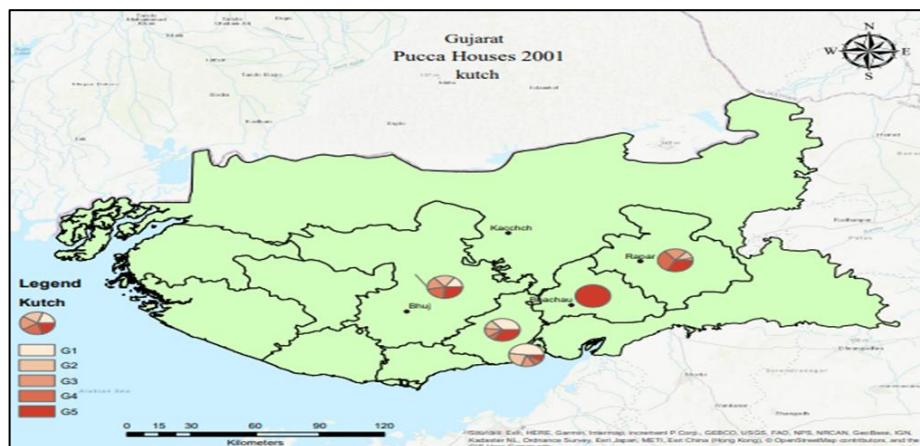
This map represents that how much intensity of damage occurred in a specific region, there are five categories of damage occurred with the pucca house. And through the spatial analysis, we can represent the data in a meaningful manner. (same with Kuchha house)

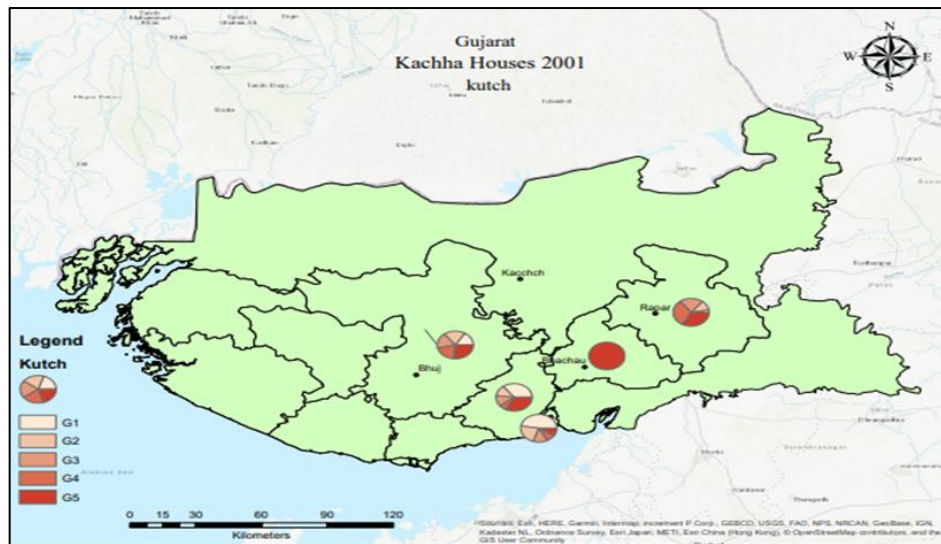
As the map shows, kutch houses and huts were the most vulnerable to damage, with 85% and 90% of these buildings suffering total damage, respectively. Pucca houses, which are made of more durable materials, were also significantly affected, with 60% of them suffering total damage.

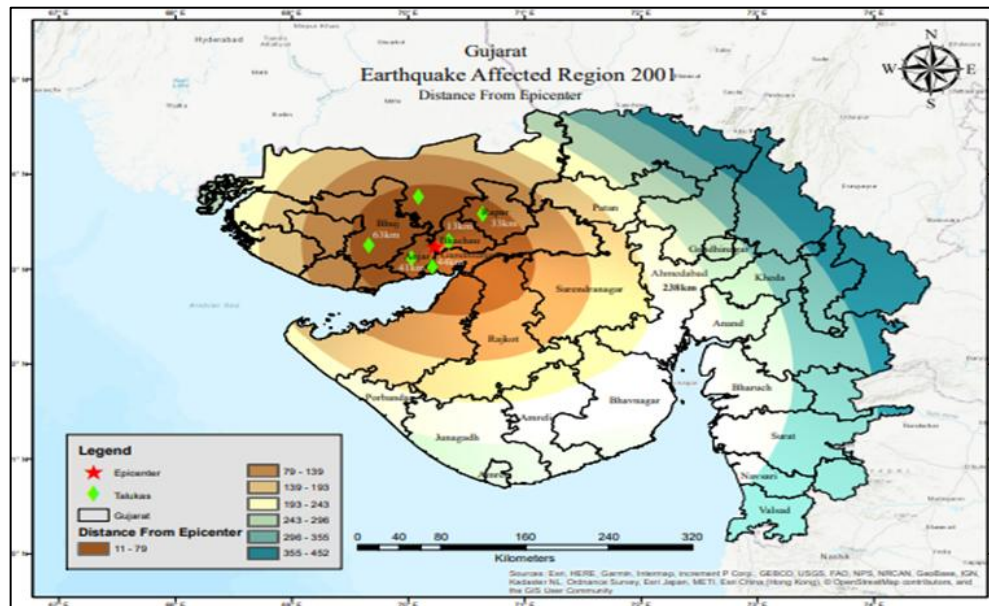
**Rapar** is another town in the Kutch district, located about 33 kilometers east of Bhuj. The town had a population of around 198000 people at the time of the earthquake and suffered significant damage. However, the intensity of the earthquake was higher in radar, and the percentage of death is lower relatively, with **0.37%** deaths and many more injuries.

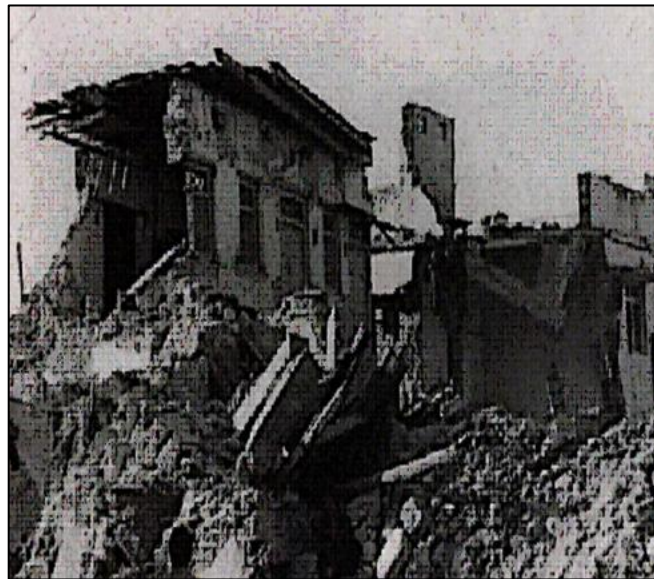
**Figure 9:** Anjar- stone in mud house

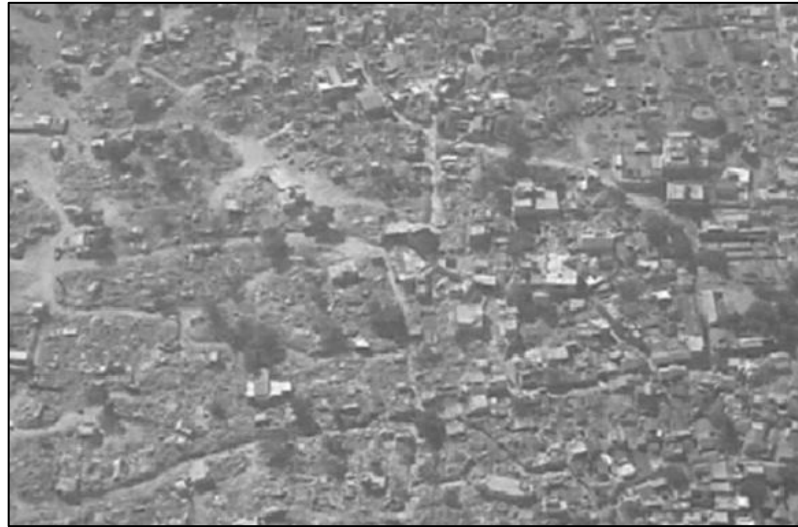
**Figure 10:** The aerial photograph of Anjar depicts extensive destruction on the left side of the image and comparatively minor damage on the right..

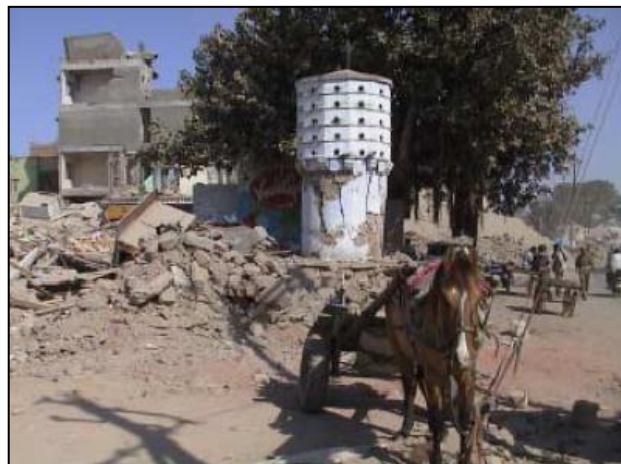
**Figure 11:** A pigeon house, built with masonry in mud mortar, was standing amidst complete destruction despite being badly cracked.

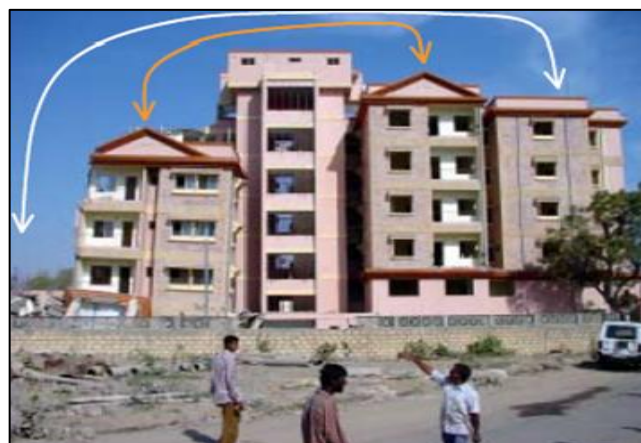
**Figure 12:** depicts a new reinforced concrete building in Anjar, located north of the pigeon house shown in **Figure 11**. The building was badly damaged and partially collapsed. It appeared to have been designed with a central set of stairs, symmetrically dividing the building into two sections

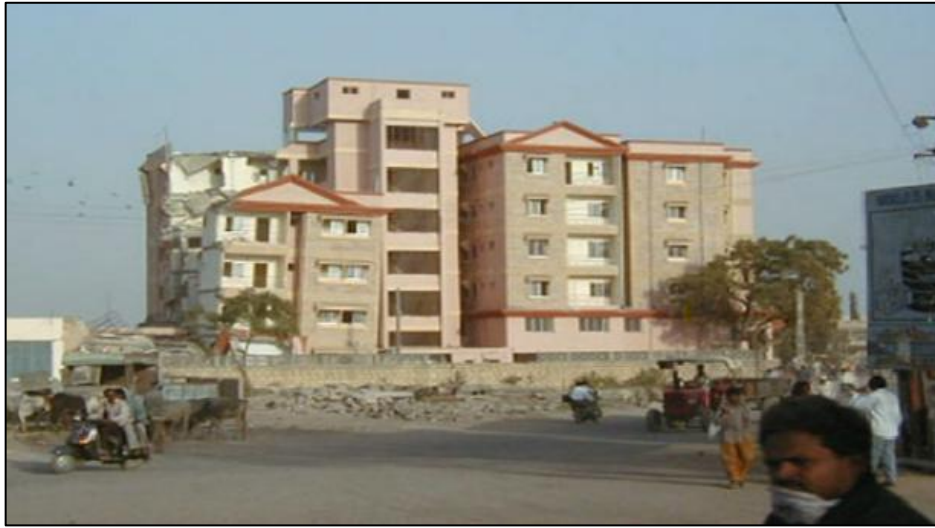
**Figure 12:** Partial collapse of an apartment building Anjar

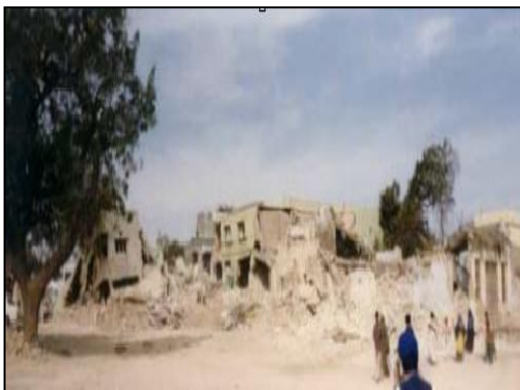
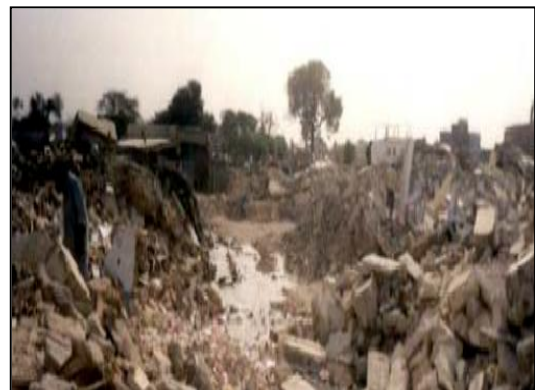
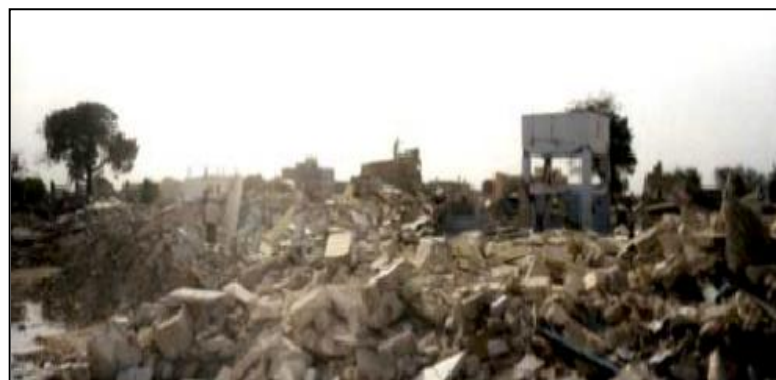
**Figure 13:** Destruction of masonry structures in the old section of Anjar

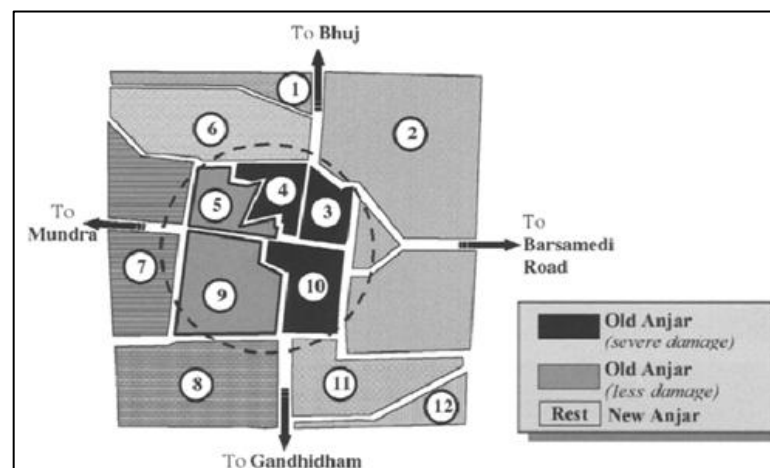
**Figure 14:** The buildings that demonstrated good performance in Anjar were situated in close proximity, about 2-3 blocks away, from the location where the photos in Figure 13 were captured.

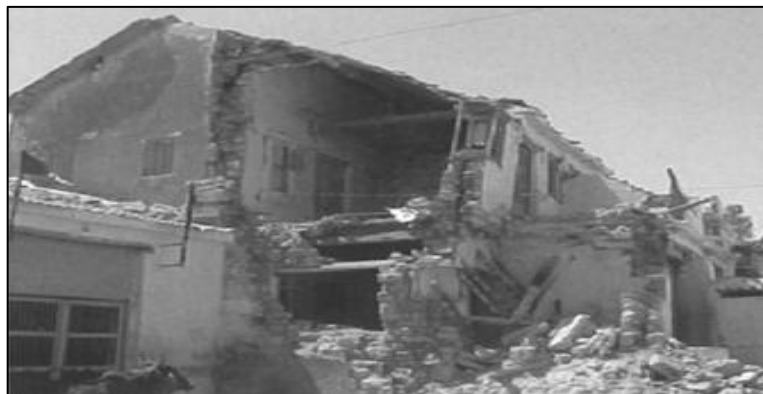
**Figure 16:** Due to the lack of through-stones and the use of thick walls made of small rubble, the walls often split into two layers, which compromised their ability to bear gravity loads.

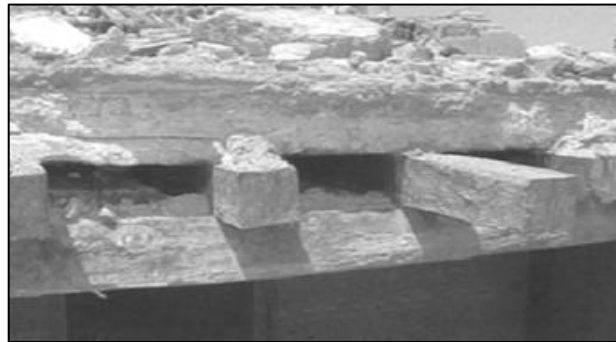
**Figure 20:** Damage or failure caused by interrupted runners over interior walls

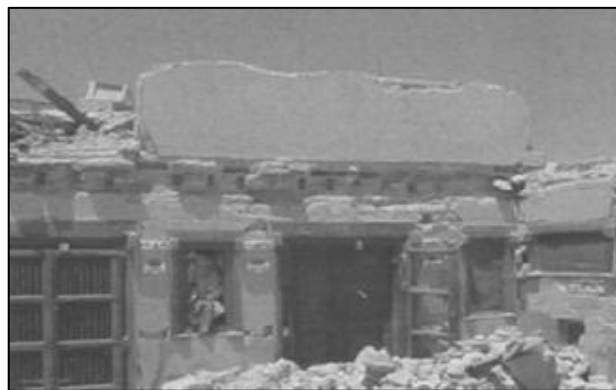
**Figure 21:** Floor separation occurred during intense shaking.

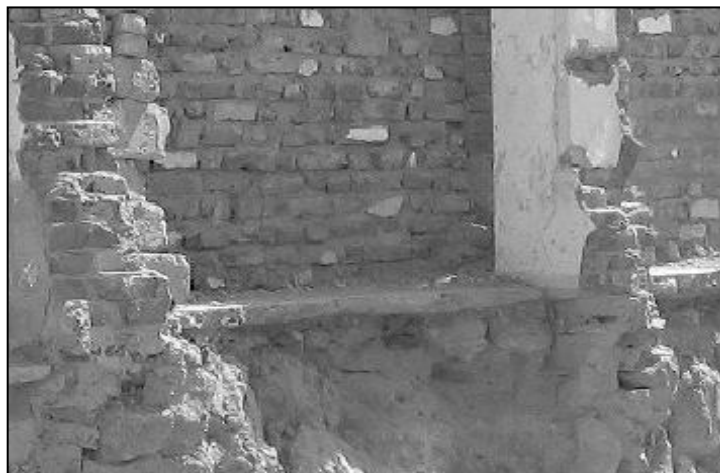
**Figure 22:** structure that is not designed. Before the earthquake, burned clay bricks and mud mortar were often used to build walls in Bachhau homes.

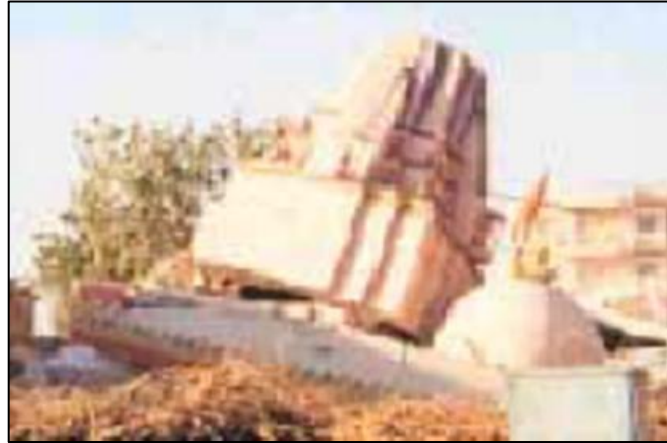
**Figure 23:** Destruction of a 5m tall temple at Bacchau

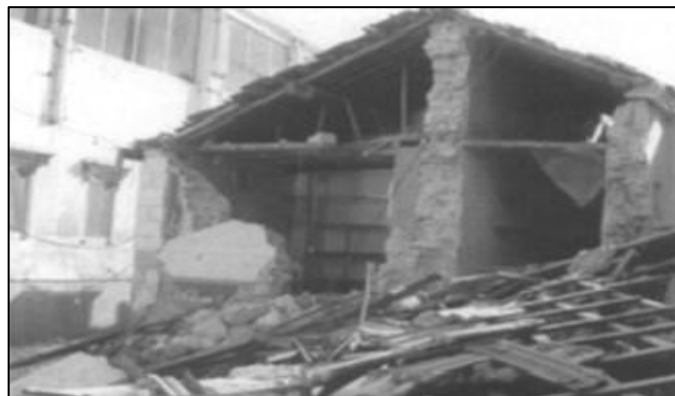
**Figure 25:** Damage to masonry construction due to inadequate connections between the walls

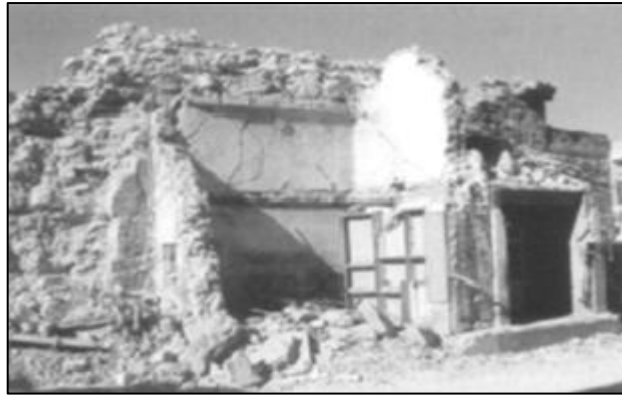
**Figure 26:** Damage to masonry construction due to inadequate connection between the walls

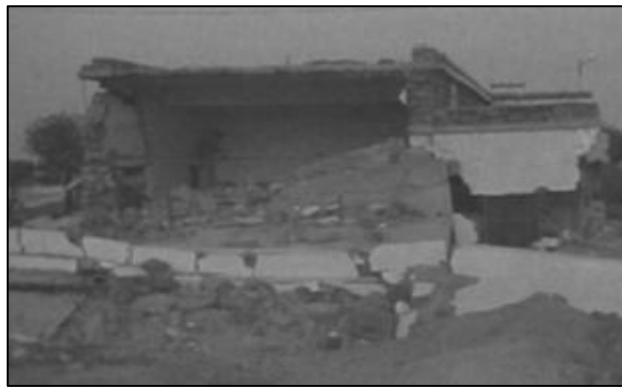
**Figure 27:** Collapse of this masonry structure was done to wall failure

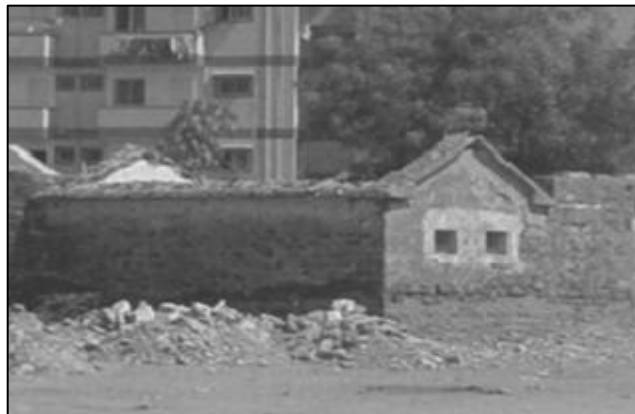
**Figure 28:** In a few instances, such as this masonry structure, the roof alone was responsible for Structural collapse

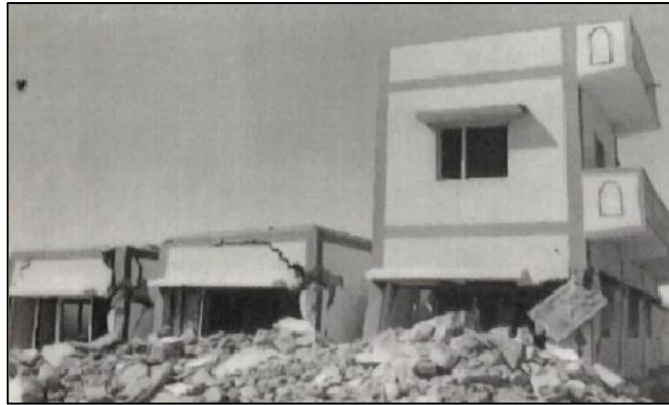
**Figure 29:** Rigid box-like behaviour above lintel band (Bachau)

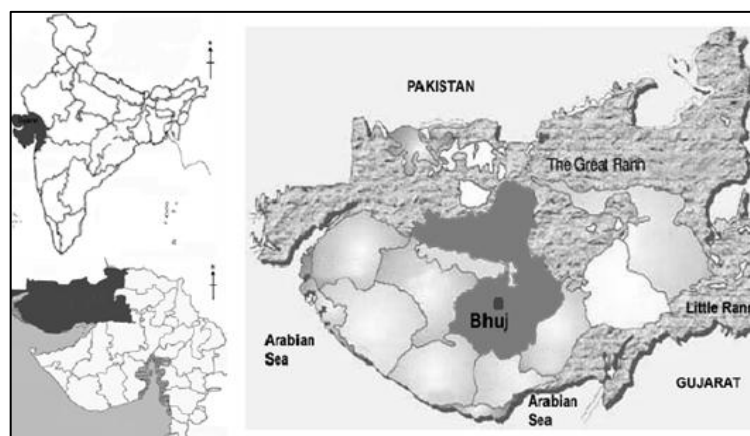
**Figure 30:** Bhuj location map. Maps on the left show location of Gujarat state of India (top left) and kutch district in Gujarat state( bottom left).(source: Maps Rewoked , Base maps from [www.mapsofindia.com](http://www.mapsofindia.com) )

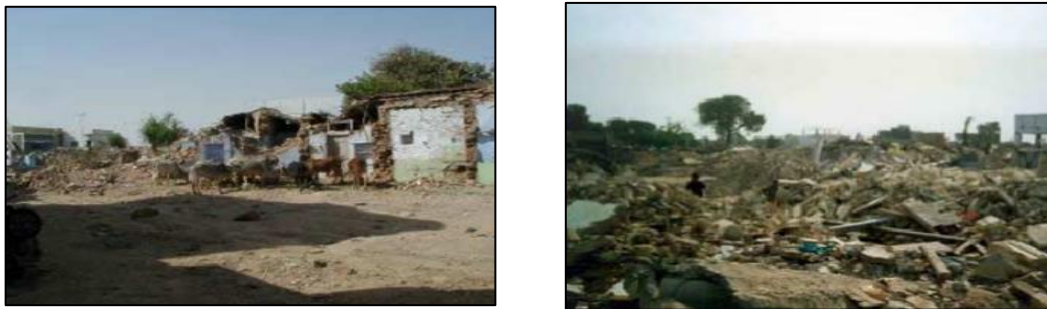
**Figure 31:** Most stone houses in the old town of Bhuj collapsed and Destruction in Bhuj

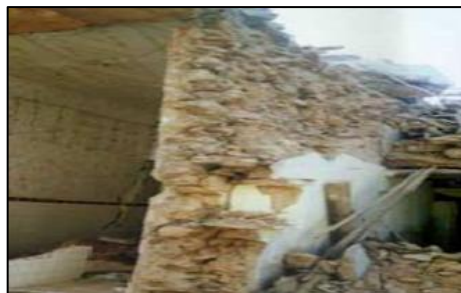
**Figure 32:** Damage to a rubble stone and mud mortar house in old Bhuj

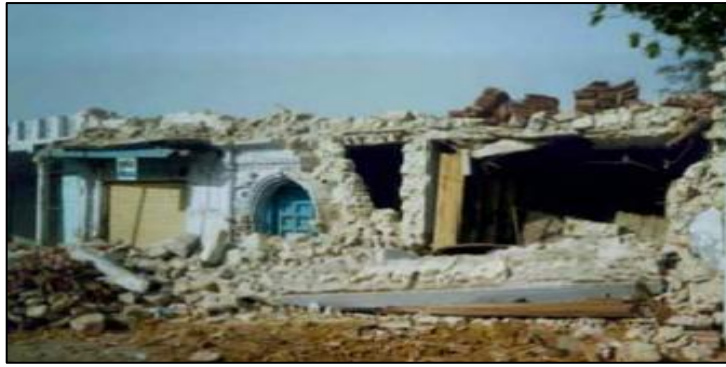
**Figure 33:** Damage to cutstone and lime mortar masonry building in old bhuj

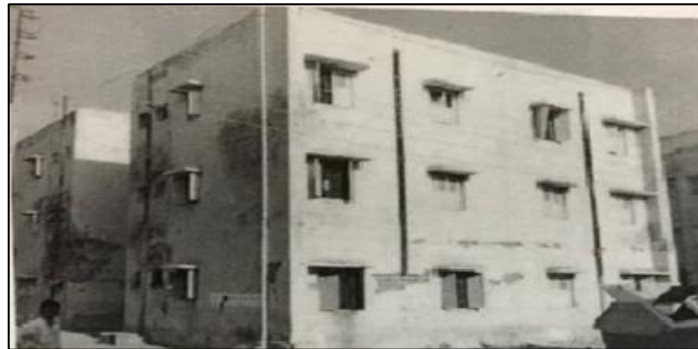
**Figure 34:** BHUJ: Stone in CM masonry building with minor damage

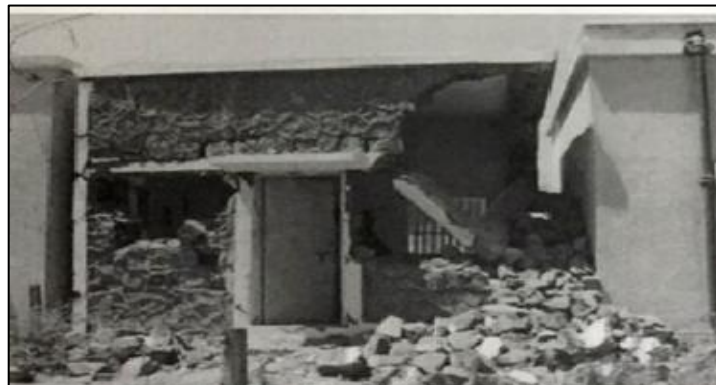
**Figure 35:** BHUJ: out of plane failure along with Lintel band failure.

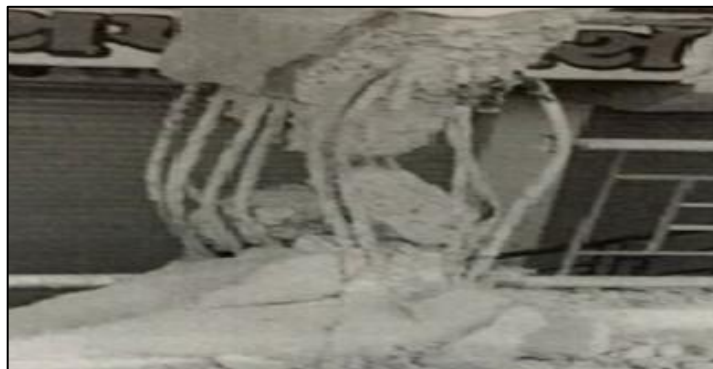
**Figure 36:** BHUJ: RC column failure

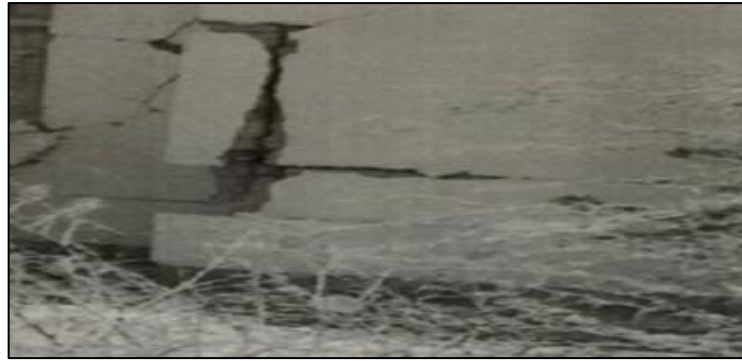
**Figure 37:** BHUJ: corner failure in the presence of corner reinforcement

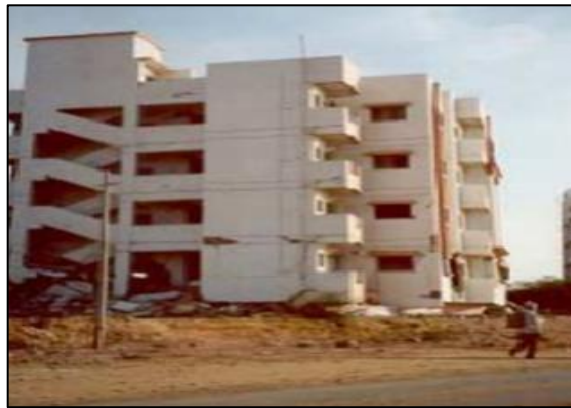
**Figure 38:** Soft storey collapse of a five storey apartment building in Bhuj

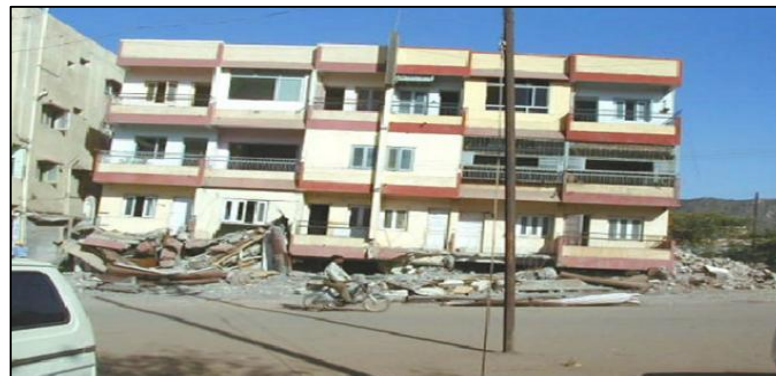
**Figure 40:** Typical soft storey collapse in Bhuj

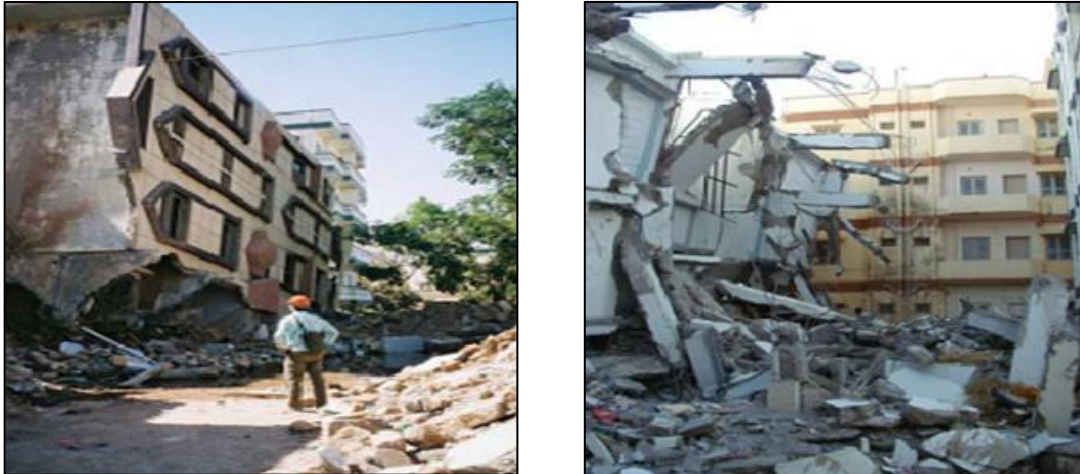
**Figure 41:** Overturned building in Bhuj

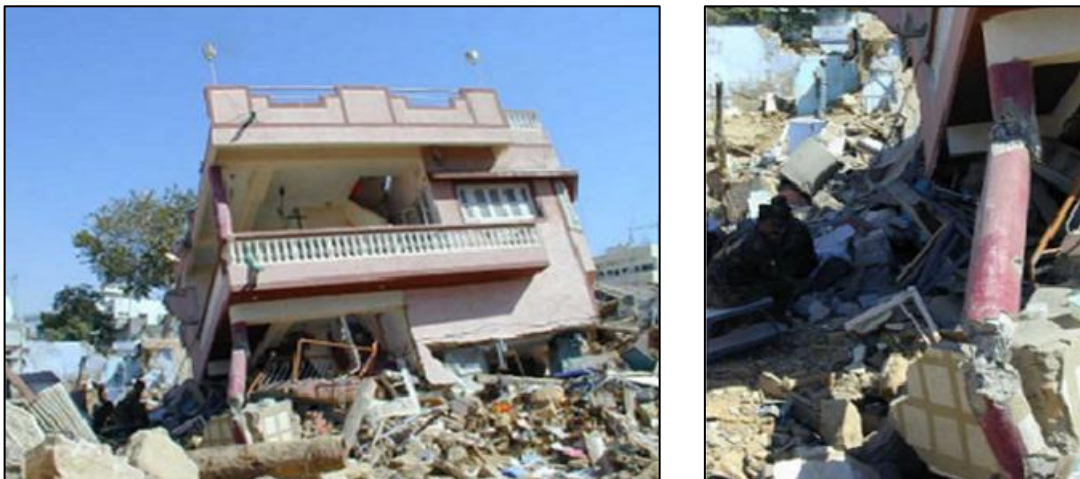
**Figure 42:** Building collapse in Bhuj

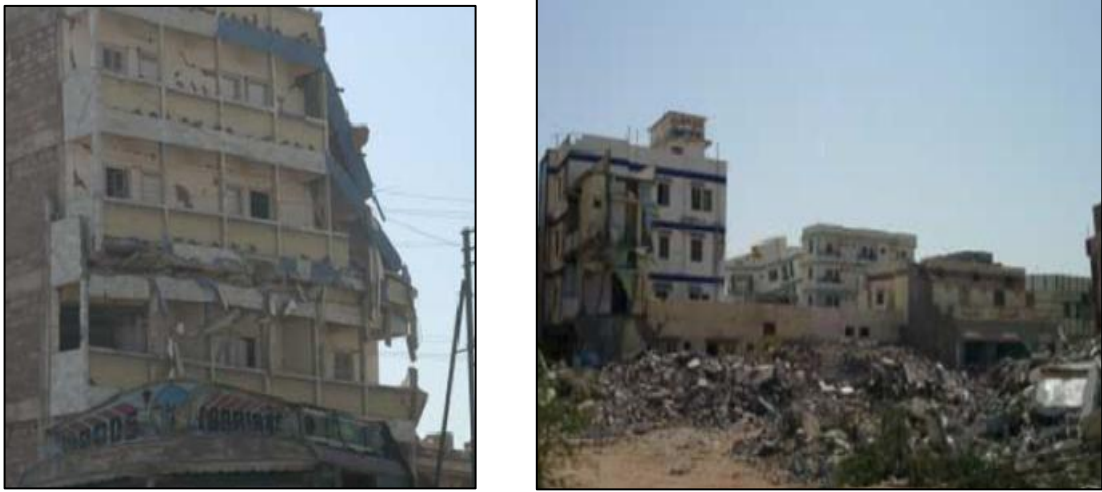
**Figure 43:** Partly collapsed massive concrete framed building structure with infill brick masonry wall

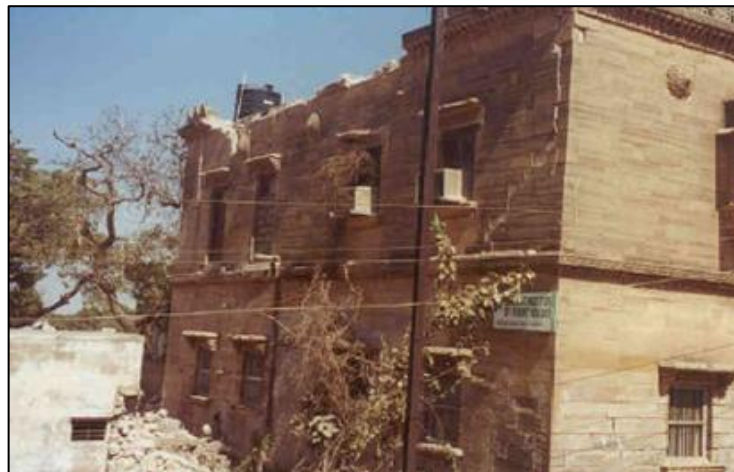
**Figure 44:** Cut-stone building in bhuj

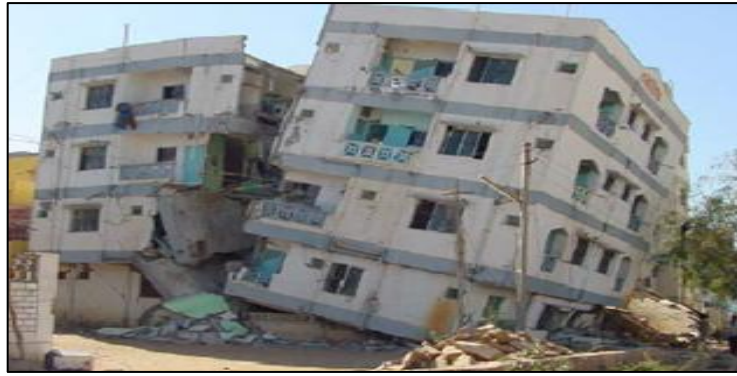
**Figure 45:** Collapsed open ground storey building in BHUJ

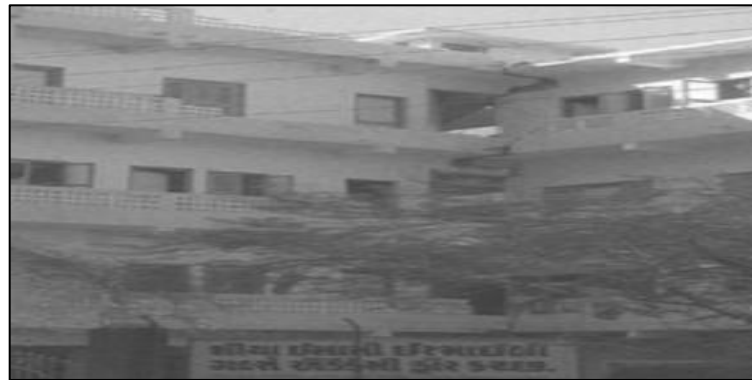
**Figure 46:** Damage to floor slabs and columns at the re-entrant corner of L-shaped building in bhuj

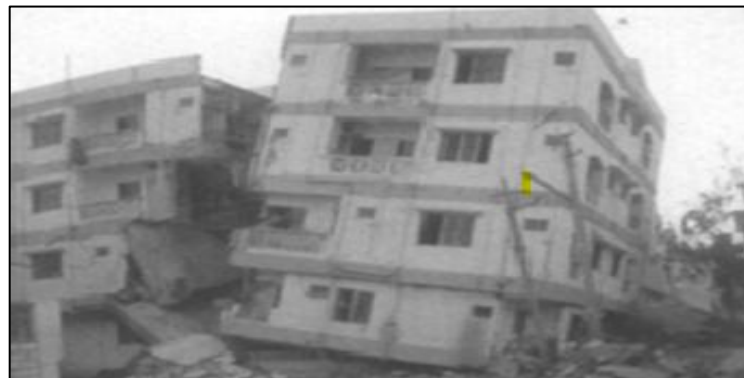
**Figure 47:** collapse of a partially open ground story building in bhuj , coupled with vertical split of the building at the midline

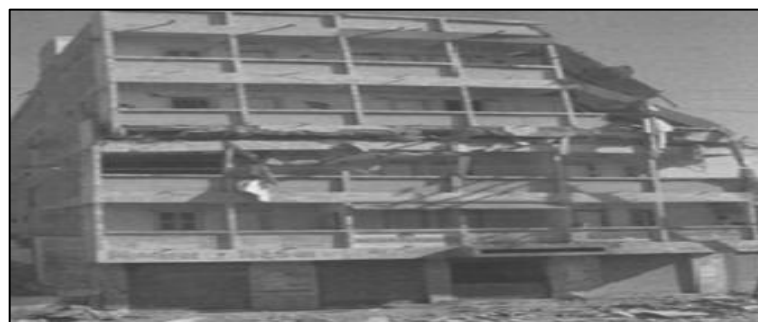
**Figure 48:** Intermediate story collapse in the 6 story building in Bhuj

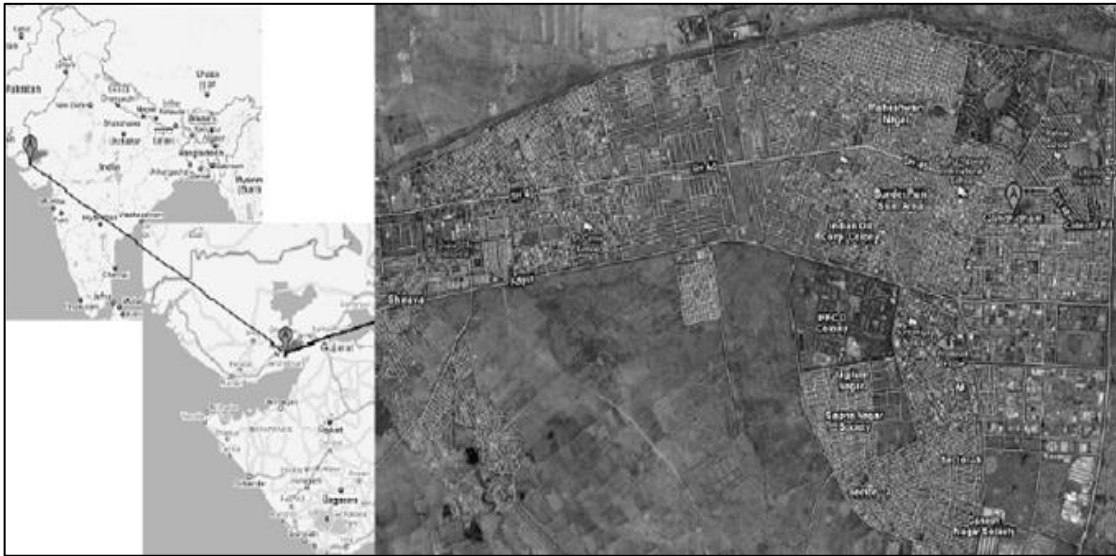
**Figure 49:** Map showing Gandhidham and Adipur cities (Image courtesy Google maps)

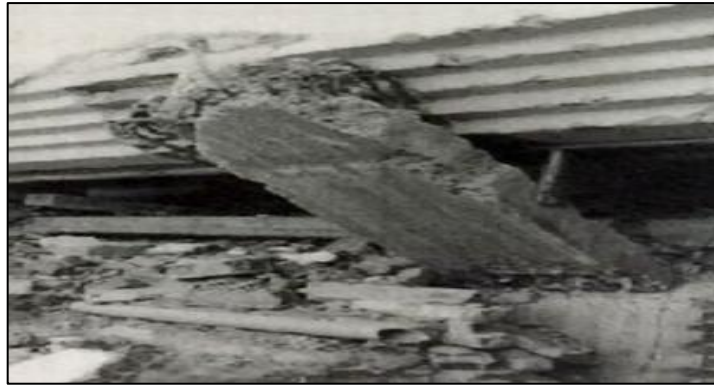
**Figure 50:** Gandhidham: Column failure – shaking in weaker direction

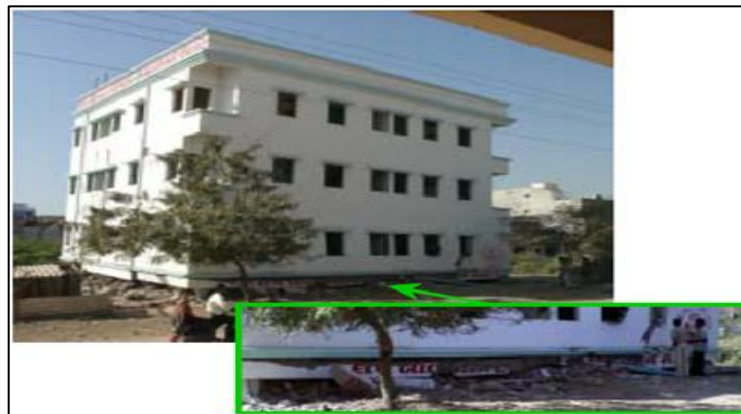
**Figure 51:** The collapsed ground floor of the children's hospital and research center in Gandhidham is a typical example of soft ground floor failure, as shown in the inset close-up view.

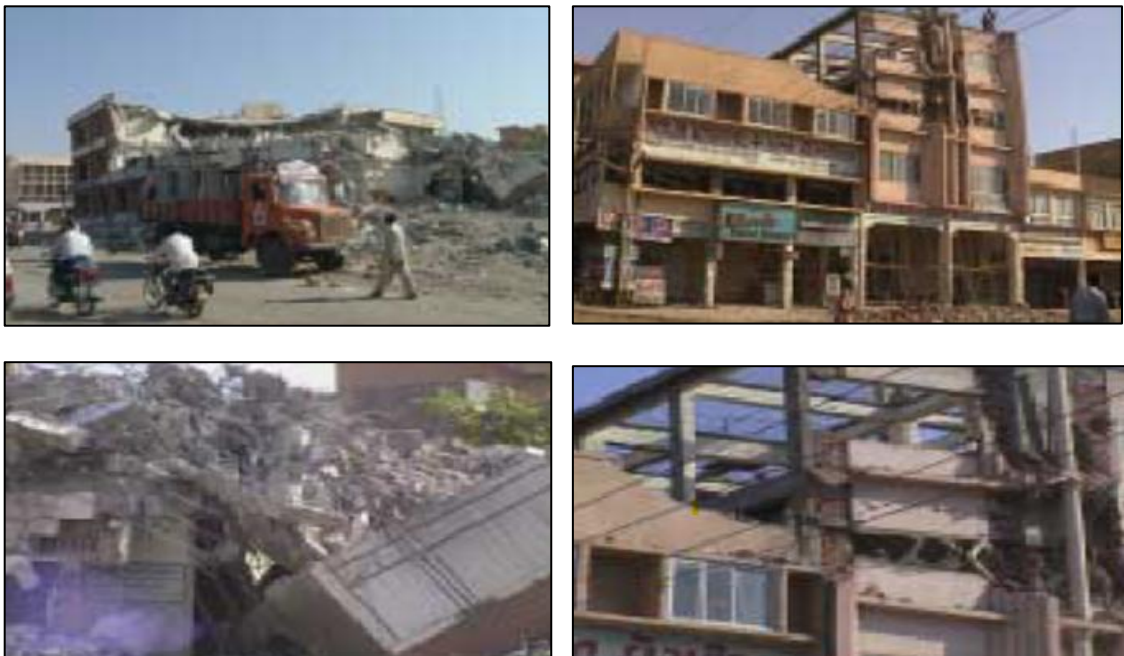
**Figure 52:** Manual demolition and removal of wreckage of damaged hospital building with mid-floor collapse in gandhidham. wreckage showing showing clear separation of concrete and steel.(RCC) and indicated the quality of material.

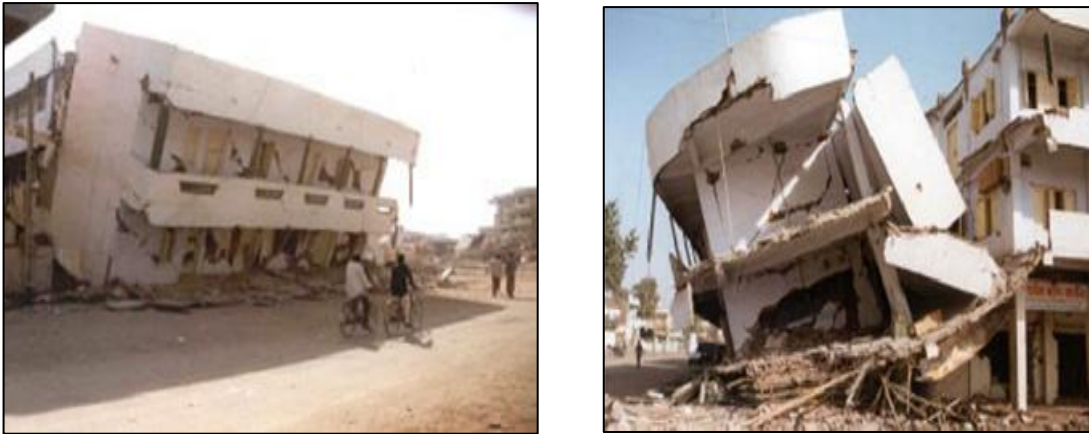
**Figure 53:** Image showing soft storey building collapse in Gandhidham, highlighting absence of structural integrity.

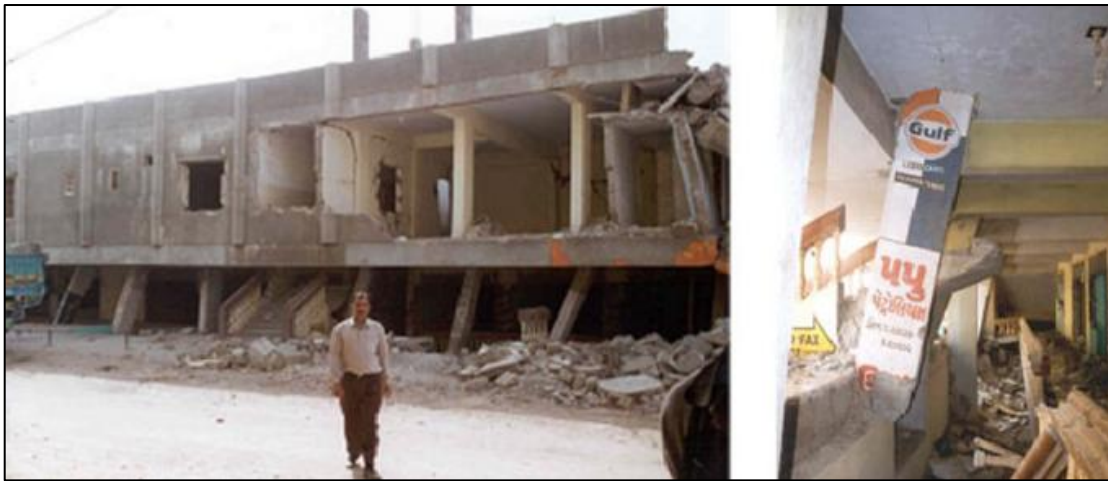
**Figure 54:** Image showing collapsed apartment complex in Gujarat, due to lack of continuous reinforcement causing failure where in, columns failed to resist shear and moments due to poor detailing and materials, particularly at the top and bottom of the columns. The basement and first storey levels collapsed, and the columns punched through the slab after shearing off the beam-column connection.
