# **DAMAGE DISTRIBUTION AND BEHAVIOUR OF BUILDINGS IN BHUJ EARTHQUAKE -2001**

A DISSERTATION

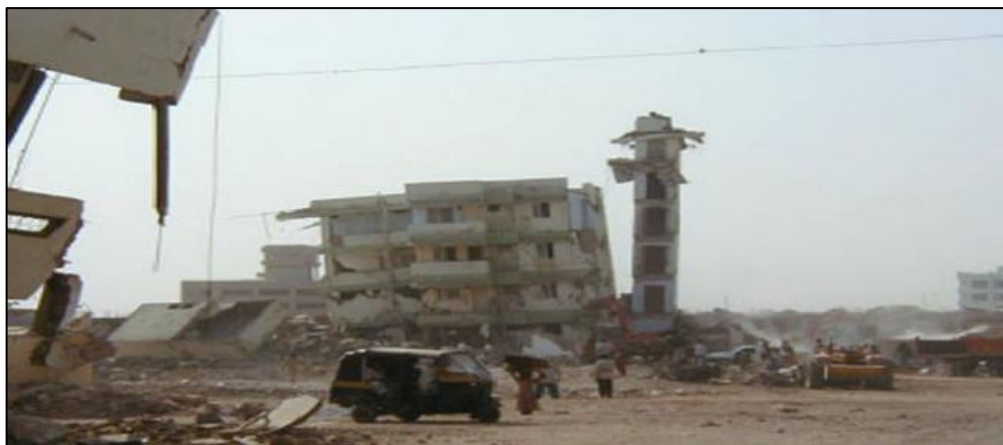
**Figure 55:** combination of collapses in Gandhidham

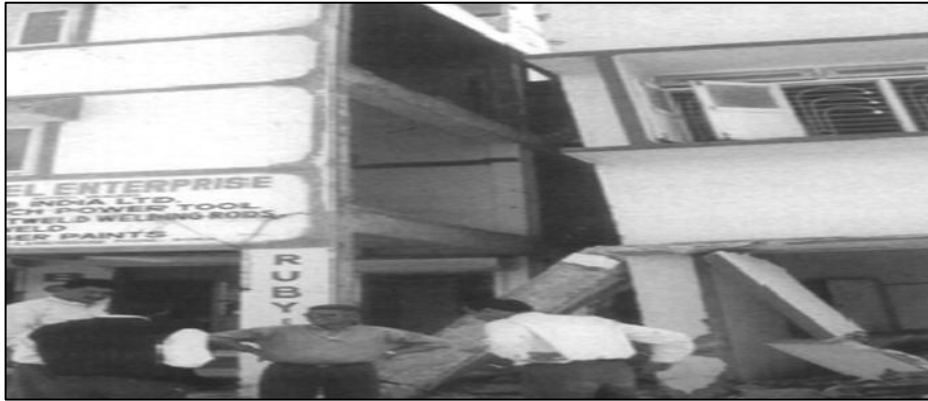
**Figure 56:** This area of Gandhidham has many row constructions where there is little to no space between adjoining buildings. In some cases, infills are only made in one of the two buildings at the interface. The building on the left had no infills in the upper stories, while the building on the right experienced a collapse at the ground story.

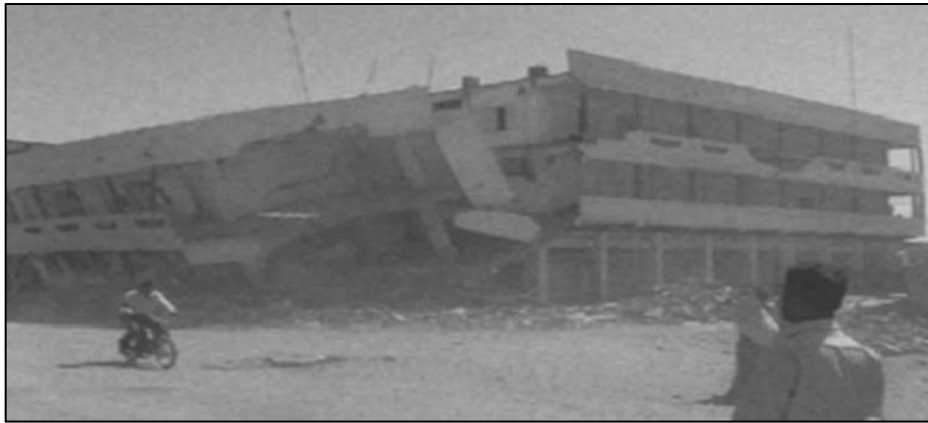
**Figure 59:** collapse of a corner of an L-shaped building in Gandhidham was caused by the failure of the floor diaphragm at the re-entrant corner.

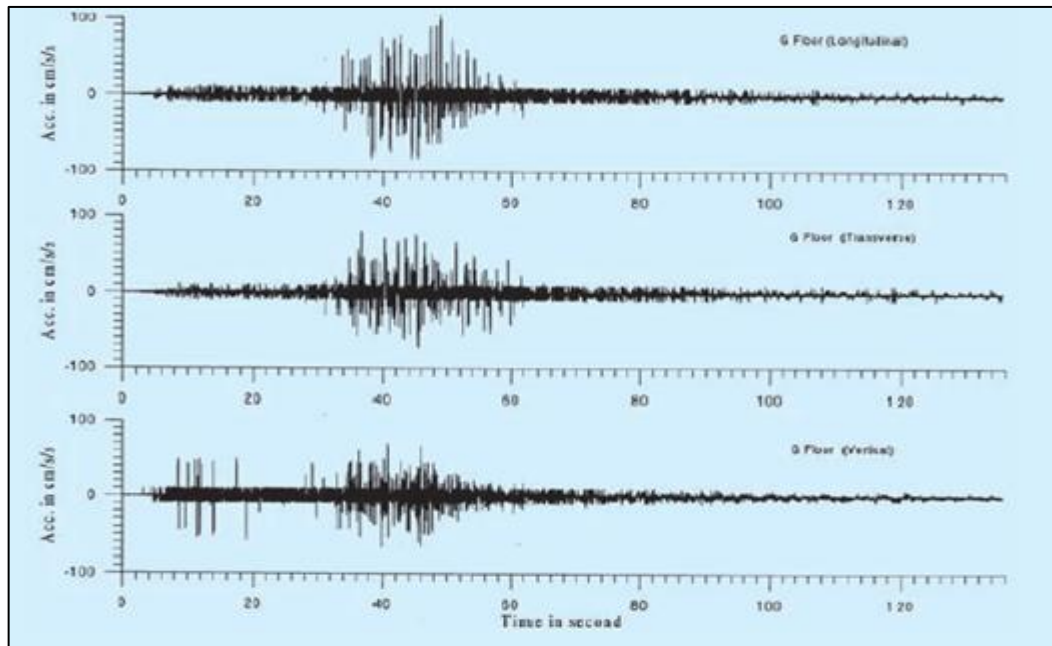
**Figure 60:** Accelerogram -recorded at the basement of building in downtown Ahmedabad

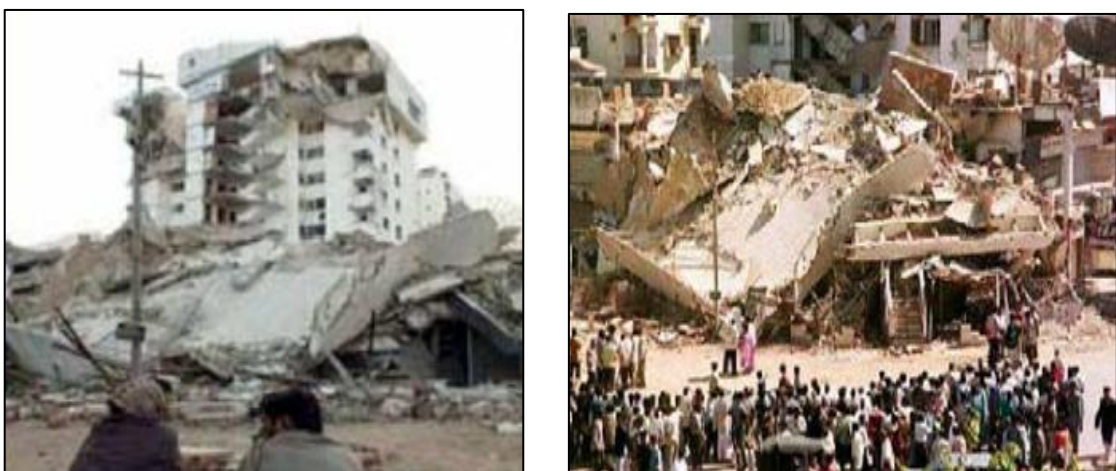
**Figure 61:** The multistorey building (Mansi complex) in Ahmadabad soon after the earthquake, shown in both general and close-up views.

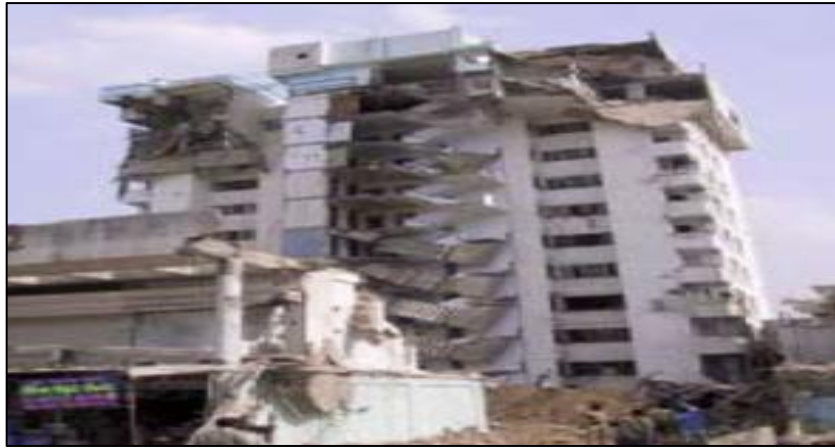
**Figure 62:** The 11-story building in front of Mansi Apartments, Ahmadabad collapsed due to a soft story. The presence of a swimming pool and reservoir at the top of the building added to the severity of the damage.

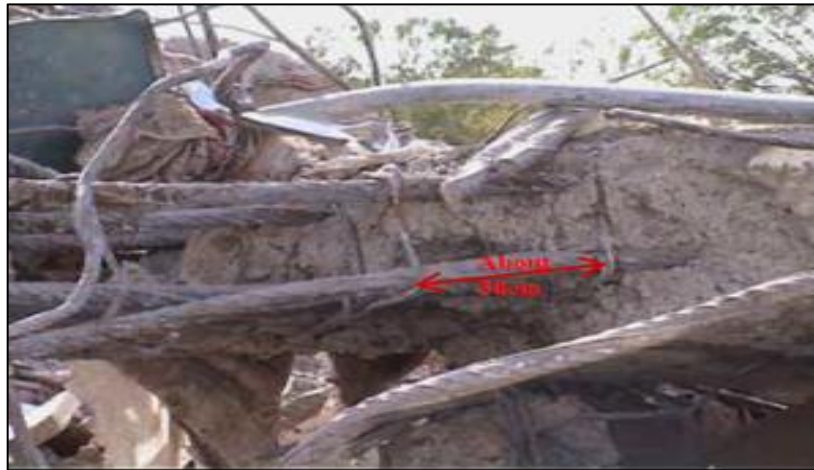
**Figure 63:** This image provides a detailed look at the debris of Mansi complex, revealing the placement of reinforcement and the quality of concrete used in the collapsed columns.

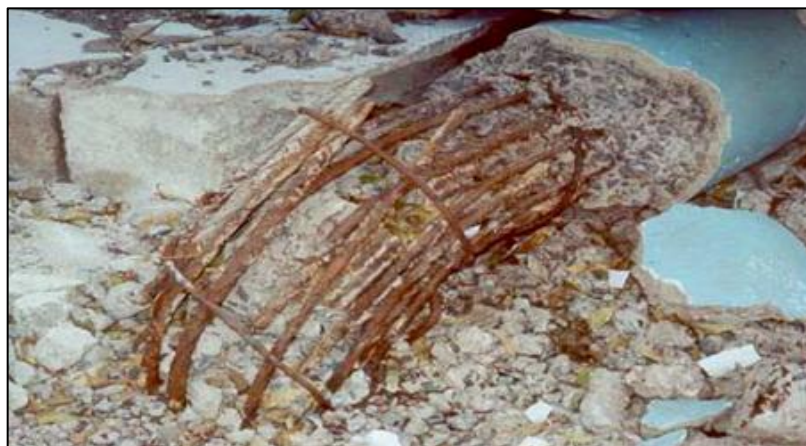
**Figure 64:** This image shows the reinforcement details of a column that failed in a soft storey collapse. It is apparent that the longitudinal bars are heavily congested due to their lapping at one location, and there are insufficient lateral ties over the splice length

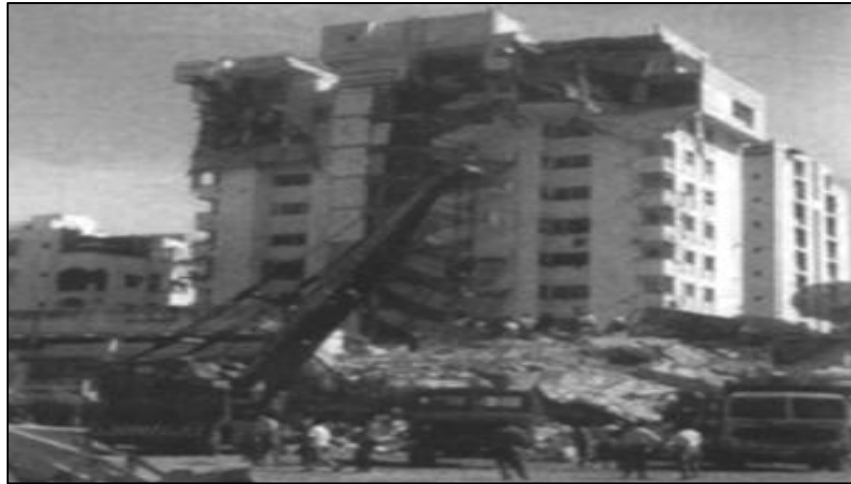
**Figure 65:** Collapse of flexible side of 11-story apartment building in Ahmedabad due to plan Irregularity

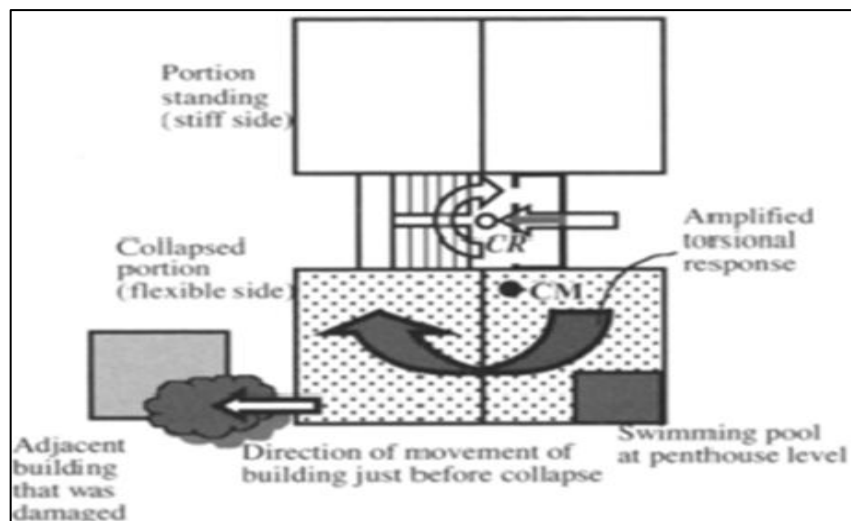
**Figure 66:** Damage and schematic representation of failure

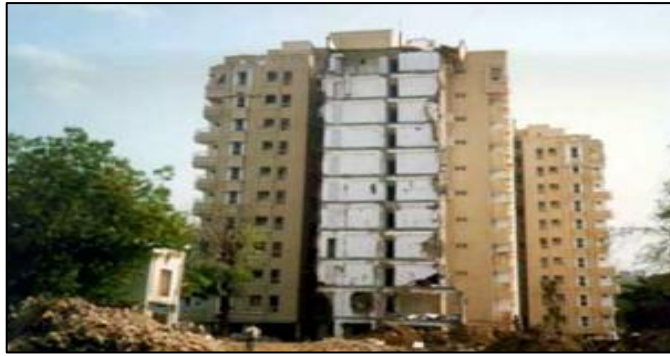
**Figure 67:** Shikhar apartments, Ahmadabad .Building collapsed due to soft story effects

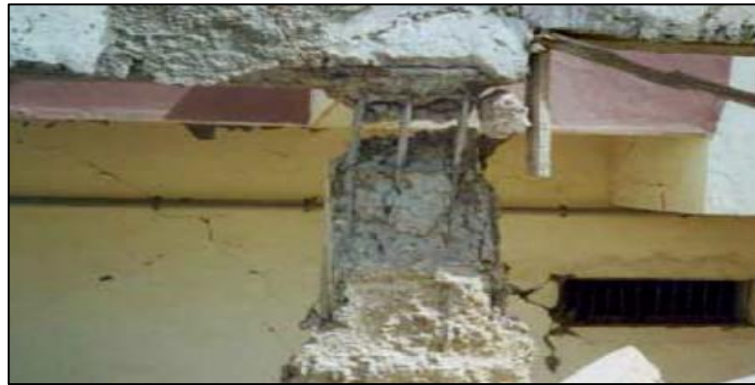
**Figure 71:** Poor quality concrete and lack of seismic detailing evident in beam column connection

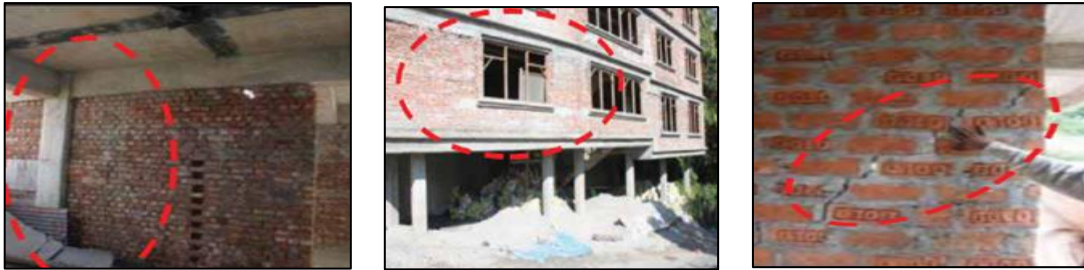
**Figure 72:** Unreinforced Masonry infill's

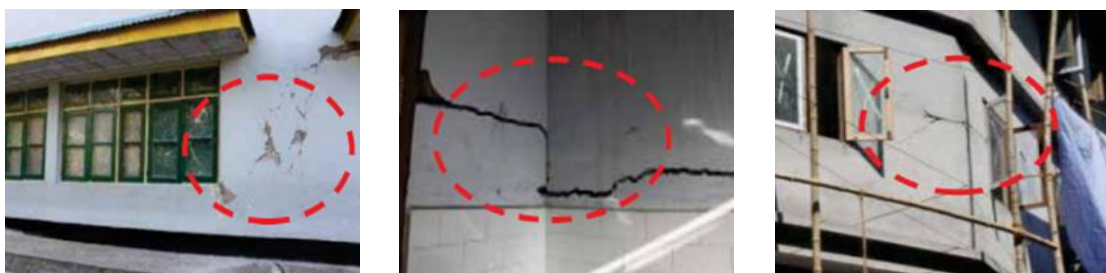
**Figure 73:** Damages in Unreinforced Masonry infill's

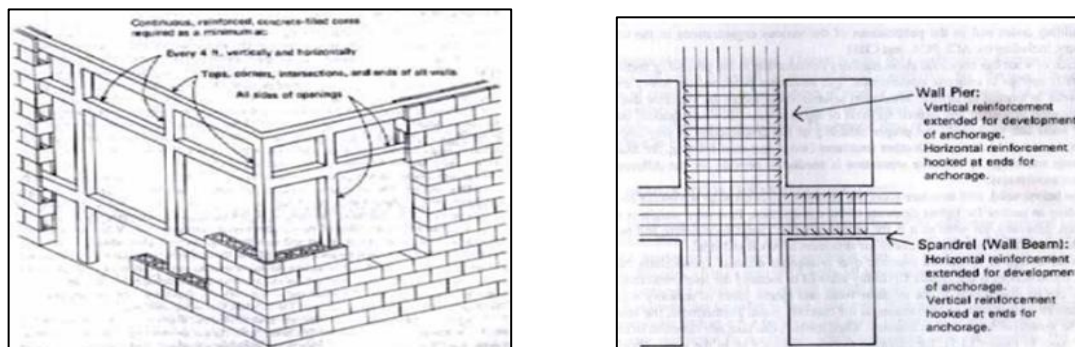
**Figure 74:** Details of Bracing for Masonry Walls A & B

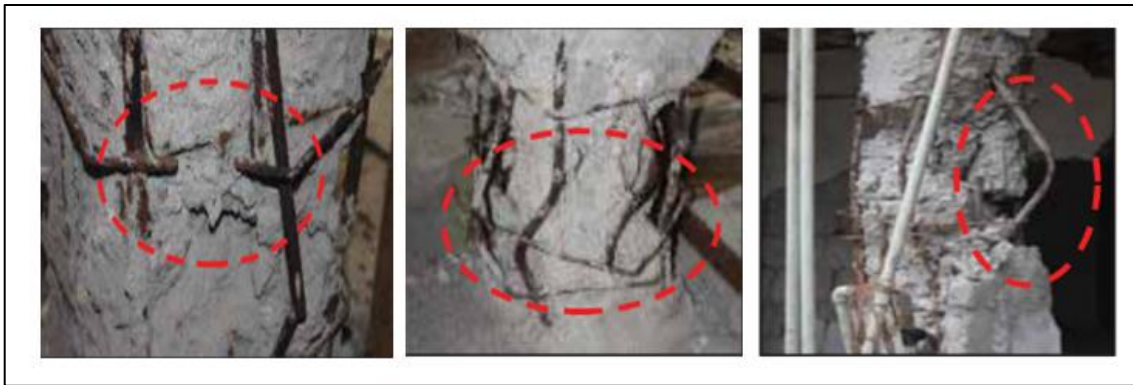
**Figure 75:** Reinforcement failures

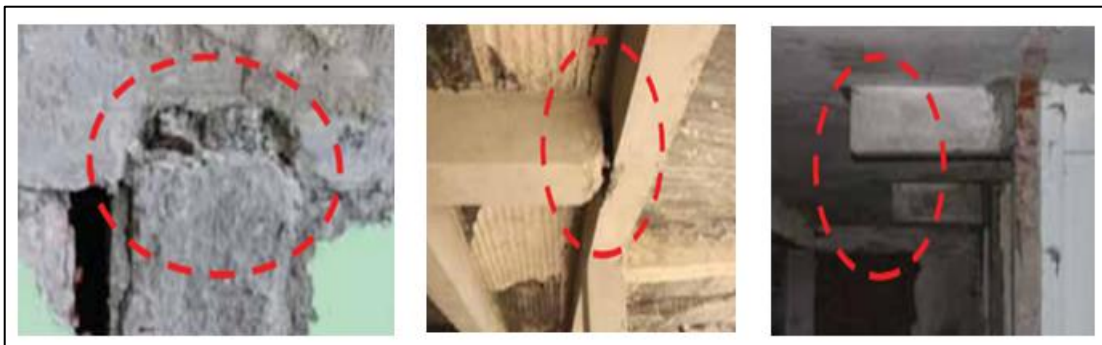
**Figure 76:** Connection between Structural Systems

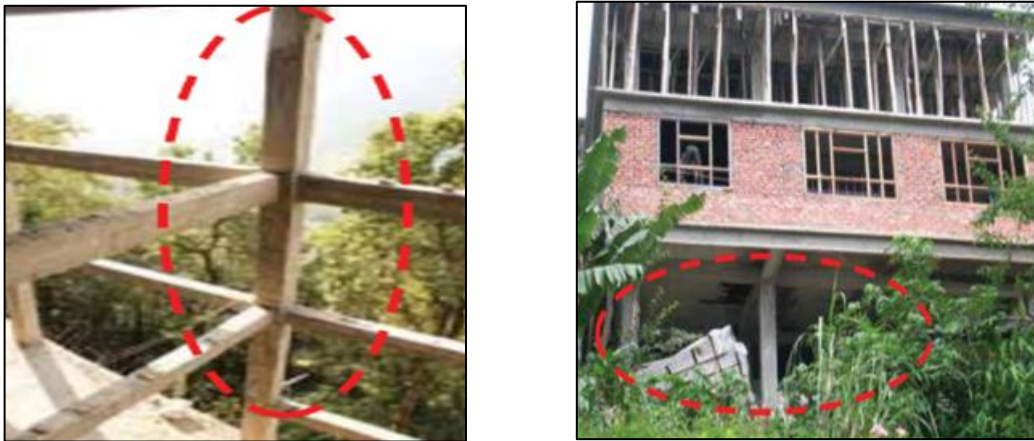
**Figure 77:** Absence of shear walls

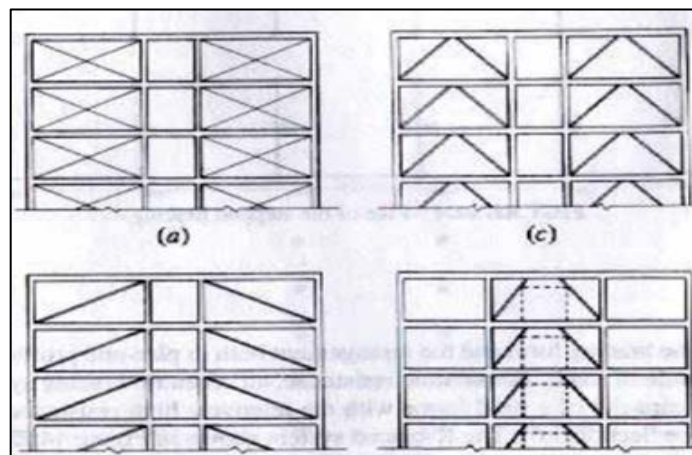
**Figure 78:** Vertical Bracing Systems

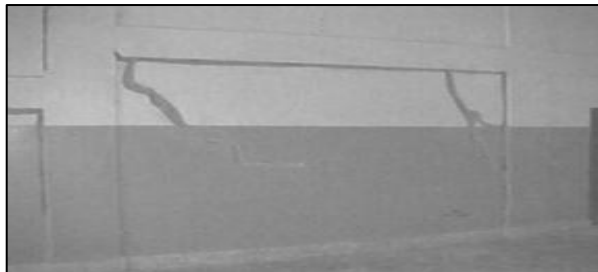
**Figure 79:** In the affected area, many buildings experienced frame-infill separation, which was fixed by cleaning and filling the gaps with rich cement mortar. The accompanying photo displays an example of this type of repair at a school building in Gandhidham

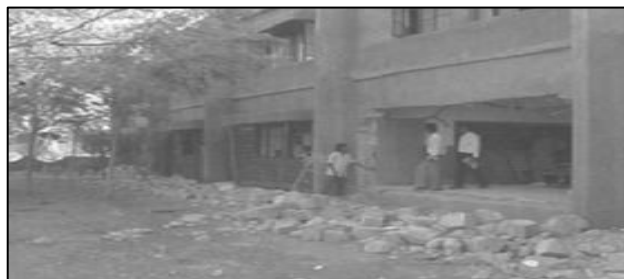
**Figure 80:** At a two-story school building in Ahmedabad, the large block sandstone masonry infills in cement mortar were replaced entirely with burnt-clay brick masonry infills in cement mortar.

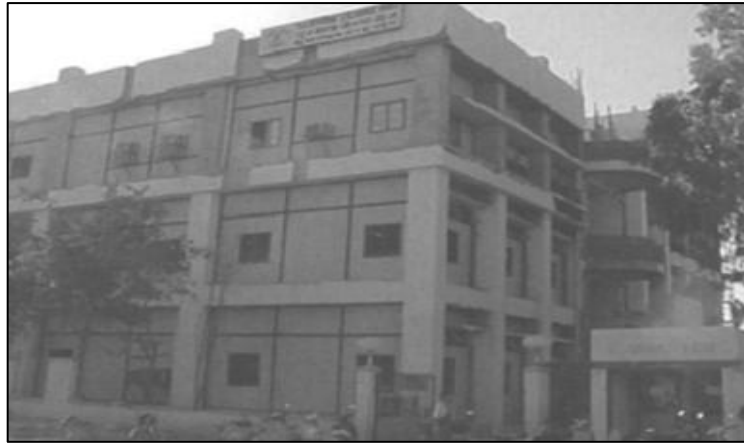
**Figure 81:** A partial collapse of the burnt-clay brick masonry infill held together with cement mortar occurred in the upper story of a three-story telephone exchange building in Bhuj. The solution to this problem involved replacing the infills in the entire building with lightweight foam concrete panels. The new panels were placed between asbestos sheets and secured to the building's frame using thin steel straps, including those at the lower stories

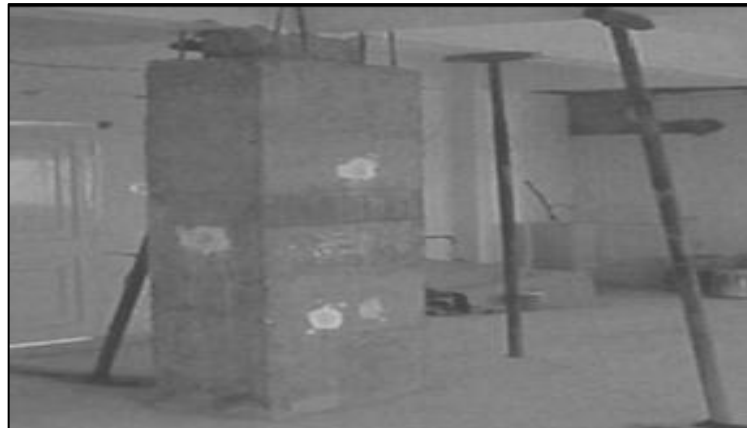
**Figure 82:** The ground level column of a seven-story old age home in Gandhidham was reinforced with a jacket, which covered it from the floor level to just below the top beams. In the visual, the column bars can be observed being curtailed on the side of the beam.

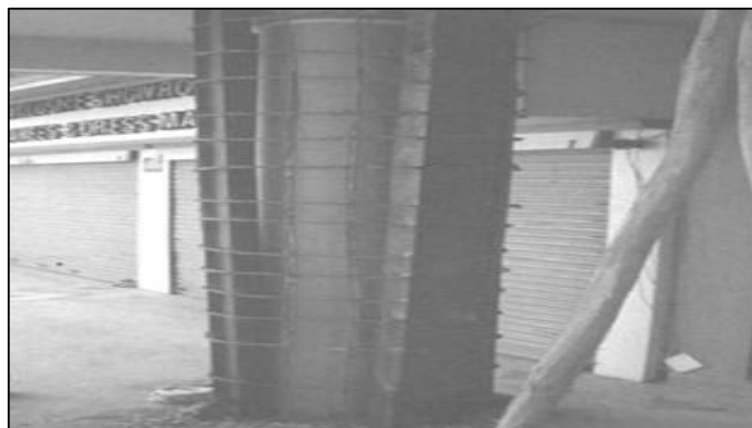
**Figure 83:** Hot-rolled I-sections were used to jacket the circular RC columns on the ground story of an 11-story commercial building in Ahmadabad. However, no connections were made between the steel I-sections and the concrete columns.

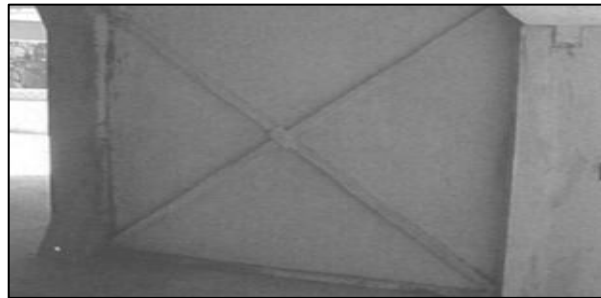
**Figure 85:** To reinforce open ground story panels, steel braces are used in specific cases. In this residential building, burnt clay brick masonry infill's were used to fill in the gaps, and steel sections were wedged at the outer faces. Additionally, steel hollow box sections with a size of 100 and a plate thickness of 8mm were used as bracing members.

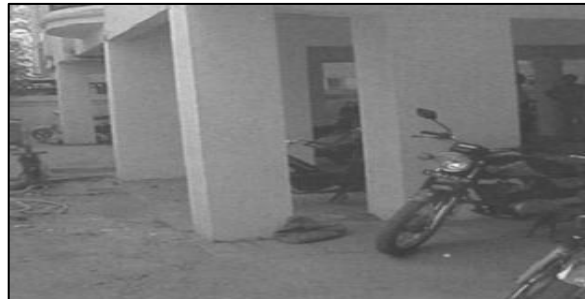
**Figure 86:** Reinforced concrete (RC) frame buildings that feature open ground stories typically have overhanging beams along the perimeter of the ground level. During the earthquake, many of these cantilevered beams experienced shear cracks. To retrofit this building, masonry columns were constructed underneath the tips of these beams.

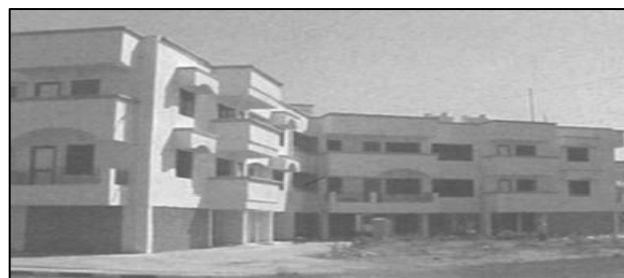
**Figure 87:** To reinforce this reinforced concrete (RC) frame building with an open ground story, masonry infills were strategically placed in certain panels of the ground level. This was done without impeding parking in the open ground story.

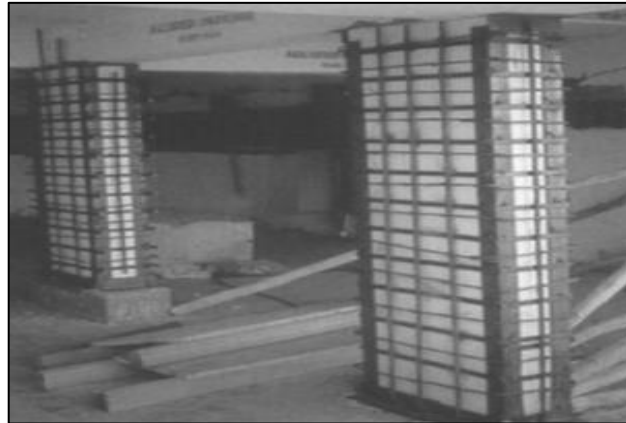
**Figure 88:** Before jacketing, mild steel angles measuring 75mm at four corners and 25mm steel flats were used as primary reinforcement for damaged RC columns in an open ground story building.

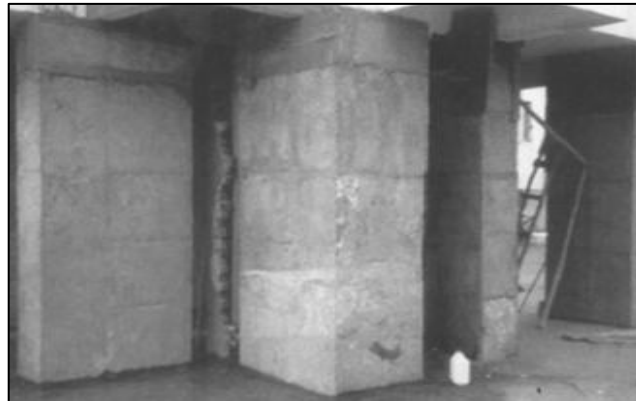
**Figure 89:** The original purpose of open ground stories in RC frame buildings was for parking, but after reinforcing the columns with jackets, the available space for cars was limited due to increased column size, leading to a disruption of the intended parking function.

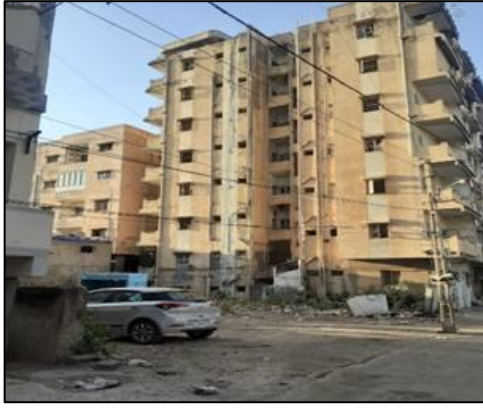
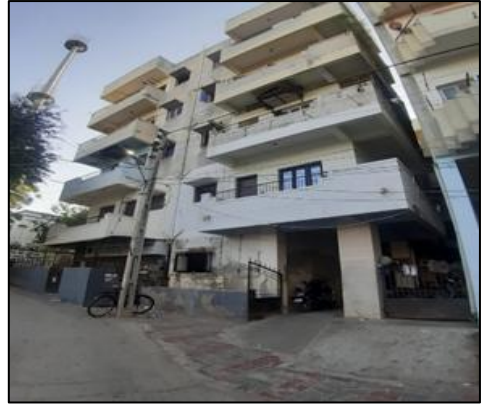
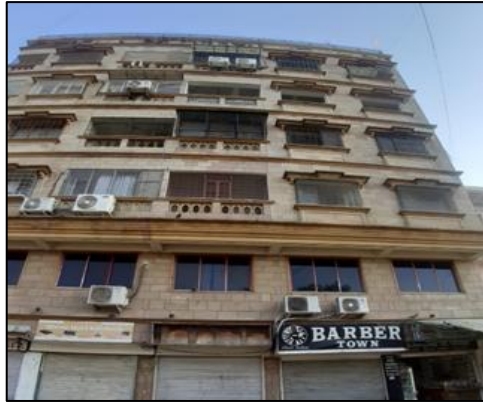
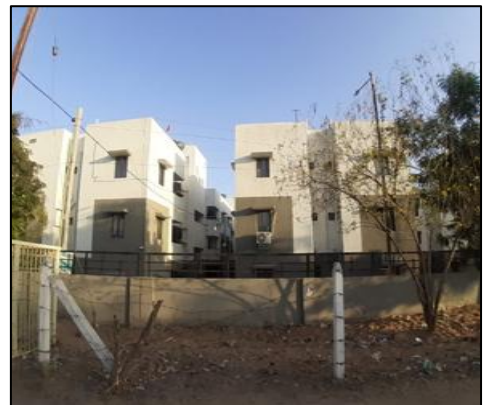
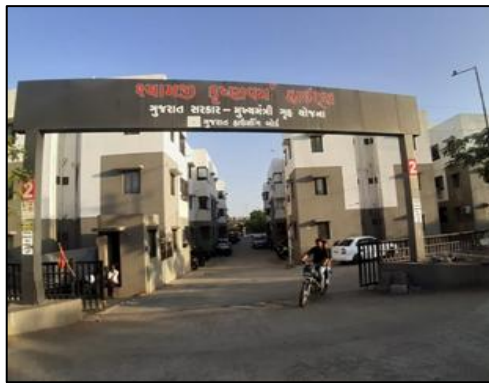
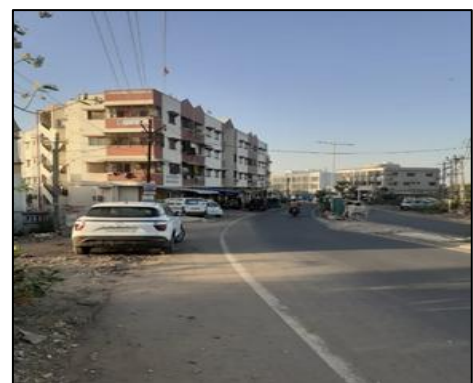
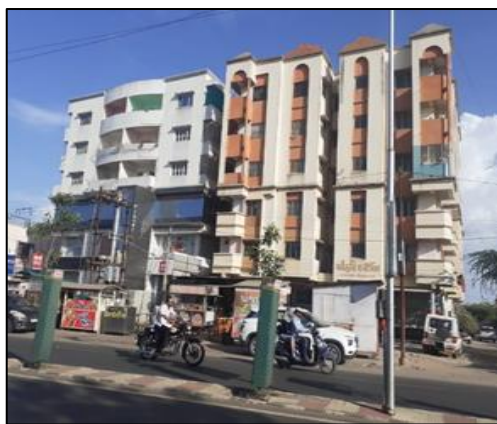
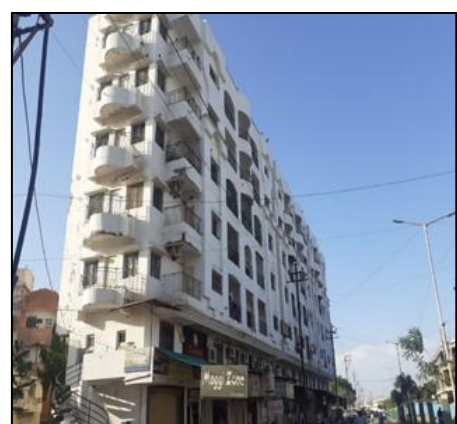
Overall, the reconstruction efforts in the aftermath of the Bhuj earthquake were significant, with thousands of homes being constructed, repaired, or retrofitted using earthquake-resistant technology. While much still needs to be done to fully rehabilitate the affected population, these initiatives provide a strong foundation for ongoing efforts to build a safer and more resilient community in the region.

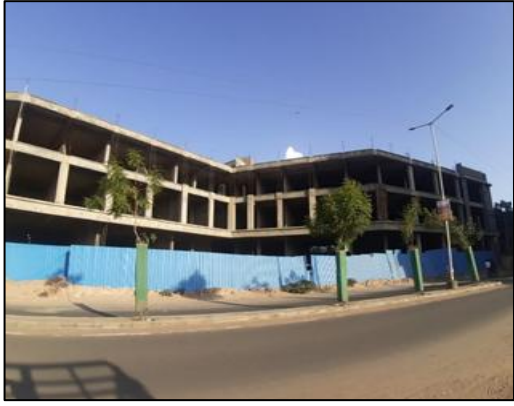
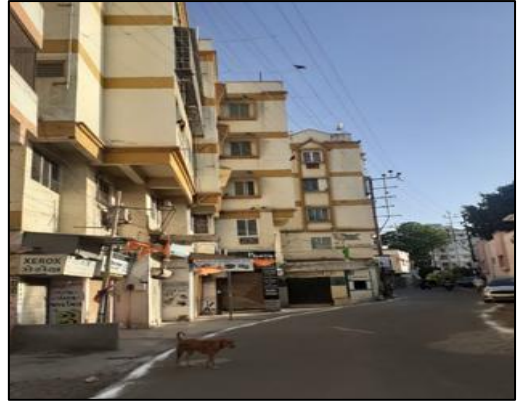
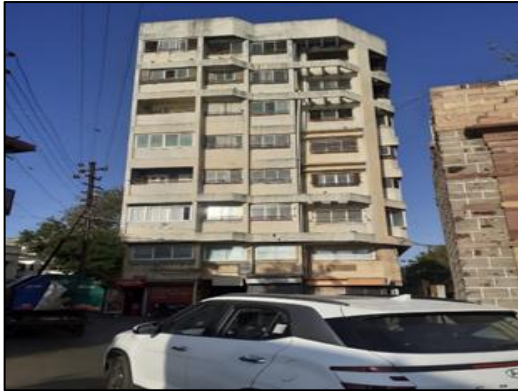
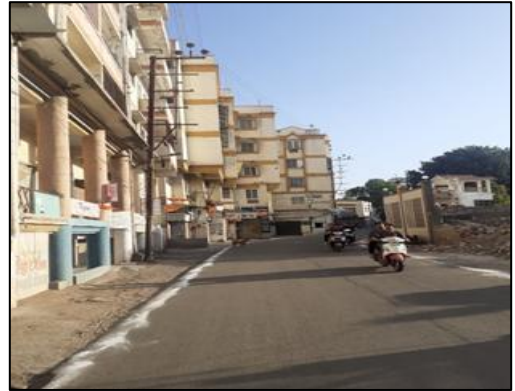
## CHAPTER-7 CONCLUSIONS AND FUTURE SCOPE OF STUDY
