1. Introduction

This report deals with the tests conducted to study the shear strengthening mechanism in reinforced concrete beams strengthened with NSM steel strips and steel rods to the sides of the beam. The objective of the present study is to understand the effect on shear strength of strengthening the beam using the NSM steel strips and steel bars in RC beams. The main parameters varied were the NSM reinforcement material and the provision of the internal shear stirrups.

1.1 NSM Technique for strengthening the RC structures

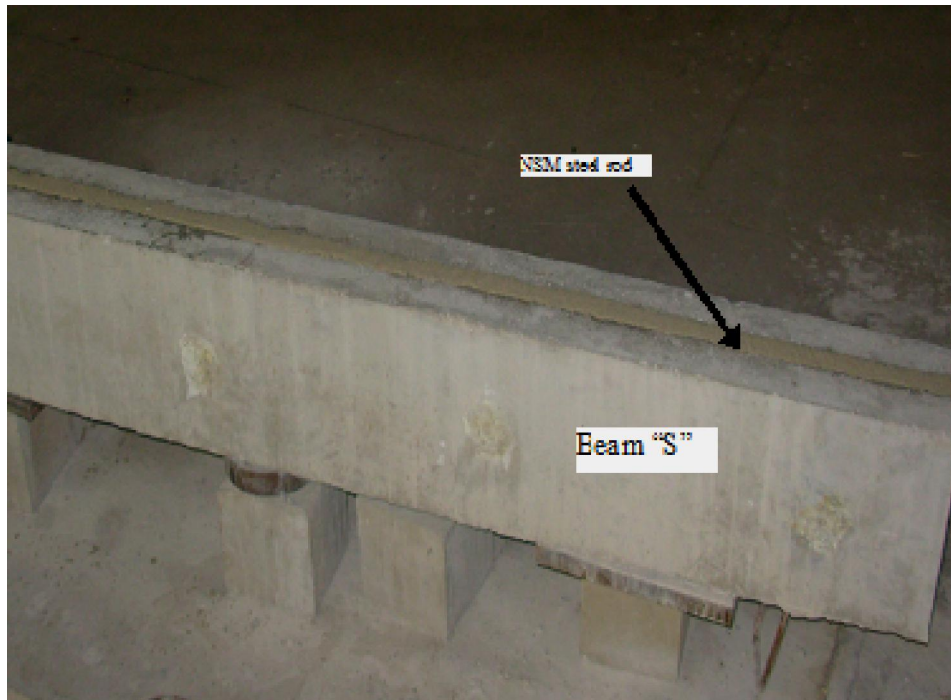
Fig 2.1 NSM Strengthened beam “S”

6. The web surface around the crack was cleaned and the crack was later covered with GFRP wrap around the crack using epoxy resin as adhesive.
7. The beam was thus strengthened for the crack as shown in fig. xx and was left to set till testing was done and before the testing the beam was painted to have good view of cracks and the test specimen RWS (reference beam without stirrups) was prepared by retrofitting beam “S” using NSM steel rod in flexure and GFRP wrap.

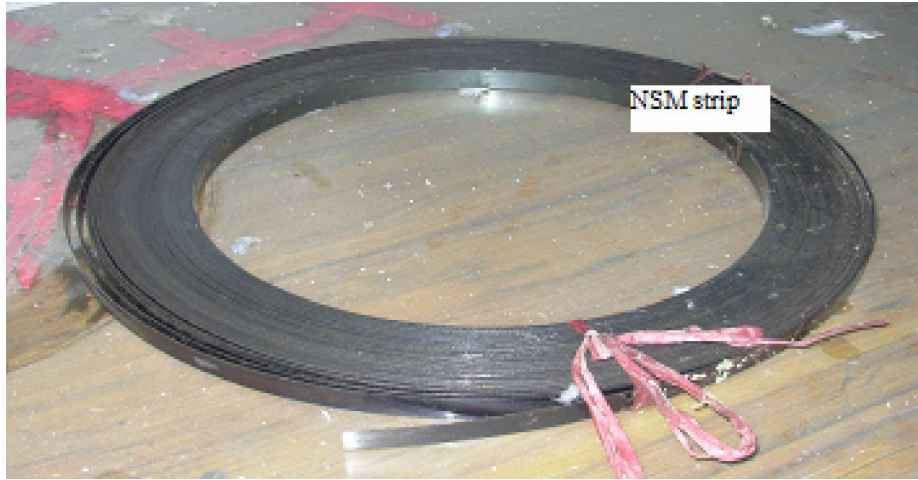
Fig. 2.3 The NSM strip

4. Mean while the NSM steel strips (Fig. 2.3) 18mm wide and 0.8mm thick was cut into equal length which was equal to 27mm the length of the groove. 22 such pieces were cut into the required length.

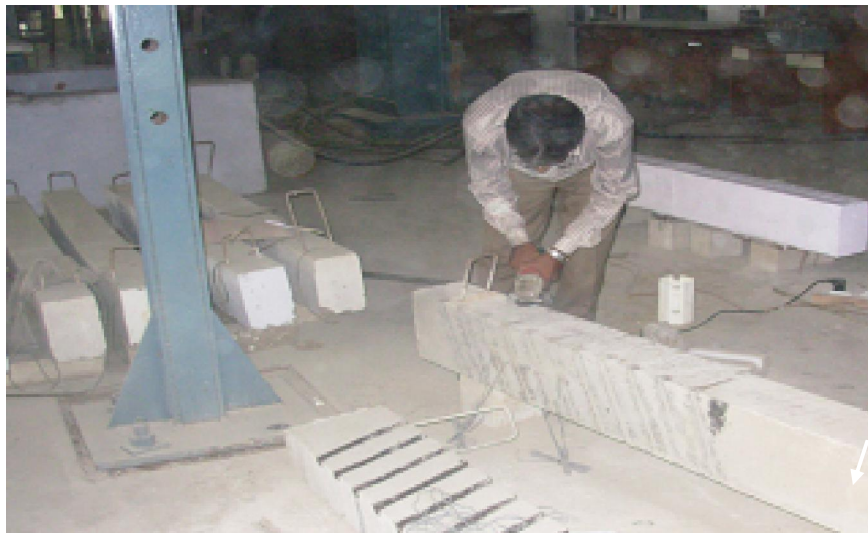
Fig 2.5 Grinding of beam surface at strengthened side to remove excessive mortar

11. The beam was later grinded of the excessive epoxy on surface (Fig. 2.5) using grinder and was painted before testing to have good view of cracks and the test specimen B1-SS was prepared using NSM shear strengthening technique using NSM steel strips.

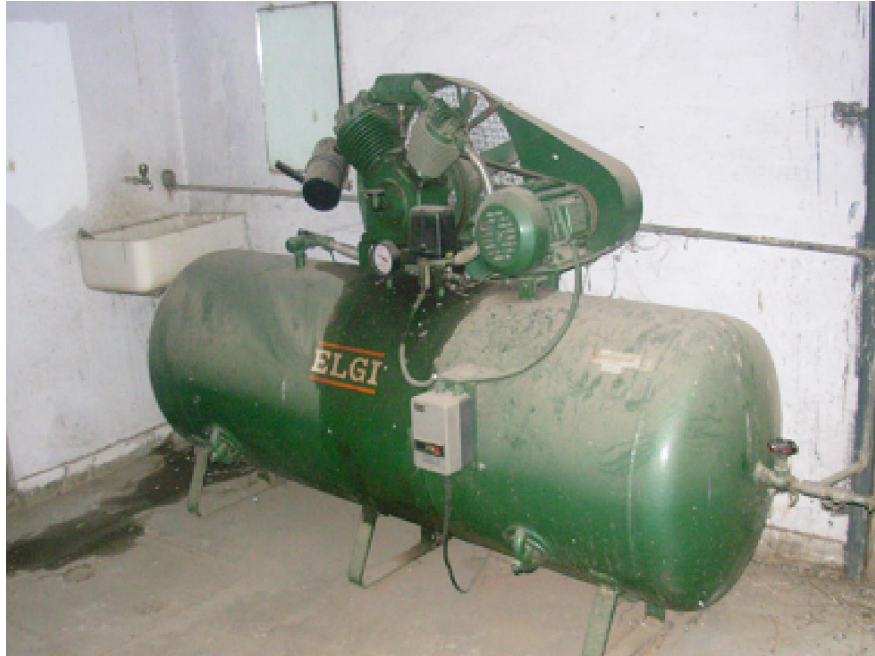
Fig 2.6 Air compressor used for cleaning the grooved surface

7. The groove was cleaned for any loose material with an iron wire brush and was blasted with compressed air to remove all the dust (Fig. 2.6).

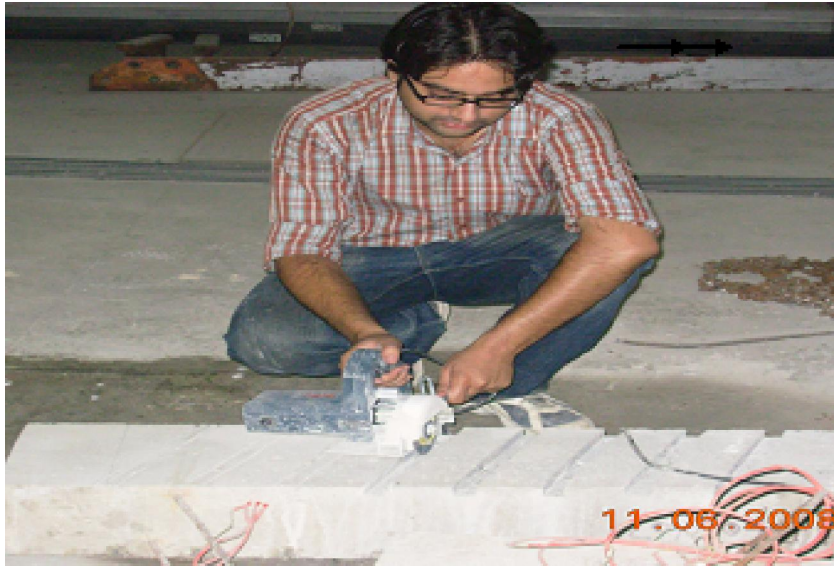
Fig 2.7 Cutting of grooves

3. After marking a groove was cut along the strip line was widened using the cutter. Depth of cut was kept 20mm and the average width of the groove was 20mm, sixteen such grooves were done on each side (Fig. 2.7).

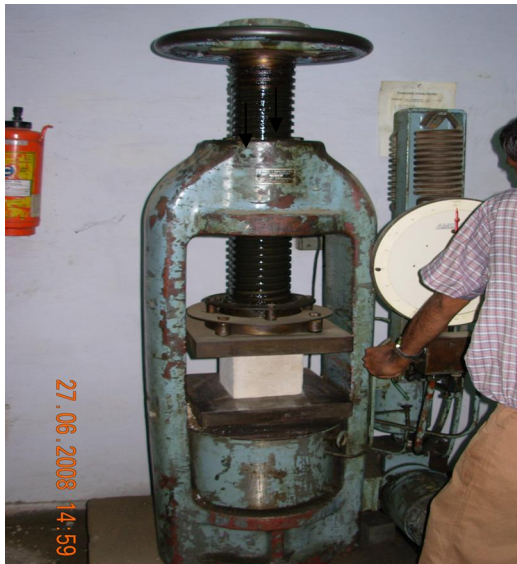
Fig 5.1 Test setup for compressive strength

The compressive strength of the concrete was tested as prescribed in test no. 5 in code IS: 516 – 1959 [17]. Three cubes of 150mm x150mm x 150mm size were casted in the laboratory for every beam casted. The cubes were casted at the time of casting beams and were tested under a compression testing machine on the day of testing to have the concrete strength at the day of testing. All the cubes were casted in the proportion of 1: 1.44: 2.94. Loading was done at the rate prescribed in the 140 kg/cm²/min i.e. 31.5 t/min. The setup is as shown in Fig 5.1. The crack pattern is as shown in Fig 5.2.

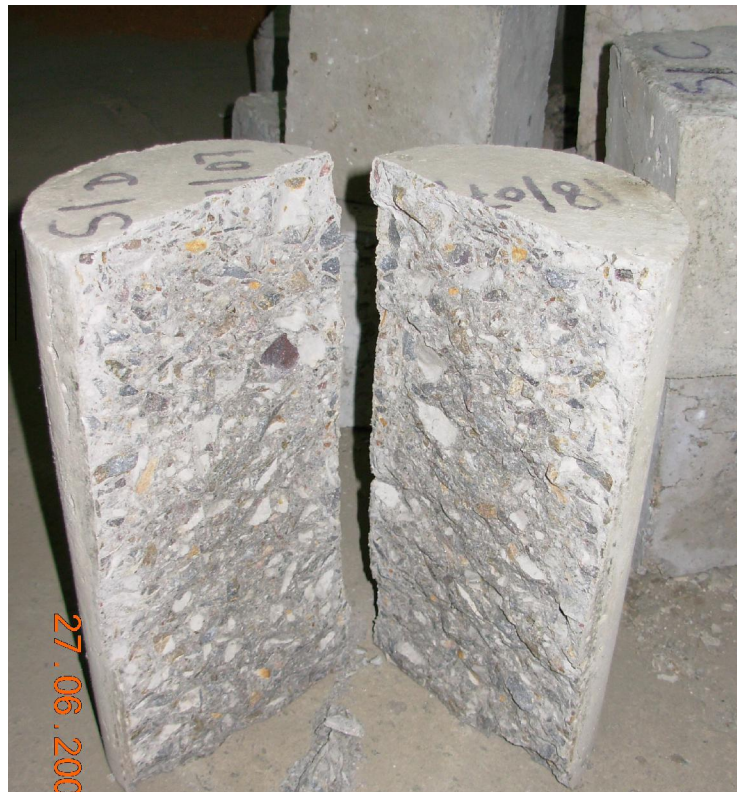
Fig 5.4 Split surface of cylinder

For tensile strength of the concrete “Brazilian tensile strength” (split cylinder test) was conducted on the cylinders under a compression testing machine as prescribed in IS: 5816 – 1999 [18]. Three representative cylinders of diameter 15mm and height of 30mm was casted while the beams were casted. The cylinders were tested on the testing of beams. Loading was done at the rate prescribed in the 140 kg/cm²/min. i.e. 31.5 t/min. The cylinder is kept in laid position and load is applied along its diameter till the cylinder splits into two parts. The setup of the test, the crack, and the split cylinder are as shown in the figures 5.3 (a), 5.3(b), 5.3(c) and 5.4. Tensile strength (f_t) is given by the following

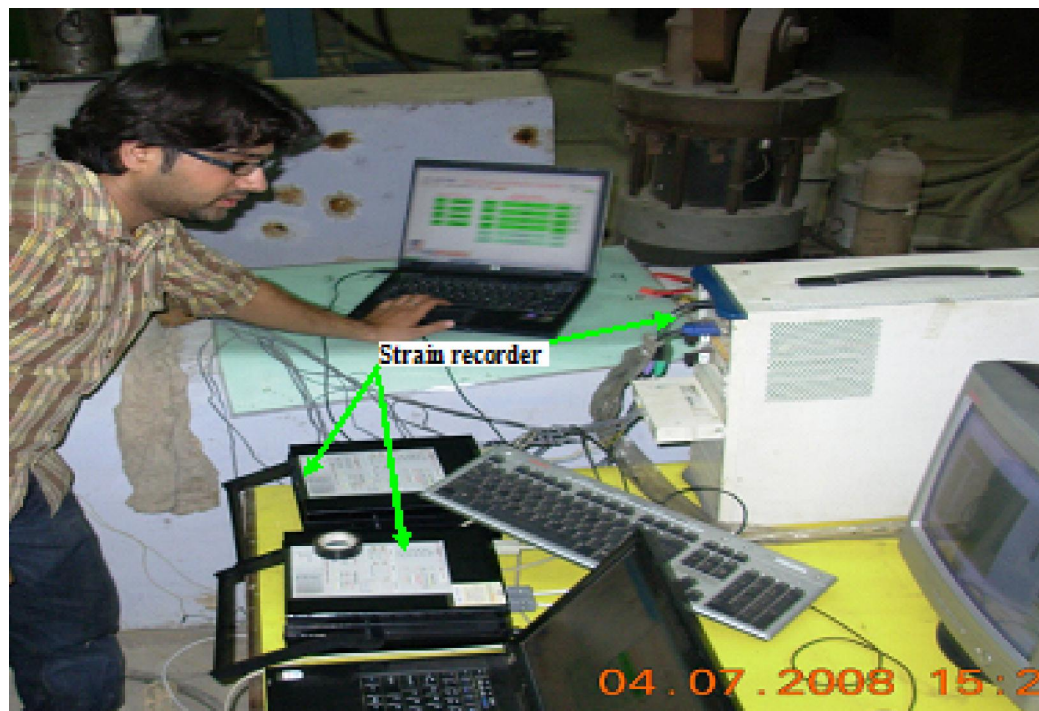
Fig 7.14 Arrangement for strain recording

In this test load was measured and applied through 200 kN capacity proving ring. And the strain was recorded with the help of SCAD 500 strain measuring system a Pyro – Dynamic made (Fig. 7.14). Strain measurements were recorded per second by the system. And the measurements were also recorded at every load interval to keep a check.

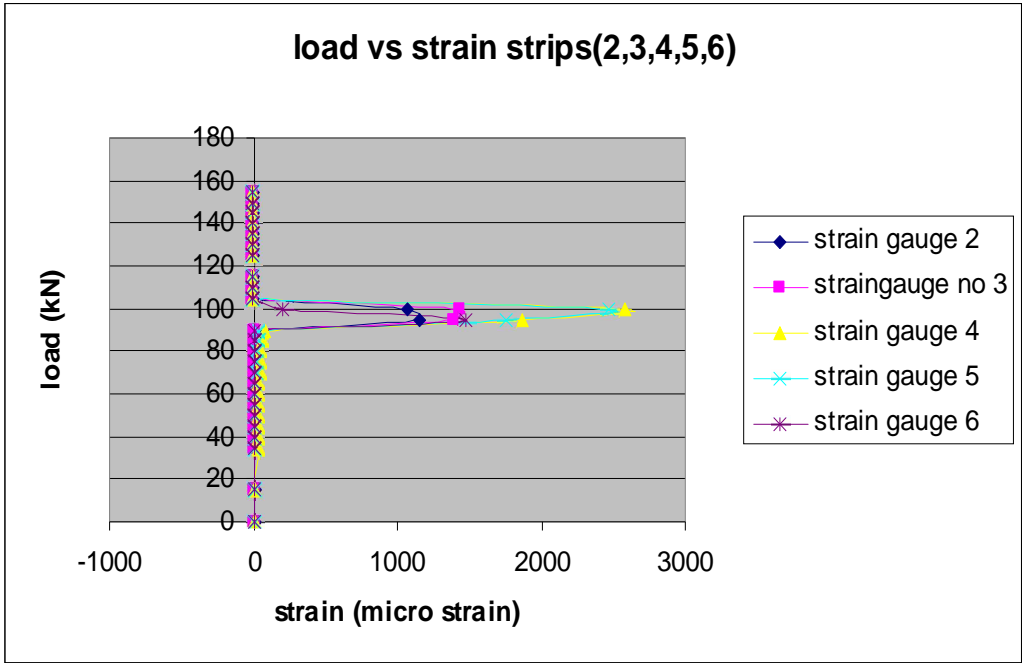
Fig 7.28 Graph showing strain (micro strain) in NSM steel strips vs load

The variation of strains in the NSM shear steel strips were recorded from strain gauges installed along with NSM strips is as shown in Fig. 4.3, 4.4. The strain variations at different stages of load application with the time are as shown in figure 7.27 and 7.30. It can be seen from the Fig. 7.27 and 7.30 that during the initial period the load was not taken by the NSM strips hence there was negligible strain. In strips with strain gauge no.9, 10, 11 strain increases abruptly to about 1000, 1900 and 300 micro-strains respectively in the final stages of load application during the tests showing that these strips were taking part in shear strengthening and it can be seen that first shear crack also occurred around these NSM shear strips in Fig. 7.19. In NSM strips with strain gauge no. 7, 8, 11 debonding at the interface of NSM and epoxy mortar had occurred and hence these strips did not show any significant strain. It is also observed that the NSM strip with strain gauge no. 1 did not take any strain. This is also evident from Fig. 7.19. In Fig. 7.28, the above mentioned observations can be validated as it can be seen that the NSM strips with strain gauges no. 7, 8 take very less strain as were debonded earlier at the interface of NSM and epoxy-sand mortar and the strips with strain gauge no.9, 10, 11 shared the shear load which was transferred to them as they show a sudden increase in strain with increase in load after load ($P = 125\text{kN}^*$). Strain in the NSM strip 4th and 5th from the support has crossed its yield limit at a load of ($P=170\text{kN}^*$). These strip had crossed there ultimate limit of

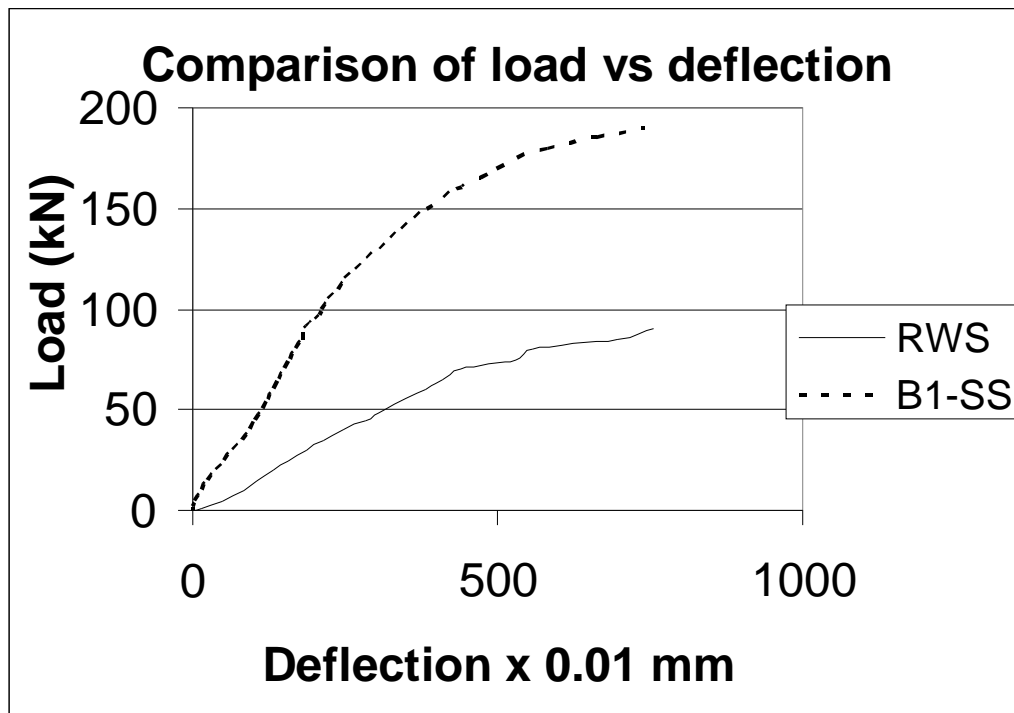
Fig 9.1 Comparison of load vs deflection

As can be seen from the graph in figure 9.1 the deflection under the load in the B1-SS is less at a load than the deflection in the beam RWS at the same load. The maximum deflection at the failure in RWS was 7.56mm. The load vs deflection line is seen nearly linear upto the load of 75kN and deflection of 4.40mm and on further increase in load by 5kN to 80kN the deflection was increased by 0.90mm. And at 90kN the beam failed in shear in a brittle manner. The change in linearity was at the same load when the shear crack was seen during the test at 75kN.

But in case of the B1-SS the maximum deflection was 7.42mm at the load 190kN (nearly same as in RWS at failure). Thus it can be seen that the load for same deflection has increased by almost 110% after strengthening the beam with NSM strips. The change in linearity was can be seen from the graph at 150kN which is
