SEISMIC EVALUATION OF UN-REINFORCED MASONARY HOSPITAL BUIDLING

(MAJOR PROJECT REPORT - II)

MASTER OF TECHNOLOGY IN STRUCTURES

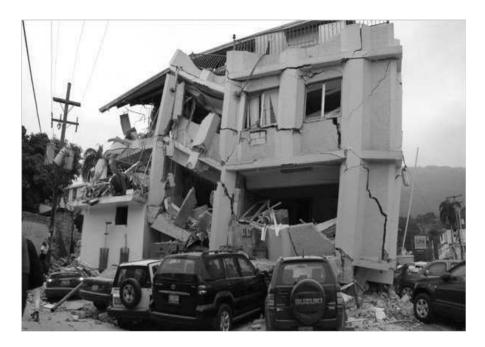
Fig.1.2: Failure of an URM building during 2010 Haiti earthquake

Normally thick walled URM buildings were designed for vertical loads, since masonry has adequate compressive strength the structure behaves well as long as the loads are vertical. When such a masonry structure is subjected to lateral inertial loads during an earthquake, the walls develop shear and flexural stresses. The strength of masonry under these conditions often depends on the bond between brick and mortar. A masonry wall can also undergo in-plane shear stresses if the lateral forces are in the plane of the wall. Shear failure in the form of diagonal cracks is observed due to this. However, catastrophic collapses take place when the wall experiences out-of-plane flexure. This can bring down a roof and cause more damage. Fig. 1.2 shows typical failure of an URM building during 2010 Haiti earthquake.

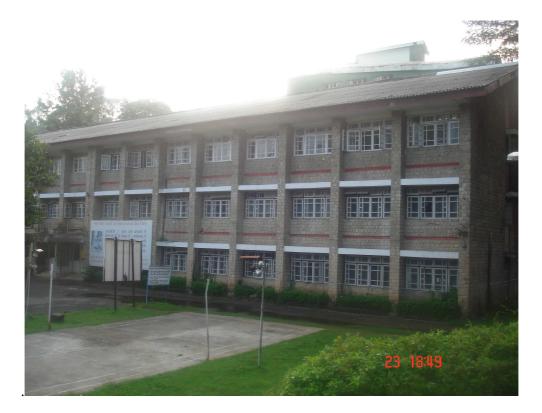
Block-A

BLOCK NAME	BLOCK-A
YEAR, TYPE OF STRUCTURE	1969, Load Bearing Structure.
TOTAL FLOOR AREA	3862.50 m2
FACILITIES PRESENT	Zonal Medical Store, District Medical Store, X-Ray rooms, Operation Theater & ICU, Administrative Block, ENT, Lecture Theater, Orthopedic, dental clinic, etc.
CONFIGURATION IRREGULARITIES (PLAN & VERTICAL)	Vertical geometric Irregularity was observed. The entire structure is G+2 storeys, but in one end of the block it is B+G+2 making it more than 3 storeys. IS Code does not permit more than 3 storeys for 'E' category buildings which makes the present structure very vulnerable and hence can be categorised as 'E+' category. This can also cause Torsional irregularity in the building structure.
FOUNDATION DETAILS	Step foundation in stone masonry of width 1.0 meter and depth 1.05 meters below ground level.

Plinth band of 400mm width and 150mm depth provided in exterior longitudinal walls only making it ineffective to tie the structure as per IS4326:1993.
Dressed Stone Masonry walls constituting of multi wythes and having total thickness of 400mm. General ratio of openings found in walls was found to range between 0.4 - 0.9 making it unsafe as per IS4326:1993.
Continuous lintel beam of 400mm width and 150mm depth provided in exterior longitudinal walls only, making it ineffective to tie the structure as per IS4326:1993.
All intermediate Floors are cast in-situ RCC Floors of 150mm thickness, simply rested on the RCC beams / Stone masonry walls as applicability.
Not observed. To be provided as per IS4326:1993.
Not observed. To be provided as per IS4326:1993.

Dampness	Observed in many areas near ducts and internal face of exterior walls where water drainage pipelines were attached.
Plaster Chip-off	Observed in damp areas.
Cracks	Separation of the longitudinal wall and cross wall was observed in Post OT room suggesting no proper connection between longitudinal wall and cross walls. Moreover it was informed by the OTA that such cracks had come in many walls but they were filled up during renovation.
Termites	Observed in corner of passage way in OT zone.

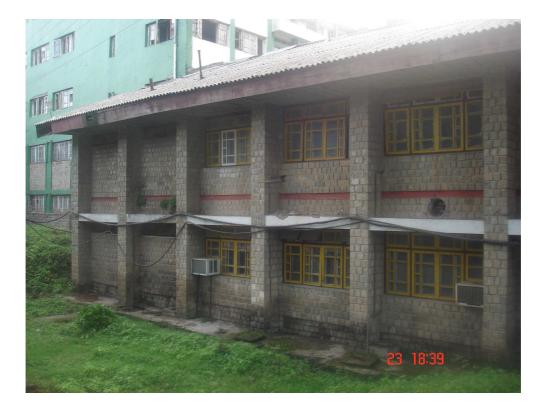
Block-B

BLOCK NAME	BLOCK-B
YEAR, TYPE OF STRUCTURE	1969, Load Bearing Structure.
TOTAL FLOOR AREA	840 m ²
FACILITIES PRESENT	Blood Bank, Imaging Department (Ultrasound & CT Scan), Gynaecological Dept, Minor OT - Labour Room, Gynaecology Ward, etc.
CONFIGURATION IRREGULARITIES (PLAN & VERTICAL)	No irregularity was observed.
FOUNDATION DETAILS	Step foundation in stone masonry of width 1.0 meter and depth 1.05 meters below ground level.
PLINTH BAND / BEAM	Not observed. As per IS4326:1993, the plinth band must be provided for better seismic performance.
WALL / INFILL PANEL	Dressed Stone Masonry walls constituting of multi wythes and having total thickness of 400mm. Partition/Cross walls of Half Brick thickness i.e. 150mm were observed. General ratio of openings found in walls was found to range between 0.4 - 0.9 making it unsafe as per IS4326:1993.

LINTEL BAND / BEAM	Continuous Lintel Beam of size 400mmX150mm depth provided along exterior longitudinal walls for ground floor only making it ineffective to tie the structure as per IS4326:1993.
INTERMMEDIATE ROOF / FLOOR	All intermediate Floors are cast in- situ RCC Floors of 150mm thickness, simply rested on the RCC beams / Stone masonry walls as applicability.
ROOF / EAVE LEVEL BAND / BEAM	Not observed. To be provided as per IS4326:1993.
GABLE BAND / BEAM	Not observed. To be provided as per IS4326:1993.
<image/>	The First Storey had a false ceiling above which was a pitched roof made of Wooden Truss like members (The Truss was in two separate parts being disjointed at the tie level and at the ridge level) placed at the center to center distance of 3.0 meters with purlin sections of 100mmX160mm and rafters, tie, struts & inclined members of size 80mmX100mm.Steel Flats were welded and bolted to connect the wooden members. This connection was improper and needs to be replaced with proper joint system. Bracing in lateral plane and inclined plane were absent. This made it very vulnerable under seismic activity. Asbestos sheeting was used as sheeting material. Many of the asbestos sheets were damaged and

water was pouring inside the building.
OTHER STRUCTURAL FEATURES OBSERVED	None Observed.
DISTRESS OBSERVATIONS	
<image/>	In almost all rooms due to cracked Asbestos sheet roofing on top floor, dampness and Moss generation was observed on the walls and bottom of roof.

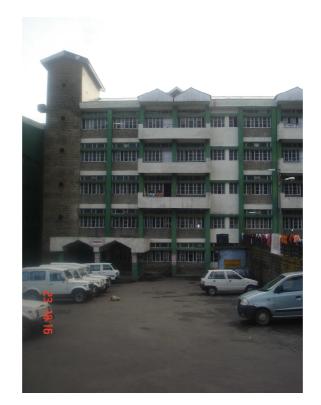
Plaster Chip-Offs	Due to Dampness Plaster had peeled off in few locations.
Termites	Termites were also observed on damp areas on walls.
