**DEVELOPMENT OF A DECISION MAKING
TOOL FOR
THE CONDITION ASSESSMENT OF BUILDING**

**A DISSERTATION SUBMITTED TOWARDS PARTIAL FULFILLMENT
OF THE REQUIREMENT FOR THE AWARD OF THE DEGREE OF**

MASTER OF TECHNOLOGY
in
Structural Engineering

Department of Civil Engineering
DELHI TECHNOLOGICAL UNIVERSITY

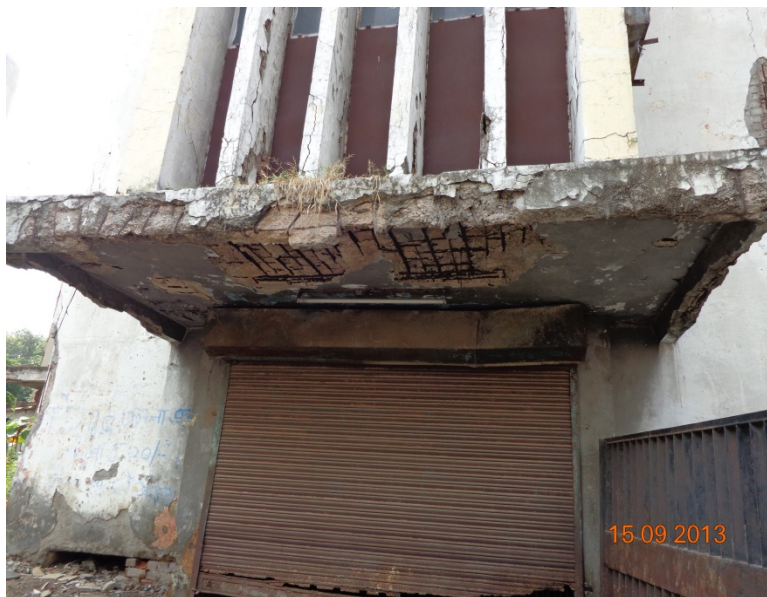
Fig. -1 Unattended repair works and poor maintenance of a building

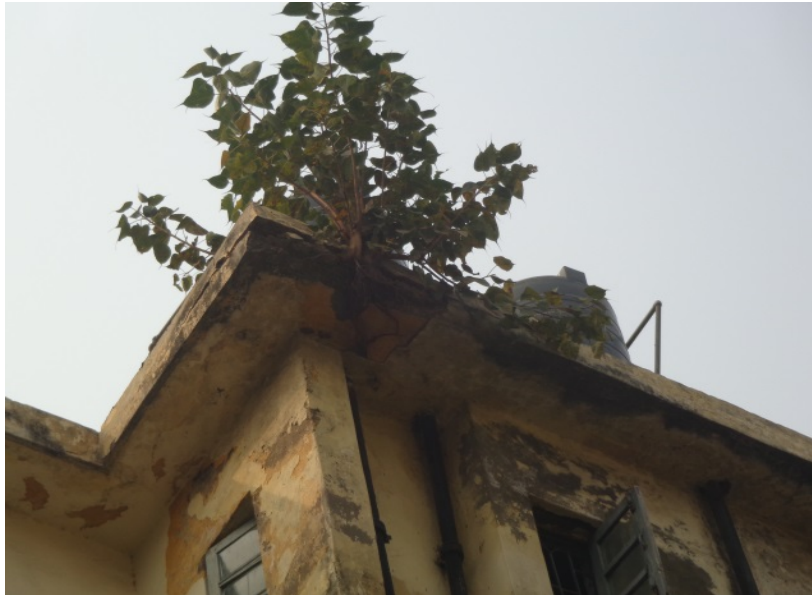
Fig. - 4.1 Vegetation on roof slab

Fig.s shows the example for poor maintenance:

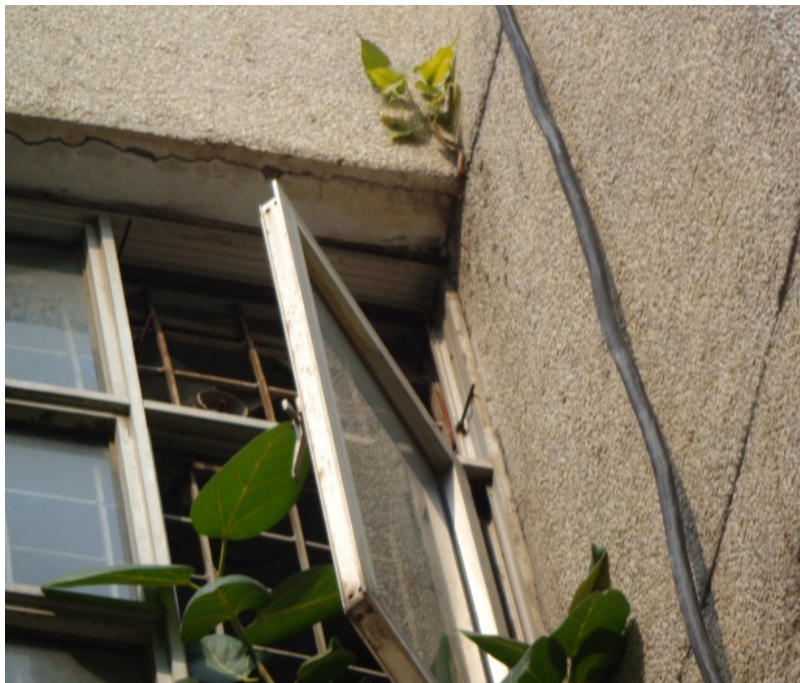
Fig. - 4.2 Vegetation at lintel level

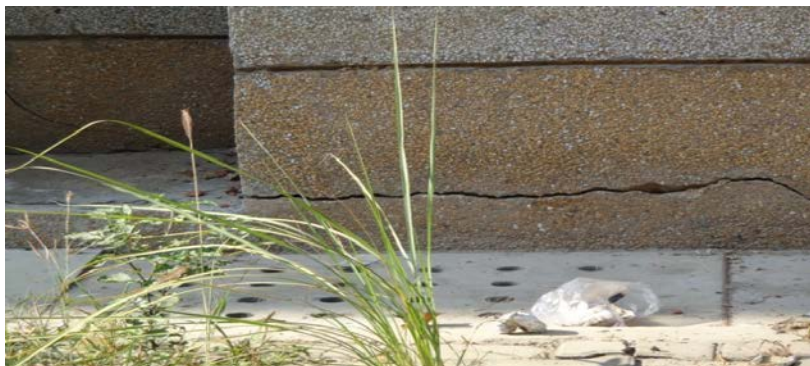
Fig. - 4.3 Horizontal crack at plinth level

It is not uncommon to find cracks in the structure as shown in Figs - 4.3 to 4.6 illustrate the defect of structure due to failure of foundation. A leaning foundation wall is not ideal, but may not be a significant defect if movement does not appear to be recent. Foundation movement may result from a wide range of factors which can include

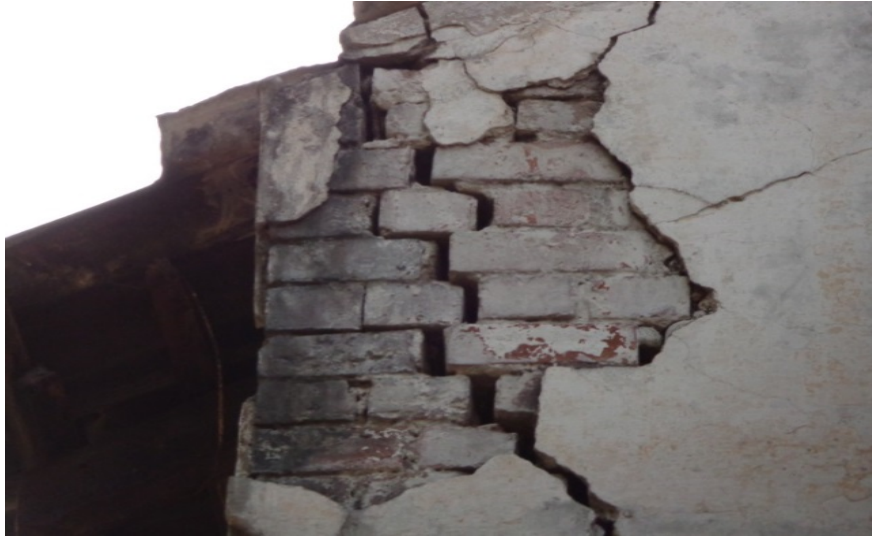
Fig. - 4.4 Major vertical crack in brick wall

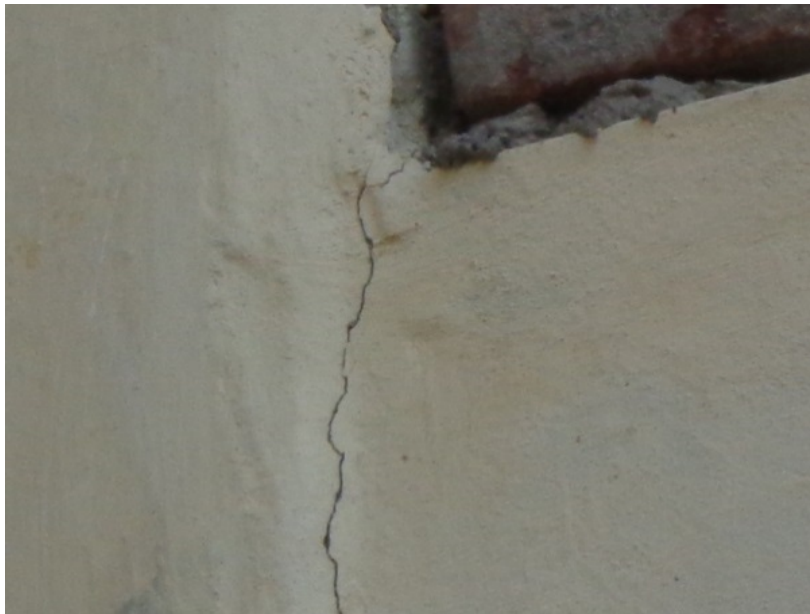
Fig. - 4.5 Vertical cracks in brick masonry at window sill level.

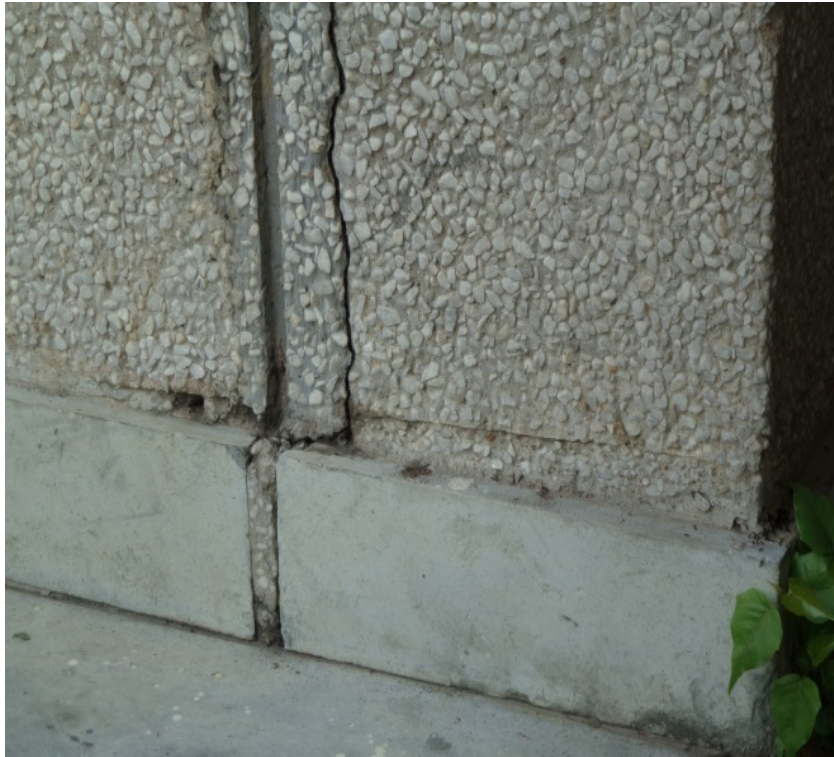
Fig. - 4.6 Vertical crack at joint

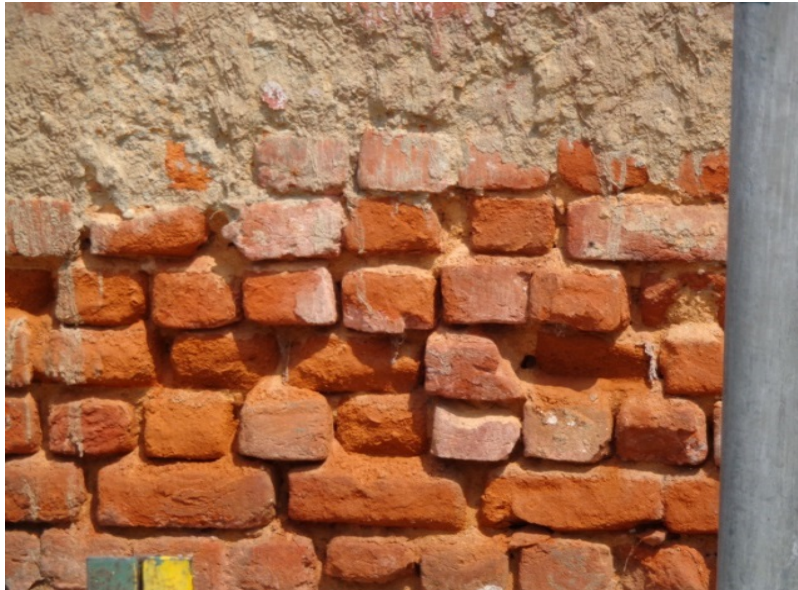
Fig. - 4.7 Loose or crumbling mortar

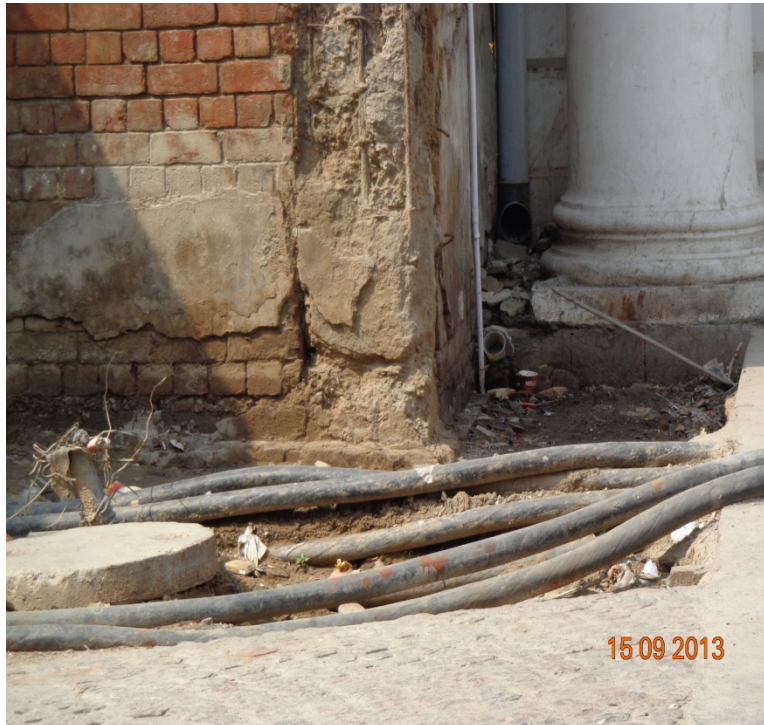
Fig. – 4.8 deterioration of brick masonry due to rising of dampness

- Rising damp from subsurface moisture

- Condensation caused by lack of ventilation
- Failure of roof systems or rainwater goods
- Infiltration through failed mortar
- Inadequate surface drainage
- Encroaching vegetation
- Defective copings and flashings or damp proof courses

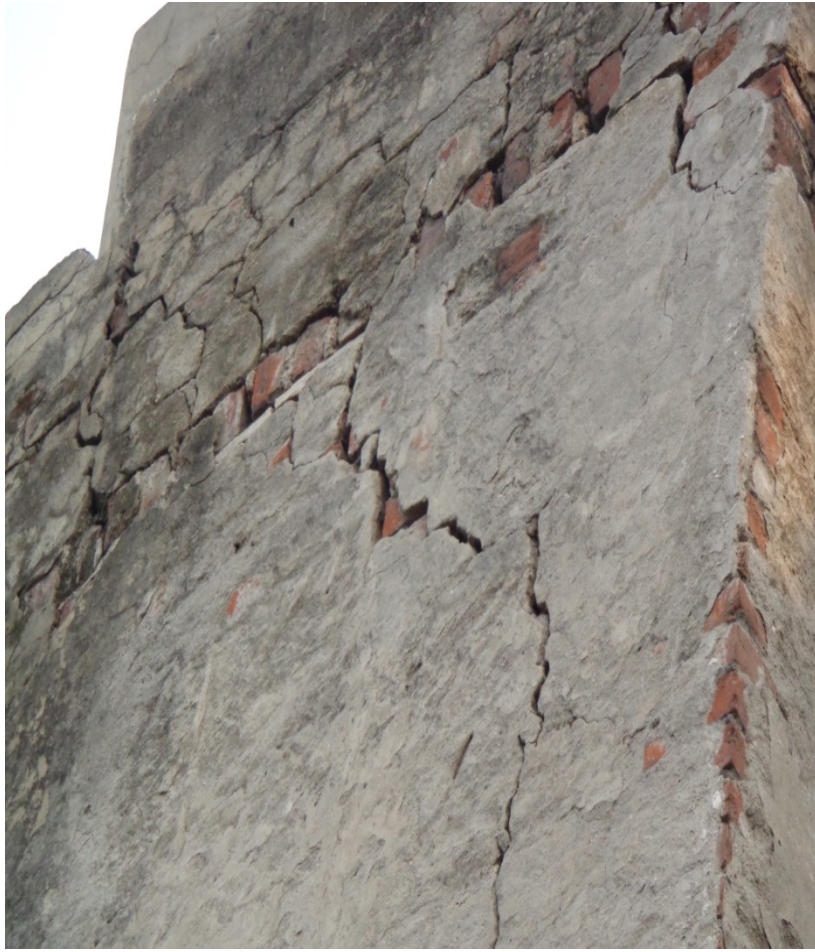
4.4.1.2 STRUCTURAL FAULTS: The most common sign of a structural fault in brickwork is cracking. This can be caused by structural movement, unstable foundation, tree roots or defects in the original construction. Minor cracking will be superficial and restricted to a few isolated bricks but extensive cracking can be an indication of a serious problem. There are also a number of structural elements which can fail and lead to associated deterioration.

Fig. - 4.9 Deterioration of brick masonry due to structural fault

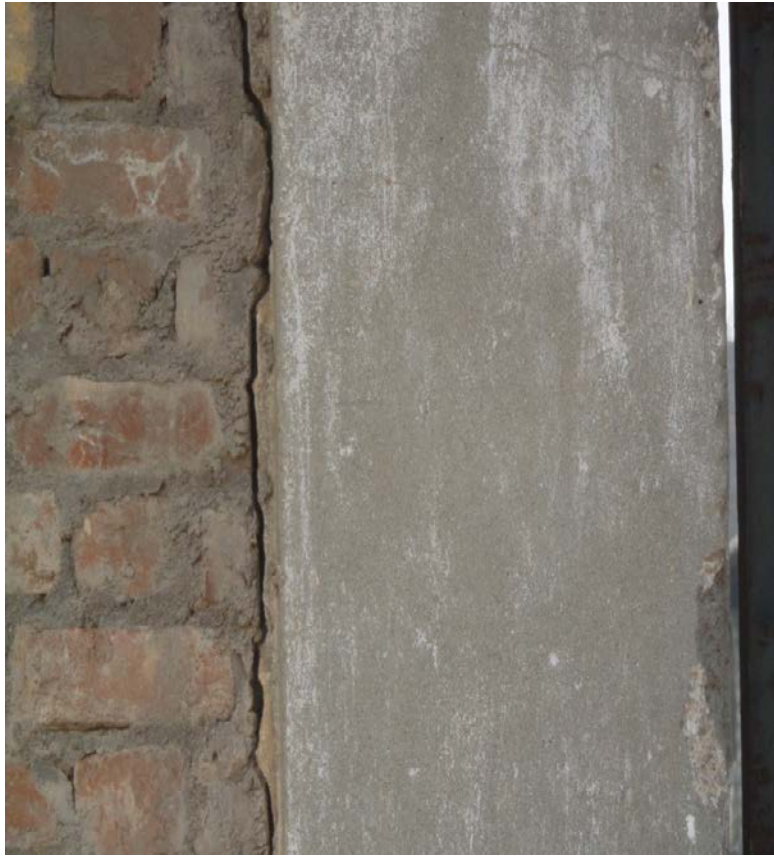
4.4.1.3 ORIGINAL CONSTRUCTION DEFECTS: Sometimes brick work was poorly constructed and defects inherent in the original construction can lead to later problems. Typical defects of this type are

- Poor bonding between walls or into existing masonry where a brick addition has been executed.
- Poor quality bricks utilized
- Frog turned upside down to reduce mortar requirements

Fig. – 4.10 Original construction defects

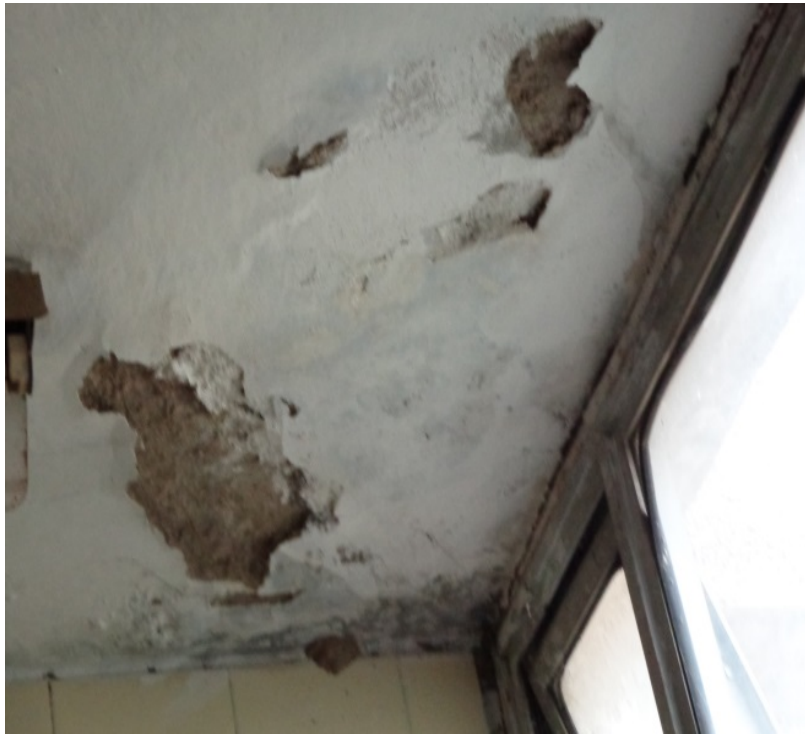
Fig.-4.11 Plastering deterioration due to dampness under slab

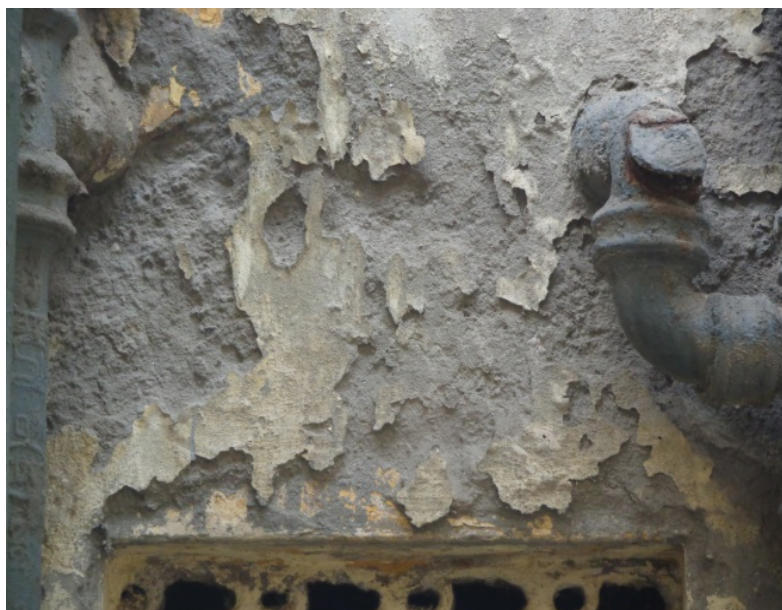
Fig.4-12 Plastering deterioration due to dampness on walls

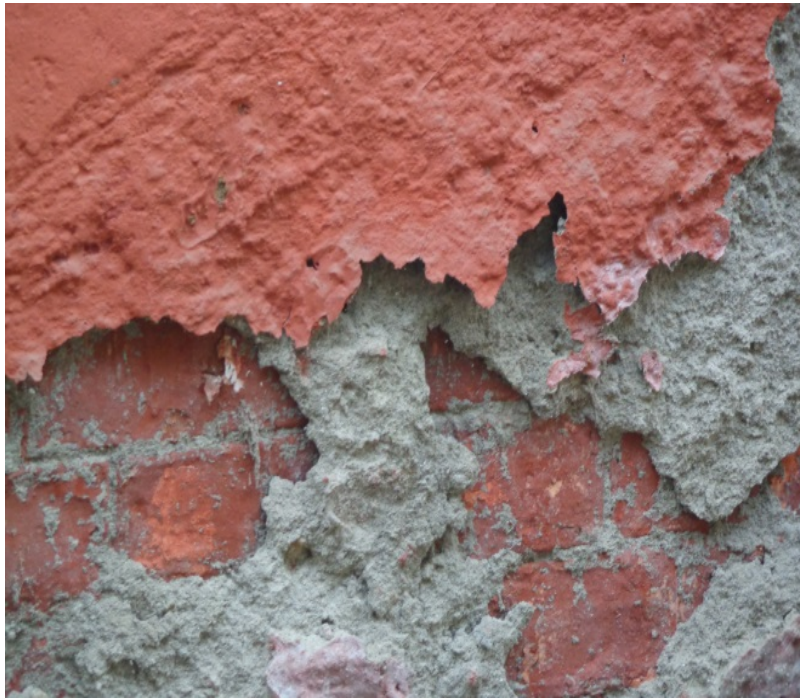
Fig.4-13 Plastering deterioration due to salt effect

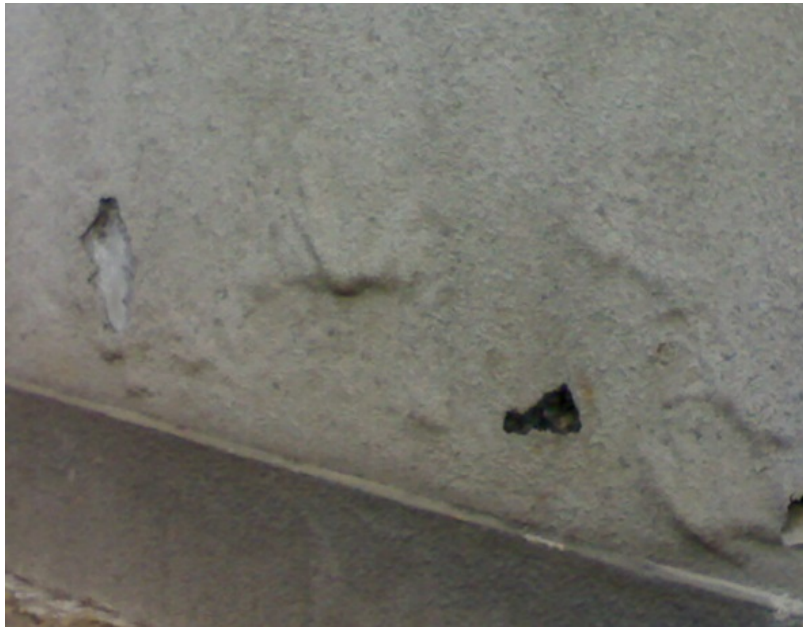
- Painting in direct sunlight or on a surface that is too hot
- Application of an oil-based or alkyd paint over a damp, wet surface
- Exposing a fresh paint fill to dew, high humidity or rain
- Moisture passing through interior walls from common household sources such as bathrooms and kitchens

Fig.-4.14 Blistering of paint

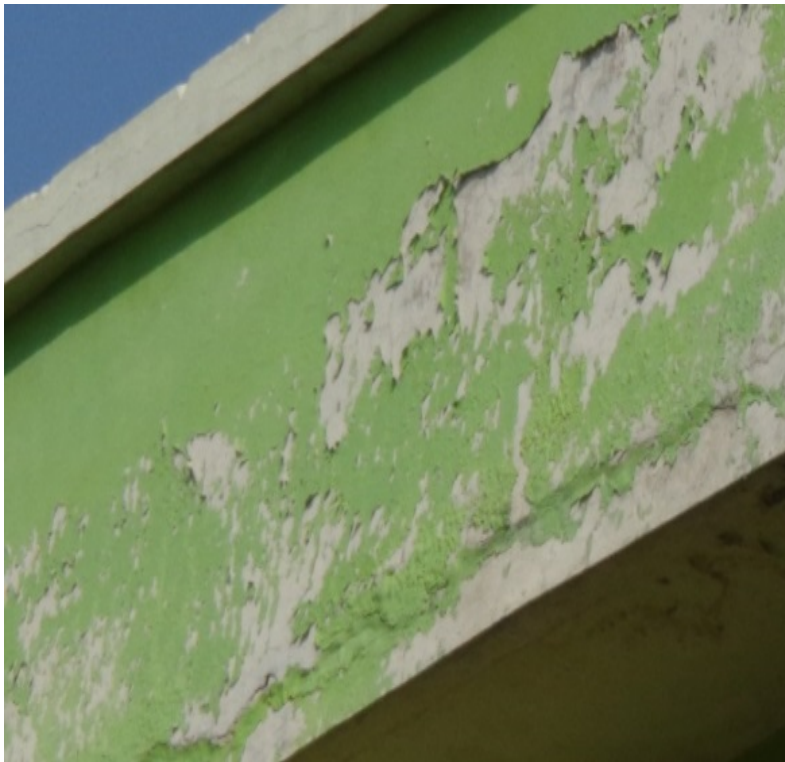
4.6.1.2. PEELING OR FLAKING Loss of adhesion can occur through a number of other causes. The effect may be slow and appearance of blistering, peeling or flaking of the paint film as visible in Fig 4.15.

- Inability of the top coat to bond smoothly to the substrata
- Applying an extremely hard, rigid coating over a more flexible coating
- Natural aging of oil-based paints in extreme climates, when subjected to continuous freezing and thawing, which results in loss of paint elasticity.
- Applying another coat before the previous coat has dried
- Applying too much paint per coat

Fig.-4.15 Peeling of paint.

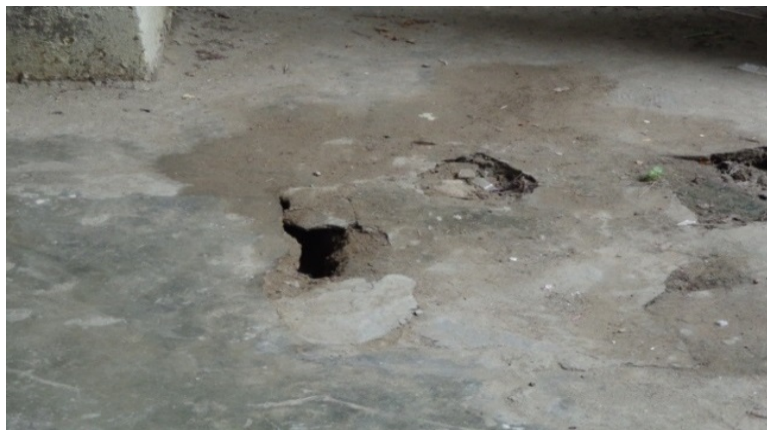
Fig.-4.17 Defect of concrete Flooring

4.7.1.1. CRACKS: Cracks are the most common defect found in concrete flooring. They range from small hairline cracks are barely visible to ones where two sections of the floor slab have completely separated and moved apart. They are caused by a number of factors including settlement of the building, insufficient or improperly located expansion joints, overloading, or defects in the concrete materials itself.

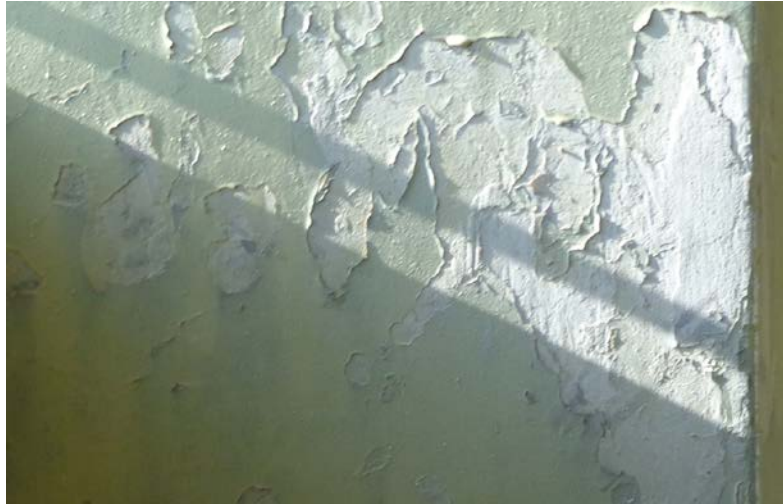
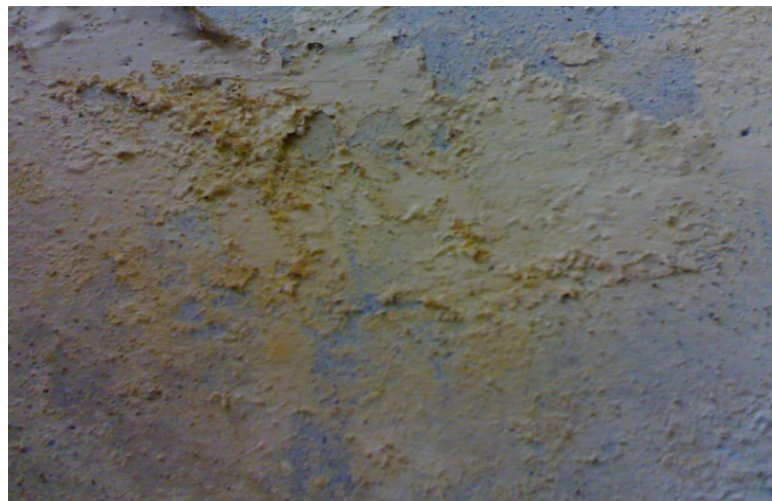
5.2.1.1 MINOR - DETERIORATION OF PAINTS

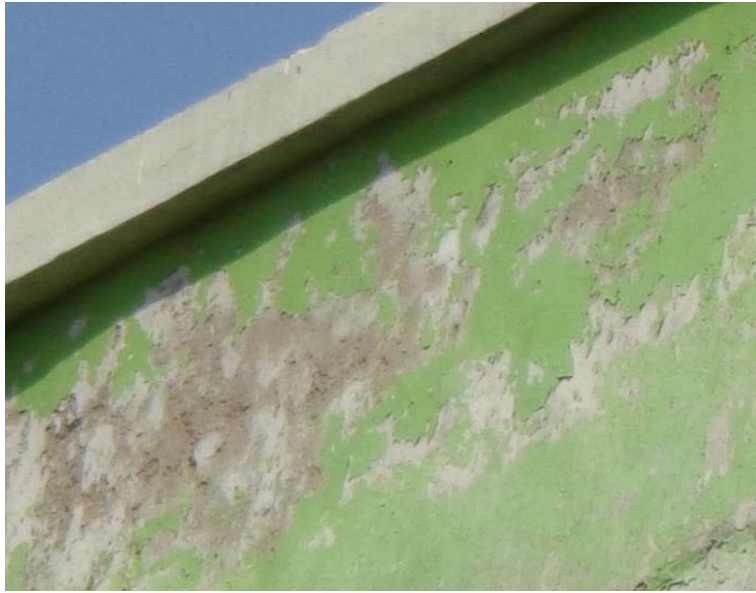
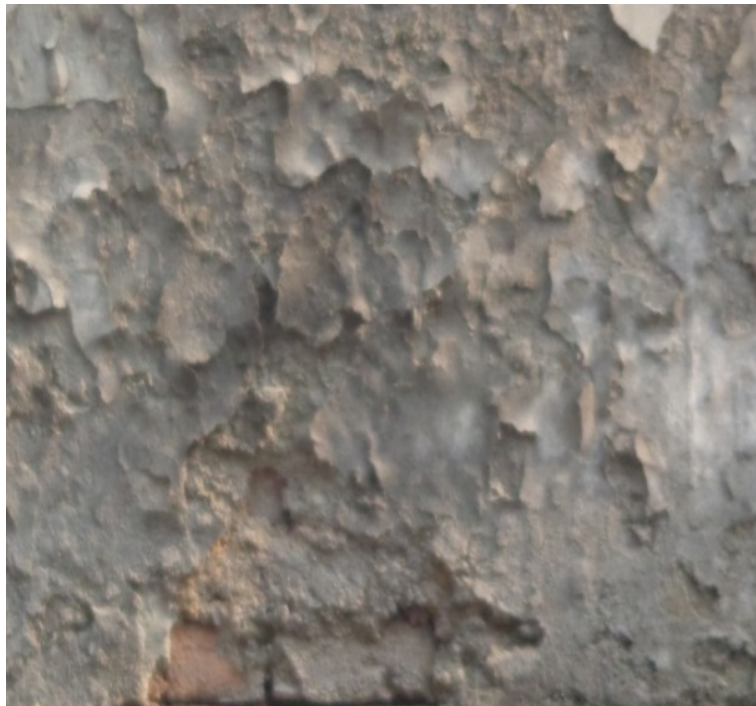
5.2.1.2.MEDIUM - DETERIORATION OF PAINTS

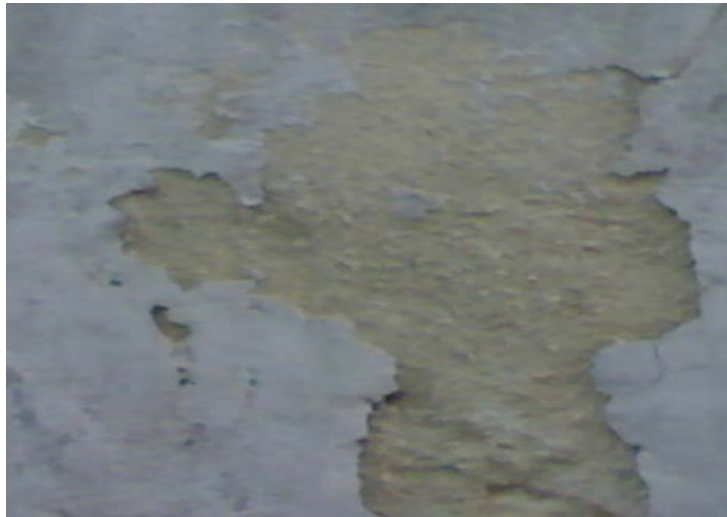
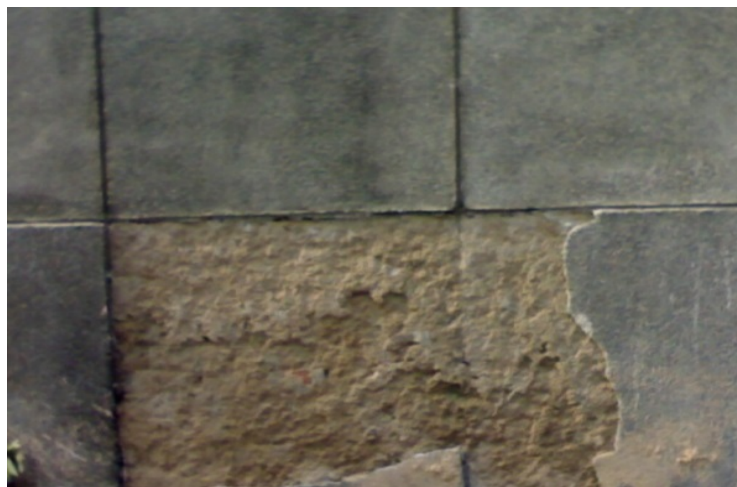
5.2.2.1 MINOR - DETERIORATION OF PLASTERING

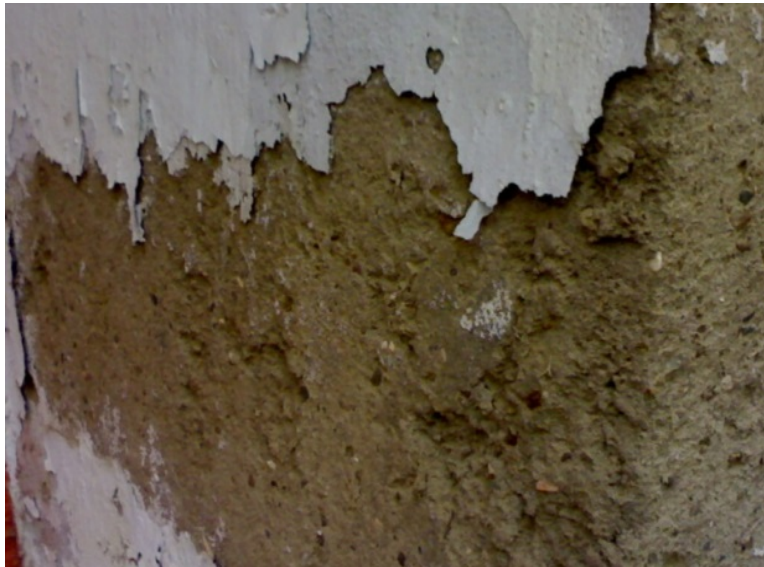
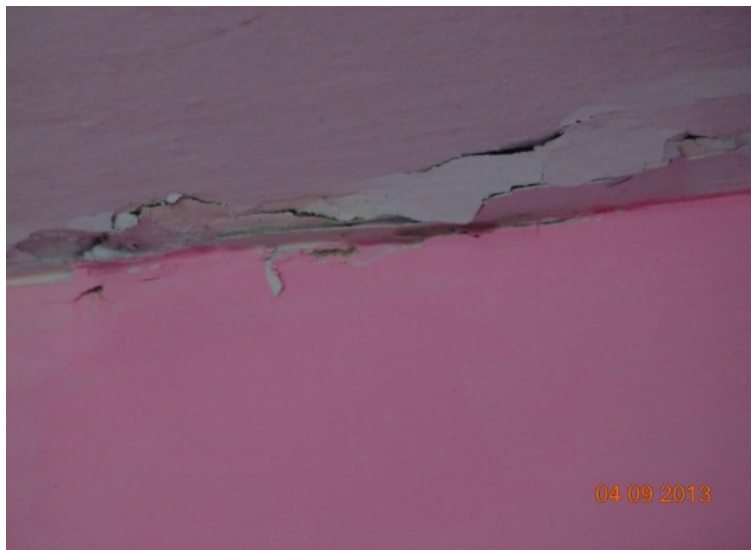
5.2.2.2 MEDIUM - DETERIORATION OF PLASTERING

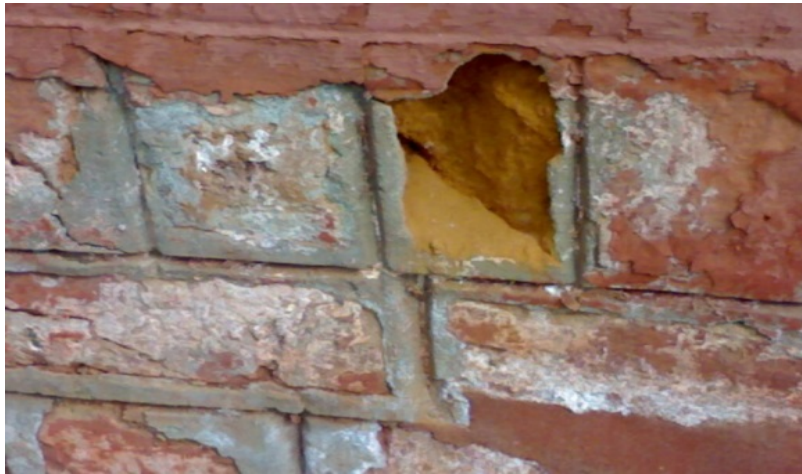
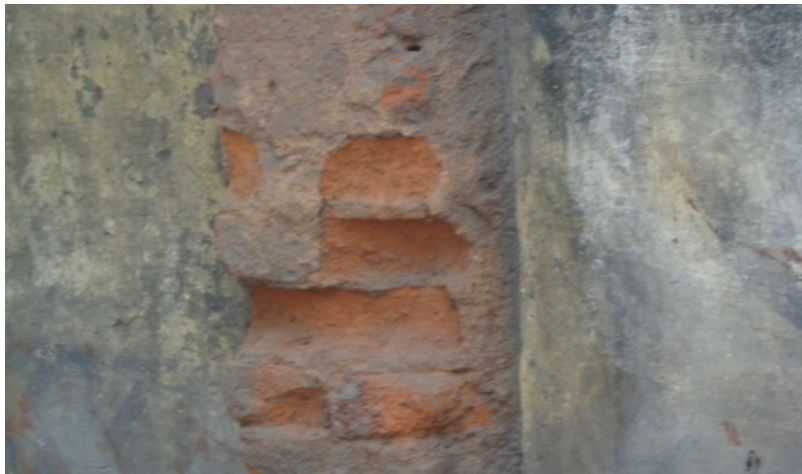
5.2.4.1. MINOR - DAMAGE / DETERIORATION OF BRICK MASONRY

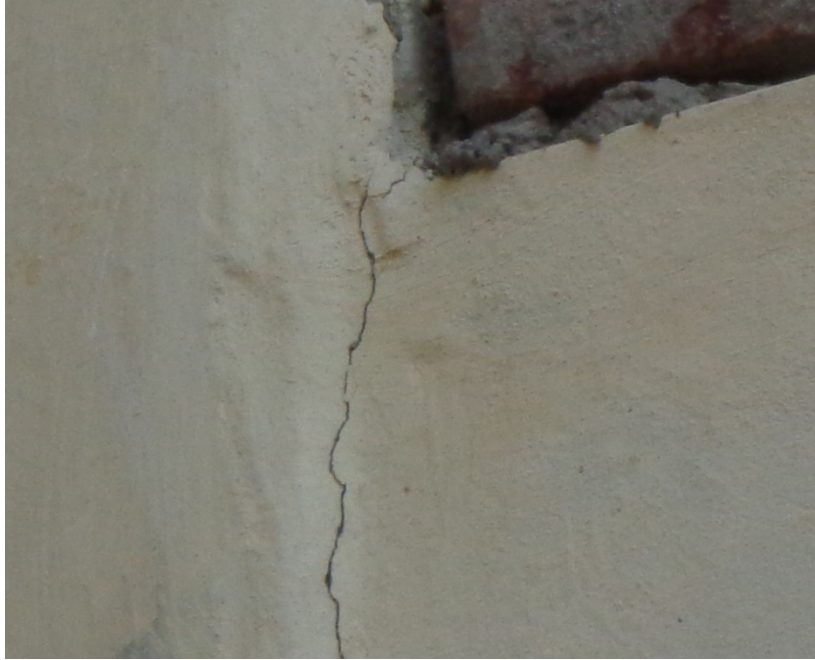
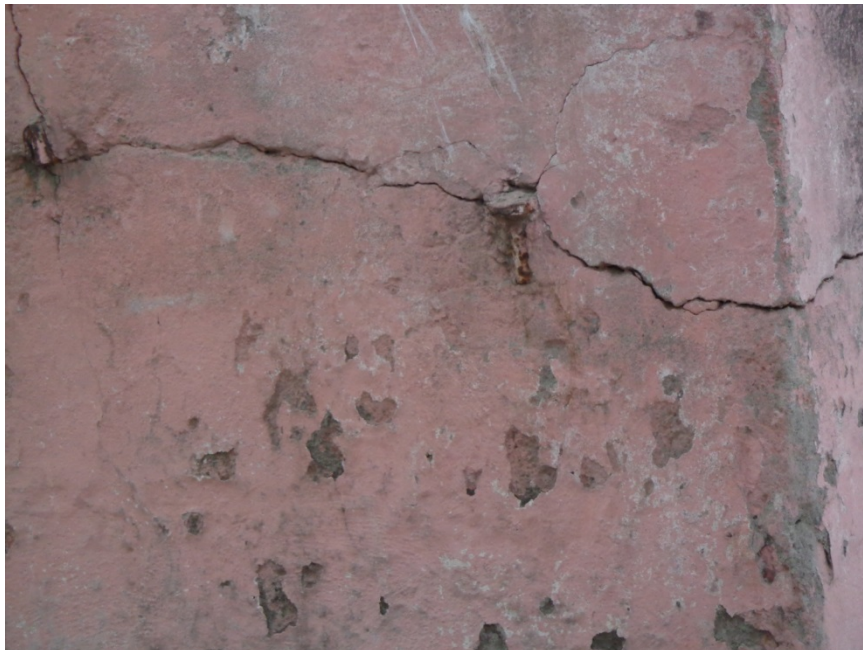
5.2.4.2 MEDIUM - DETERIORATION OF BRICK MASONRY

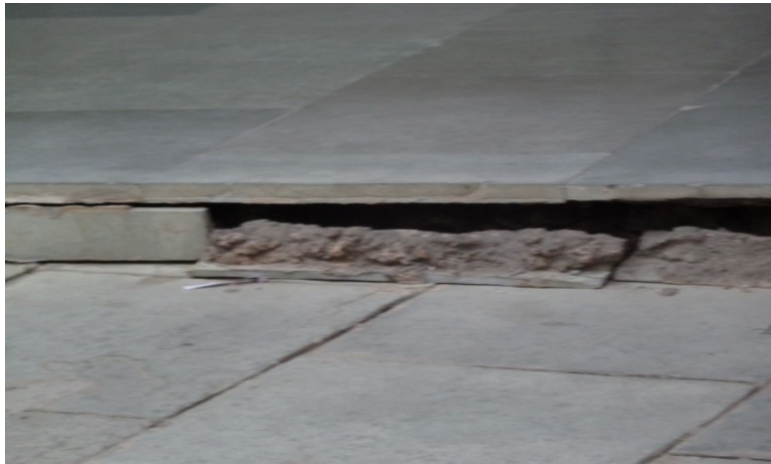
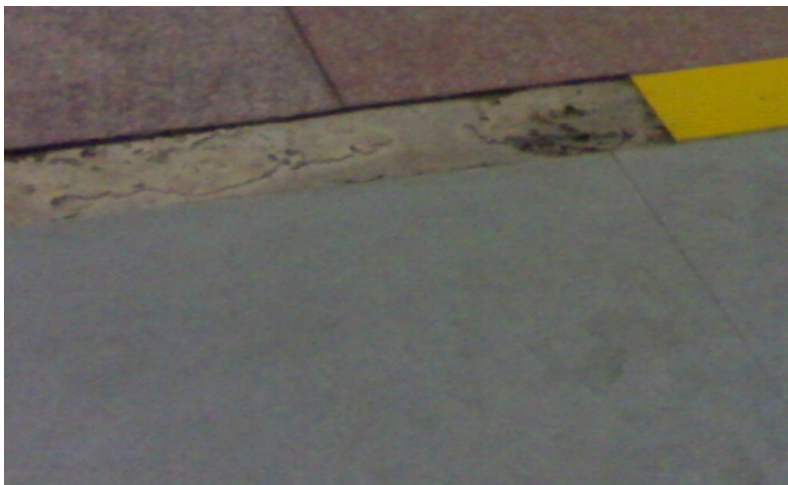
5.2.5.1 MINOR - DAMAGES OF FLOORING

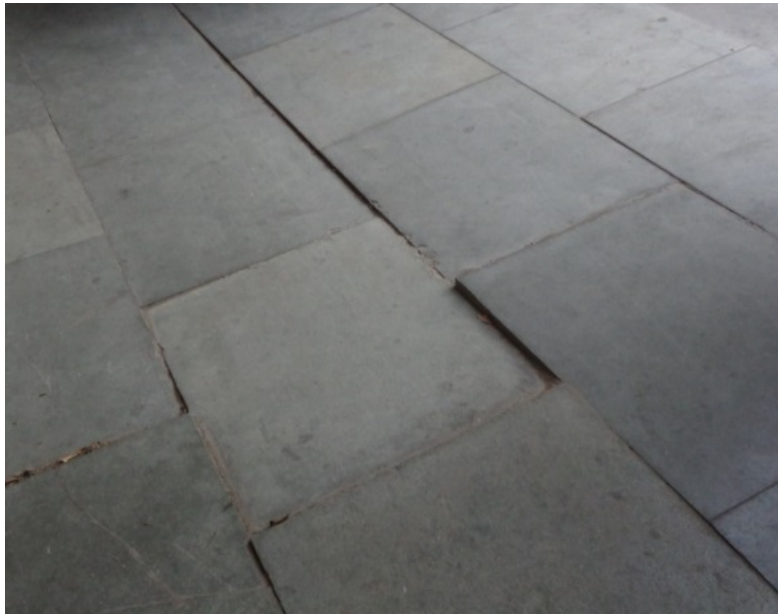
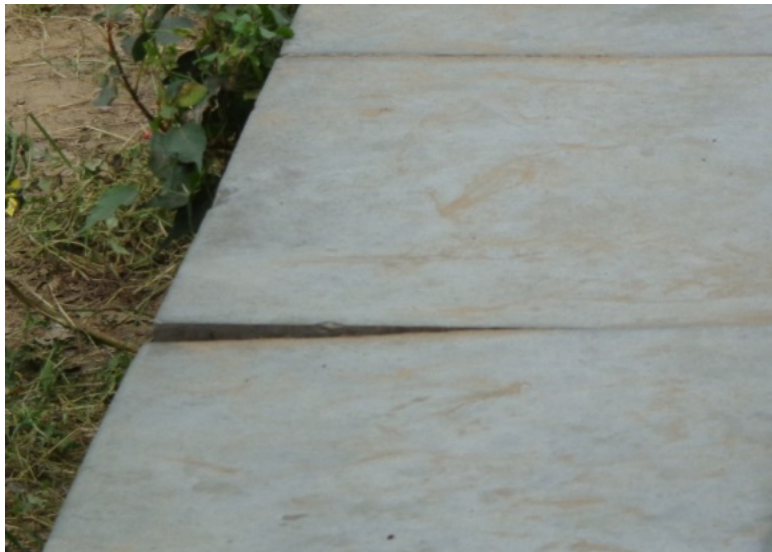
5.2.5.2 MEDIUM - DETERIORATION OF FLOORING

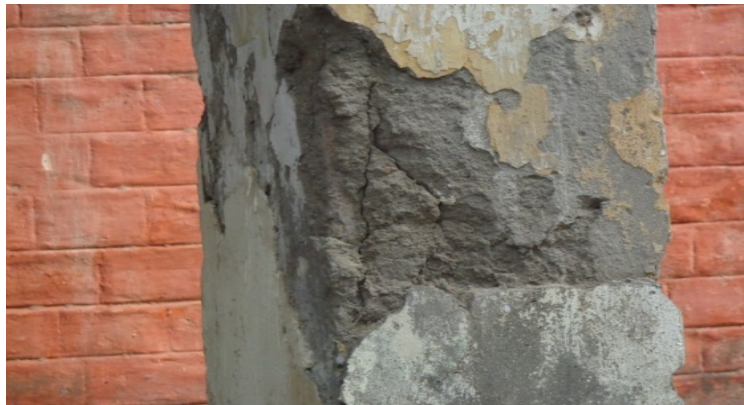
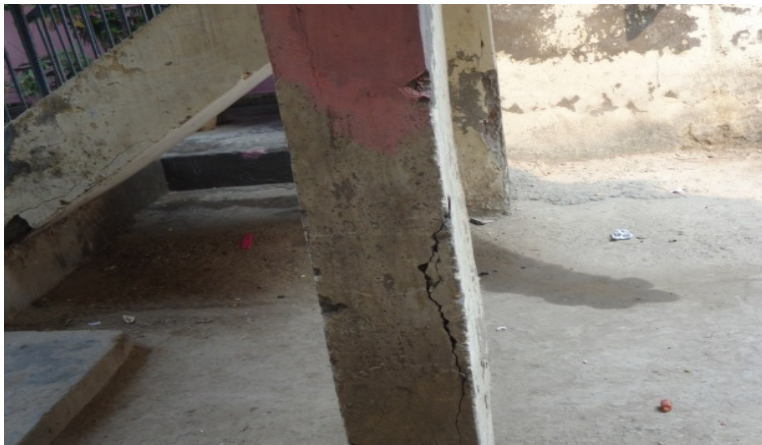
5.2.6.1 MINOR-DAMAGE/DETERIORATION OF RCC COLUMN

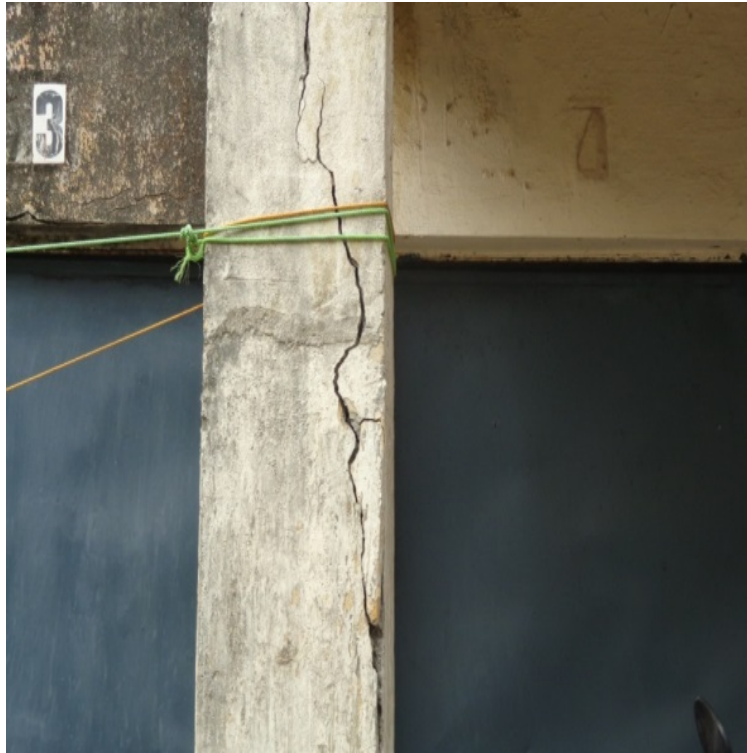
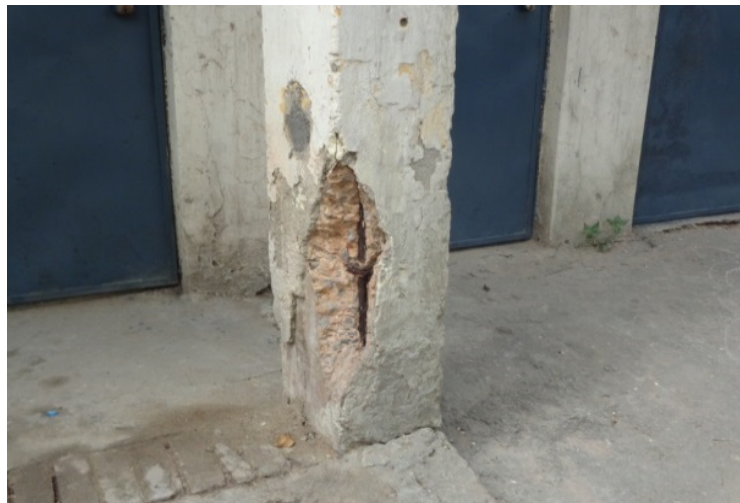
5.2.6.2 MEDIUM - DETERIORATION OF COLUMN

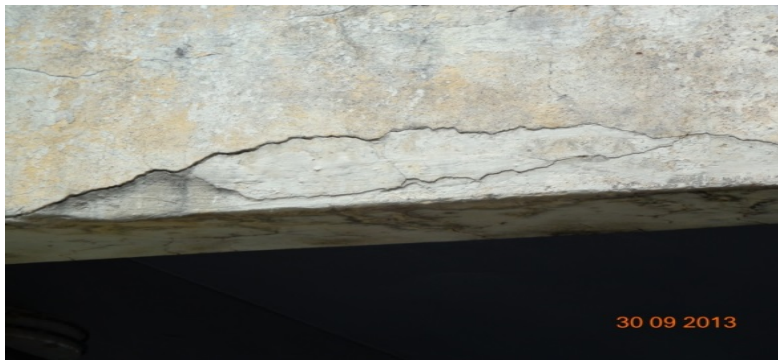
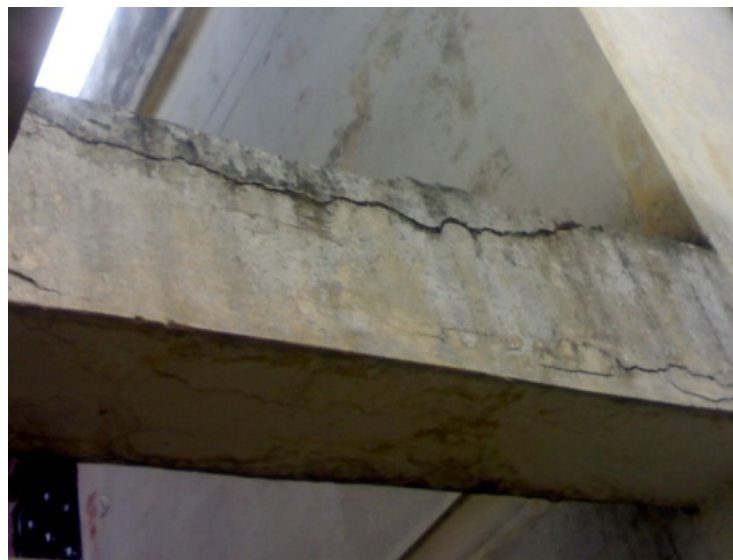
5.2.7.1 MINOR – DAMAGES OF RCC BEAM

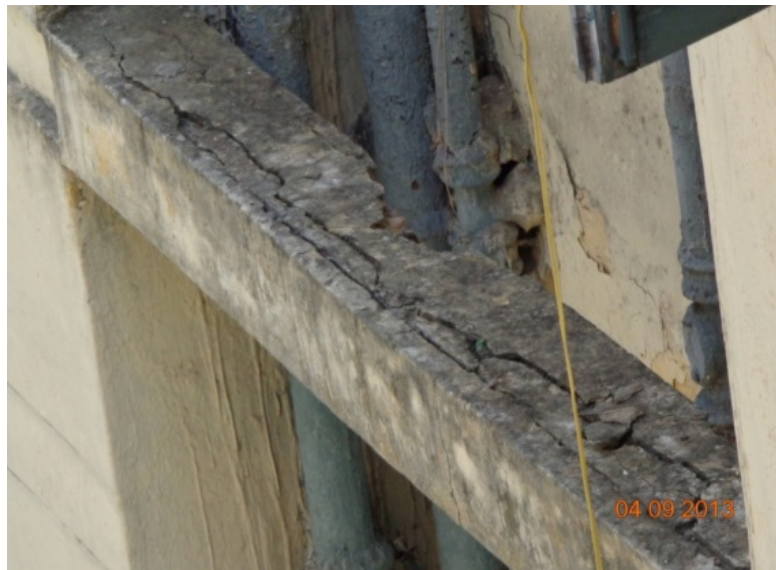
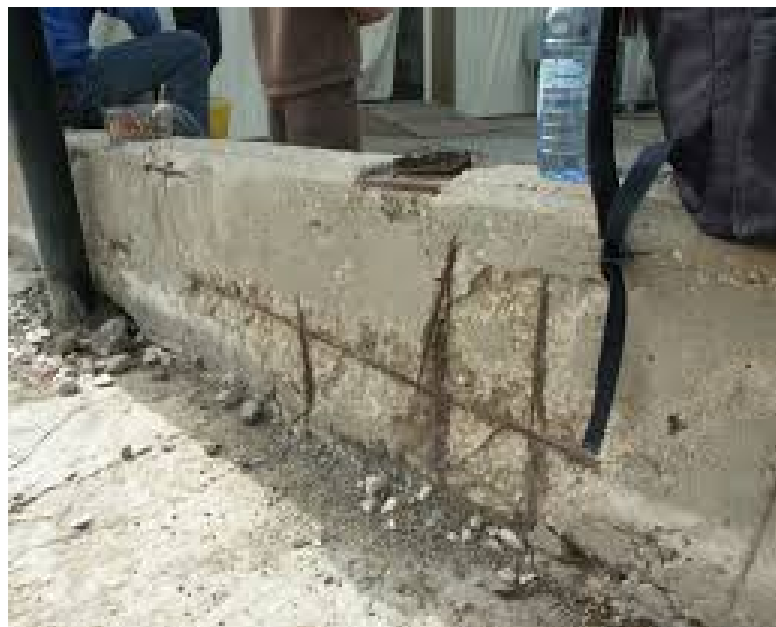
5.2.7.2 MEDIUM-DAMAGES/DETERIORATION OF RCC BEAM

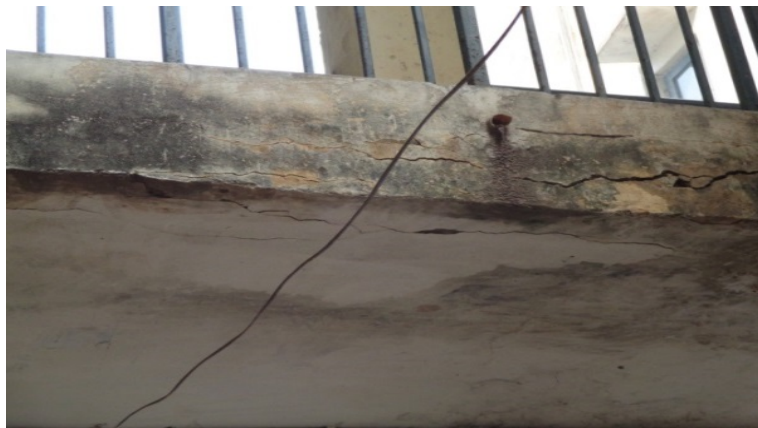
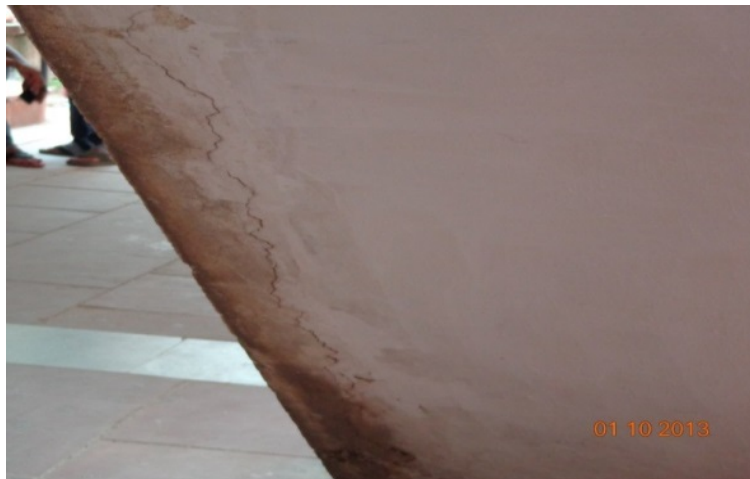
5.2.8.1 MINOR – DAMAGES OF RCC SLAB

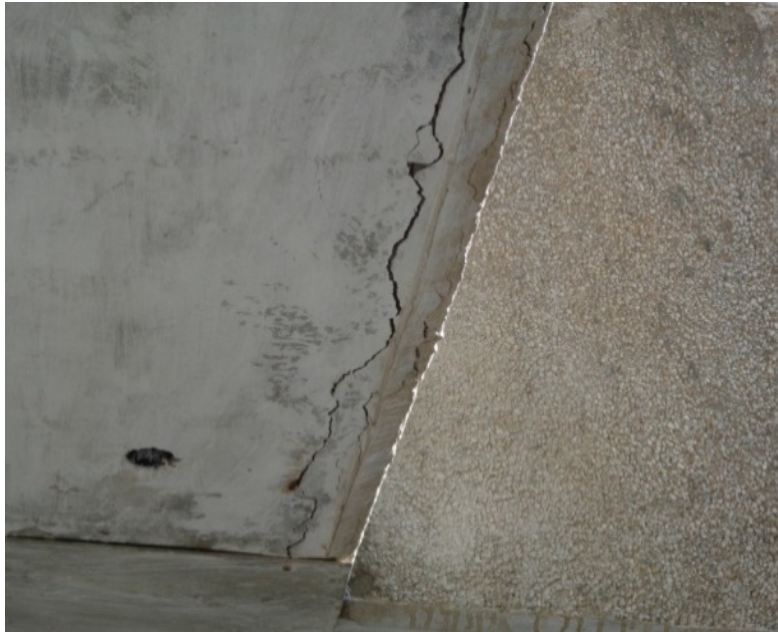
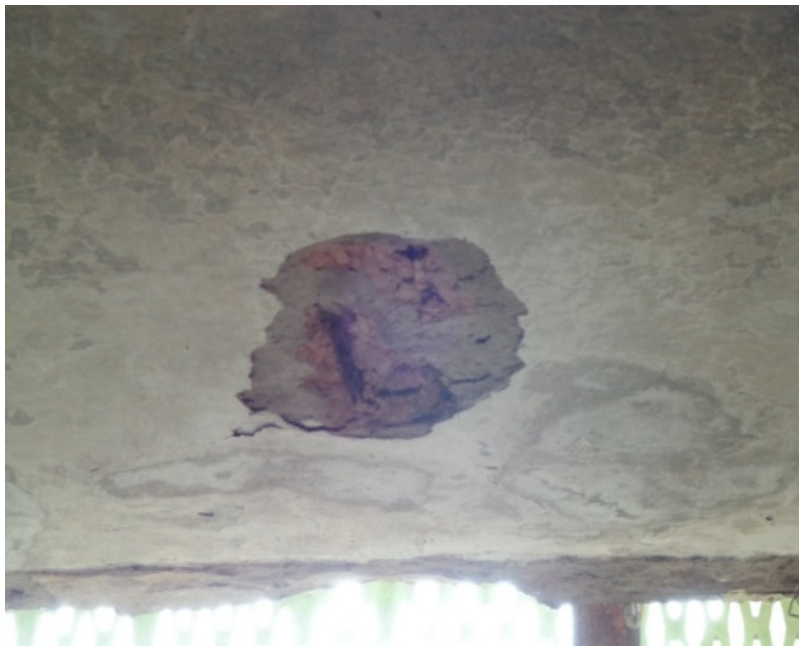
5.2.8.2 MEDIUM – DETERIORATION OF RCC SLAB
