**DEVELOPMENT OF A DECISION MAKING
TOOL FOR
THE CONDITION ASSESSMENT OF BUILDING**

**A DISSERTATION SUBMITTED TOWARDS PARTIAL FULFILLMENT
OF THE REQUIREMENT FOR THE AWARD OF THE DEGREE OF**

MASTER OF TECHNOLOGY
in
Structural Engineering

Department of Civil Engineering
DELHI TECHNOLOGICAL UNIVERSITY

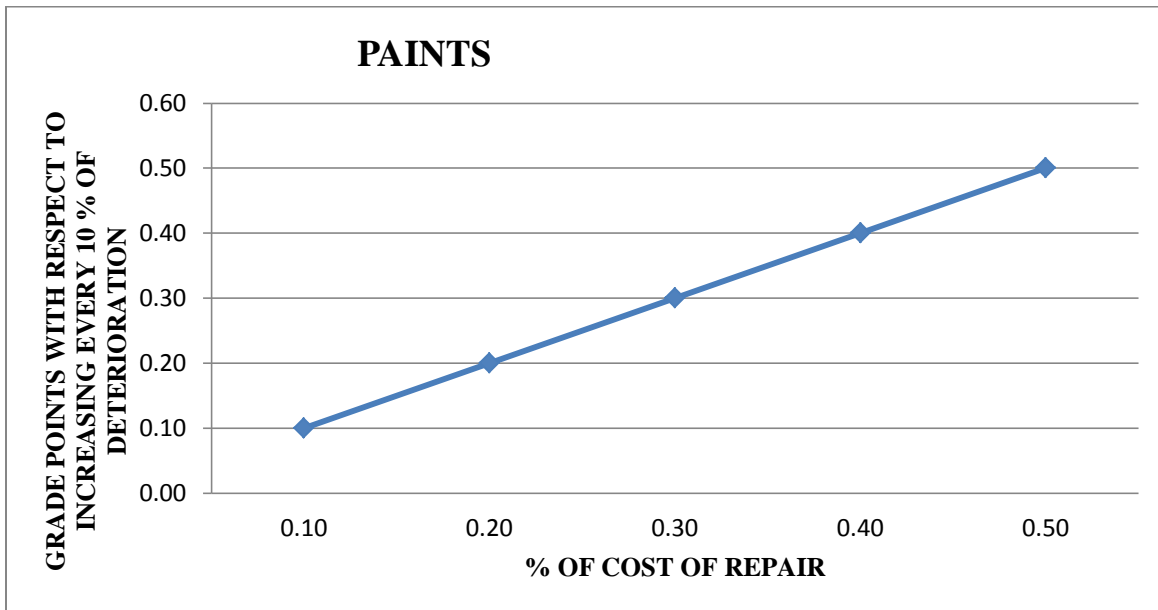
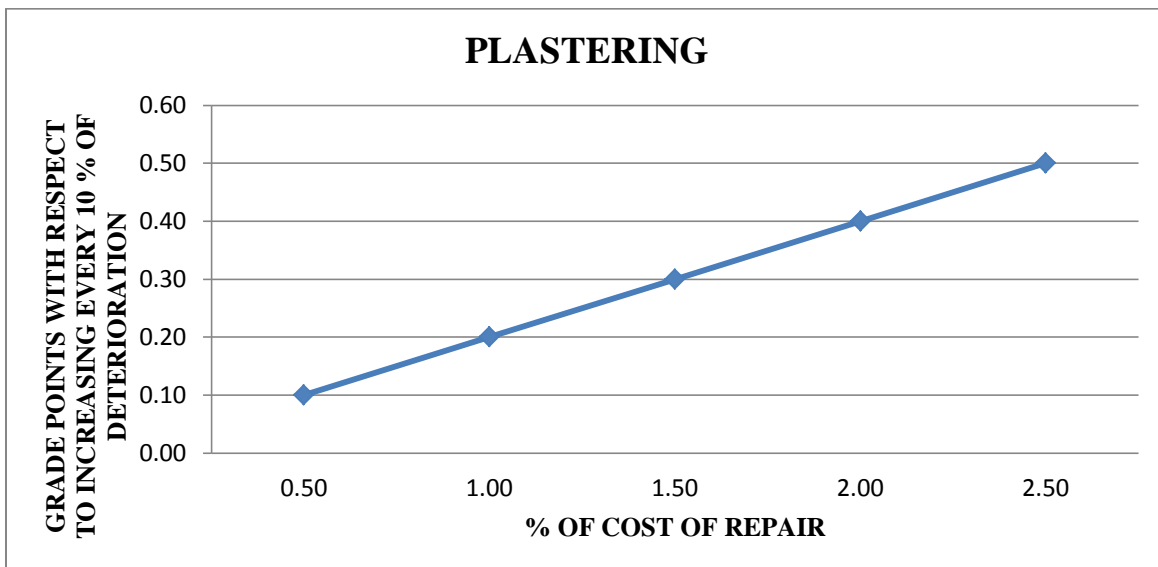
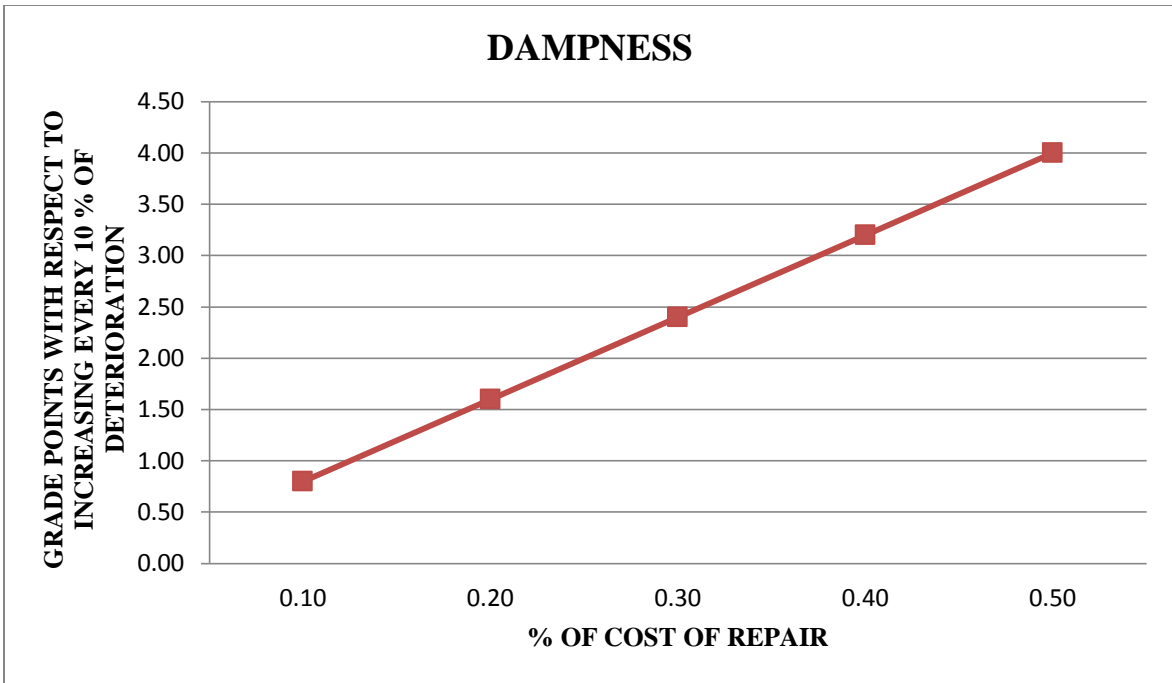
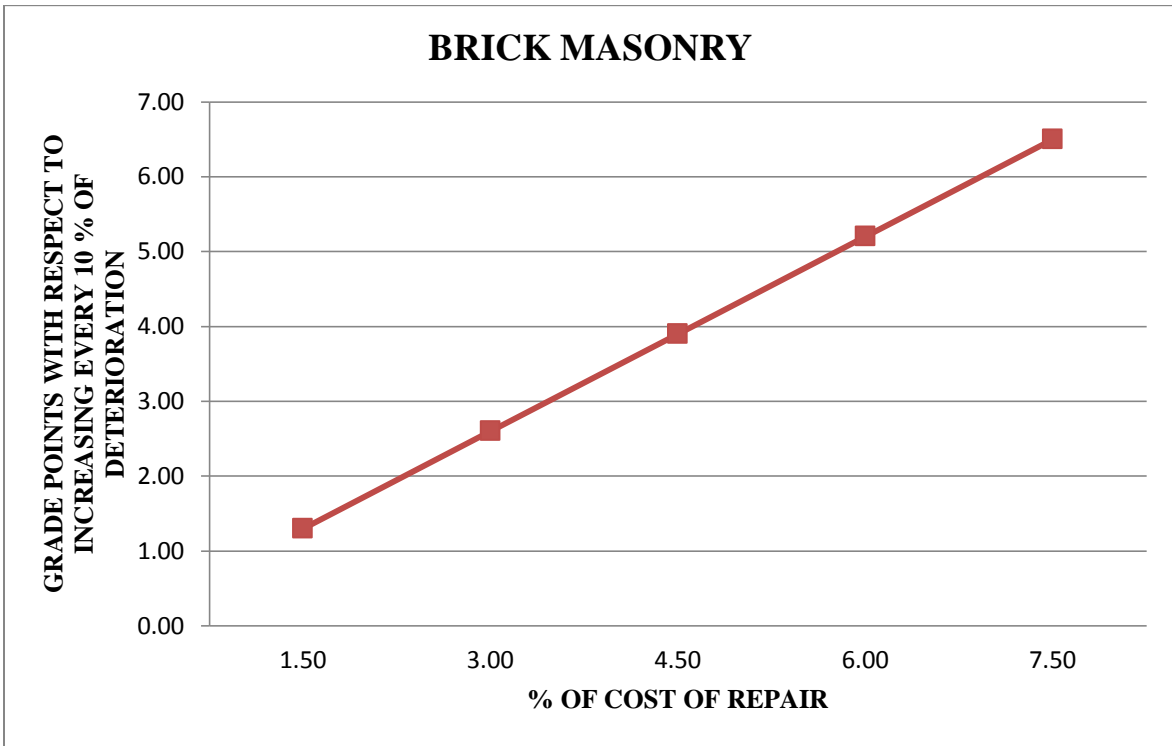
Based on the comparison of the grade points with cost of repair, The tool shows that whenever the increasing grade points which is based on degree of deterioration of different item of building, correspondingly The cost of repair also increased. These comparisons are shown in graphical form as below.
