DISSERTATION

“Application of RVS procedure for condition assessment of structures”

M.Tech. (Structural Engineering)

Delhi Technological University

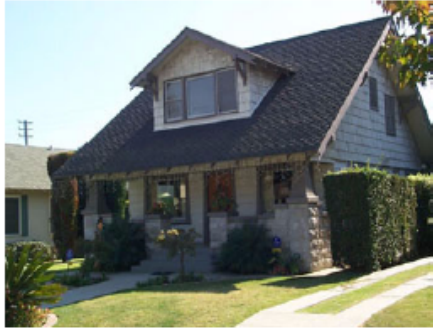
<i>Building Identifier</i>	<i>Photograph</i>	<i>Basic Structural Hazard Score</i>	<i>Characteristics and Performance</i>
<p>W1 Light wood frame residential and commercial buildings equal to or smaller than 5,000 square feet</p>

<p>H = 2.8 M = 5.2 L = 7.4</p>	<ul style="list-style-type: none"> ● Wood stud walls are typically constructed of 2-inch by 4-inch vertical wood members set about 16 inches apart (2-inch by 6-inch for multiple stories). ● Most common exterior finish materials are wood siding, metal siding, or stucco. ● Buildings of this type performed very well in past earthquakes due to inherent qualities of the structural system and because they are lightweight and low rise. ● Earthquake-induced cracks in the plaster and stucco (if any) may appear, but are classified as non-structural damage. ● The most common type of structural damage in older buildings results from a lack of connection between the superstructure and the foundation, and inadequate chimney support.

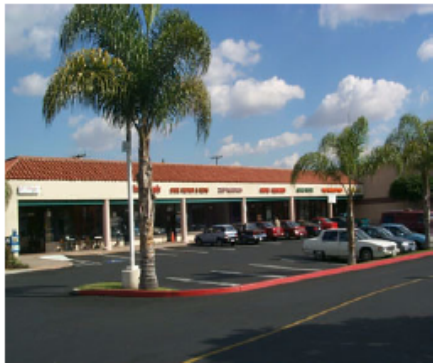
<p>W2 Light wood frame buildings greater than 5,000 square feet</p>

<p>H = 3.8 M = 4.8 L = 6.0</p>	<ul style="list-style-type: none"> ● These are large apartment buildings, commercial buildings or industrial structures usually of one to three stories, and, rarely, as tall as six stories.

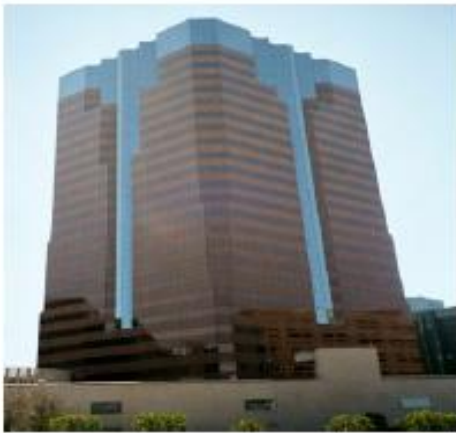
Building Identifier	Photograph	Basic Structural Hazard Score	Characteristics and Performance
<p>S1 Steel moment-resisting frame</p>

<p>H = 2.8 M = 3.6 L = 4.6</p>	<ul style="list-style-type: none"> • Typical steel moment-resisting frame structures usually have similar bay widths in both the transverse and longitudinal directions, around 20-30 ft. • The floor diaphragms are usually concrete, sometimes over steel decking. This structural type is used for commercial, institutional and public buildings. • The 1994 Northridge and 1995 Kobe earthquakes showed that the welds in steel moment-frame buildings were vulnerable to severe damage. The damage took the form of broken connections between the beams and columns.
<p>S2 Braced steel frame</p>

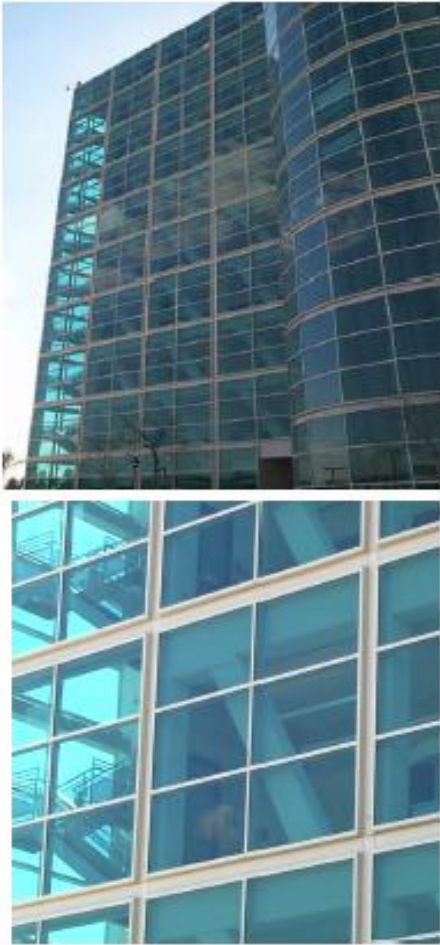
<p>Zoom-in of upper photo</p>	<p>H = 3.0 M = 3.6 L = 4.8</p>	<ul style="list-style-type: none"> • These buildings are braced with diagonal members, which usually cannot be detected from the building exterior. • Braced frames are sometimes used for long and narrow buildings because of their stiffness. • From the building exterior, it is difficult to tell the difference between steel moment frames, steel braced frames, and steel frames with interior concrete shear walls. • In recent earthquakes, braced frames were found to have damage to brace connections, especially at the lower levels.

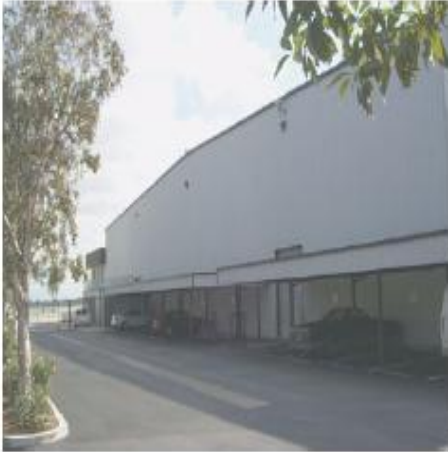
<i>Building Identifier</i>	<i>Photograph</i>	<i>Basic Structural Hazard Score</i>	<i>Characteristics and Performance</i>
<p>S3 Light metal building</p>

<p>H = 3.2 M = 3.8 L = 4.6</p>	<ul style="list-style-type: none"> • The structural system usually consists of moment frames in the transverse direction and braced frames in the longitudinal direction, with corrugated sheet-metal siding. In some regions, light metal buildings may have partial-height masonry walls. • The interiors of most of these buildings do not have interior finishes and their structural skeleton can be seen easily. • Insufficient capacity of tension braces can lead to their elongation and consequent building damage during earthquakes. • Inadequate connection to a slab foundation can allow the building columns to slide on the slab. • Loss of the cladding can occur.
<p>S4 Steel frames with cast-in-place concrete shear walls</p>

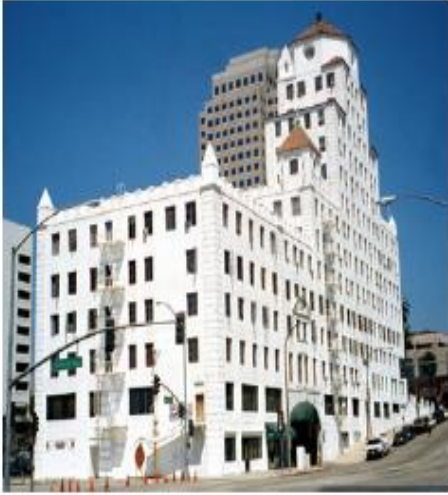
<p>H = 2.8 M = 3.6 L = 4.8</p>	<ul style="list-style-type: none"> • Lateral loads are resisted by shear walls, which usually surround elevator cores and stairwells, and are covered by finish materials. • An interior investigation will permit a wall thickness check. More than six inches in thickness usually indicates a concrete wall. • Shear cracking and distress can occur around openings in concrete shear walls during earthquakes. • Wall construction joints can be weak planes, resulting in wall shear failure below expected capacity.

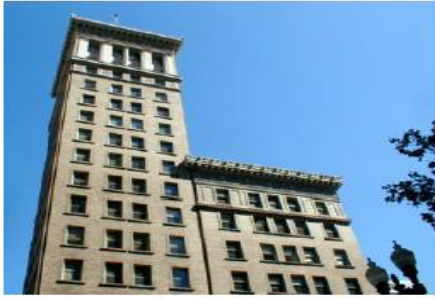
<i>Building Identifier</i>	<i>Photograph</i>	<i>Basic Structural Hazard Score</i>	<i>Characteristics and Performance</i>
S5 Steel frames with unreinforced masonry infill walls

H = 2.0 M = 3.6 L = 5.0	<ul style="list-style-type: none"> Steel columns are relatively thin and may be hidden in walls. Usually masonry is exposed on exterior with narrow piers (less than 4 ft wide) between windows. Portions of solid walls will align vertically. Infill walls are usually two to three wythes thick. Veneer masonry around columns or beams is usually poorly anchored and detaches easily.
C1 Concrete moment-resisting frames

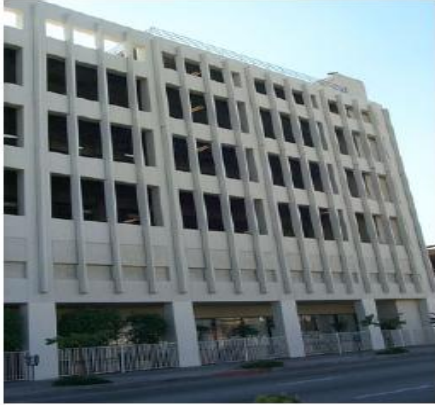
H = 2.5 M = 3.0 L = 4.4	<ul style="list-style-type: none"> All exposed concrete frames are reinforced concrete (not steel frames encased in concrete). A fundamental factor governing the performance of concrete moment-resisting frames is the level of ductile detailing. Large spacing of ties in columns can lead to a lack of concrete confinement and shear failure. Lack of continuous beam reinforcement can result in hinge formation during load reversal. The relatively low stiffness of the frame can lead to substantial nonstructural damage. Column damage due to pounding with adjacent buildings can occur.

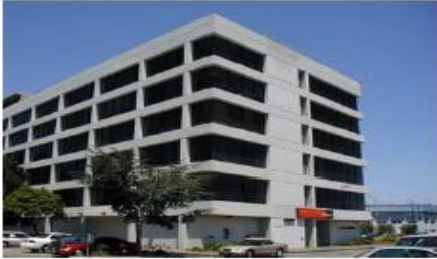
<i>Building Identifier</i>	<i>Photograph</i>	<i>Basic Structural Hazard Score</i>	<i>Characteristics and Performance</i>
C2 Concrete shear wall buildings

H = 2.8 M = 3.6 L = 4.8	<ul style="list-style-type: none"> Concrete shear-wall buildings are usually cast in place, and show typical signs of cast-in-place concrete. Shear-wall thickness ranges from 6 to 10 inches. These buildings generally perform better than concrete frame buildings. They are heavier than steel-frame buildings but more rigid due to the shear walls. Damage commonly observed in taller buildings is caused by vertical discontinuities, pounding, and irregular configuration.
C3 Concrete frames with unreinforced masonry infill walls

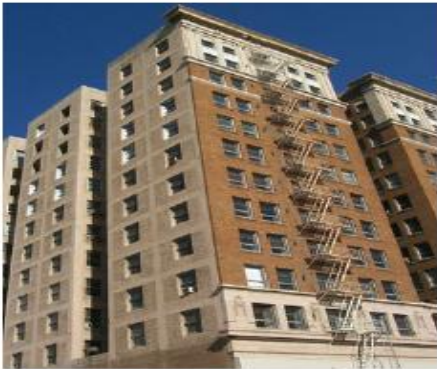
H = 1.6 M = 3.2 L = 4.4	<ul style="list-style-type: none"> Concrete columns and beams may be full wall thickness and may be exposed for viewing on the sides and rear of the building. Usually masonry is exposed on the exterior with narrow piers (less than 4 ft wide) between windows. Portions of solid walls will align vertically. This type of construction was generally built before 1940 in high-seismicity regions but continues to be built in other regions. Infill walls tend to buckle and fall out-of-plane when subjected to strong lateral out-of-plane forces. Veneer masonry around columns or beams is usually poorly anchored and detaches easily.

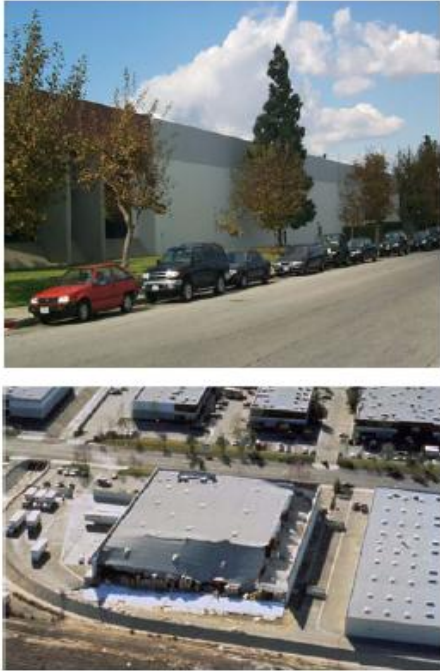
Building Identifier	Photograph	Basic Structural Hazard Score	Characteristics and Performance
<p>PC1 Tilt-up buildings</p>

<p>Partial roof collapse due to failed diaphragm-to-wall connection</p>	<p>H = 2.6 M = 3.2 L = 4.4</p>	<ul style="list-style-type: none"> • Tilt-ups are typically one or two stories high and are basically rectangular in plan. • Exterior walls were traditionally formed and cast on the ground adjacent to their final position, and then “tilted-up” and attached to the floor slab. • The roof can be a plywood diaphragm carried on wood purlins and glulam beams or a light steel deck and joist system, supported in the interior of the building on steel pipe columns. • Weak diaphragm-to-wall anchorage results in the wall panels falling and the collapse of the supported diaphragm (or roof).

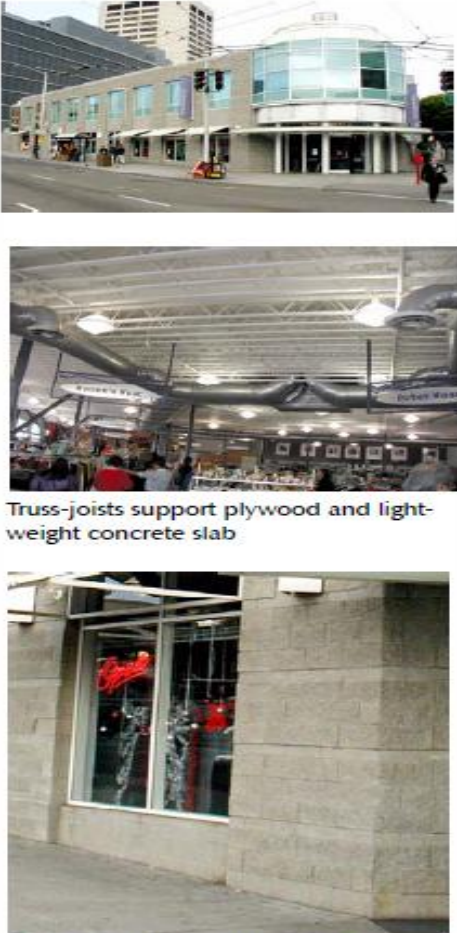
Building Identifier	Photograph	Basic Structural Hazard Score	Characteristics and Performance
<p>RM1 Reinforced masonry buildings with flexible diaphragms</p>

<p>Truss-joists support plywood and light-weight concrete slab</p> <p>Detail showing reinforced masonry</p>	<p>H = 2.8 M = 3.6 L = 4.8</p>	<ul style="list-style-type: none"> • Walls are either brick or concrete block. • Wall thickness is usually 8 inches to 12 inches. • Interior inspection is required to determine if diaphragms are flexible or rigid. • The most common floor and roof systems are wood, light steel, or precast concrete. • These buildings can perform well in moderate earthquakes if they are adequately reinforced and grouted, with sufficient diaphragm anchorage. • Poor construction practice can result in ungrouted and unreinforced walls, which will fail easily.

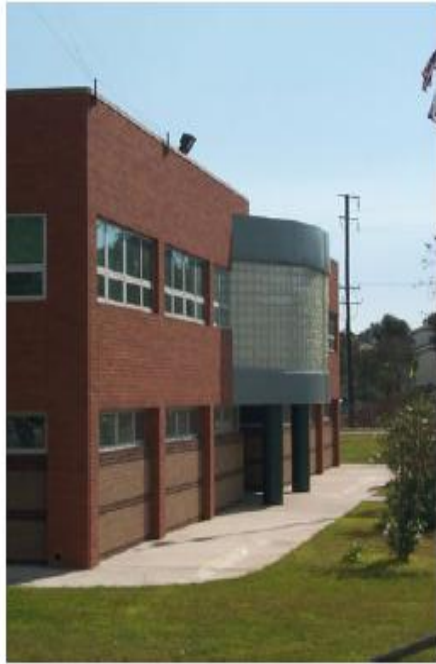
<i>Building Identifier</i>	<i>Photograph</i>	<i>Basic Structural Hazard Score</i>	<i>Characteristics and Performance</i>
<p>RM2 Reinforced masonry buildings with rigid diaphragms</p>

<p>H = 2.8 M = 3.4 L = 4.6</p>	<ul style="list-style-type: none"> ● Walls are either brick or concrete block. ● Wall thickness is usually 8 inches to 12 inches. ● Interior inspection is required to determine if diaphragms are flexible or rigid. ● The most common floor and roof systems are wood, light steel, or precast concrete. ● These buildings can perform well in moderate earthquakes if they are adequately reinforced and grouted, with sufficient diaphragm anchorage. ● Poor construction practice can result in ungrouted and unreinforced walls, which will fail easily.
<p>URM Unreinforced masonry buildings</p>

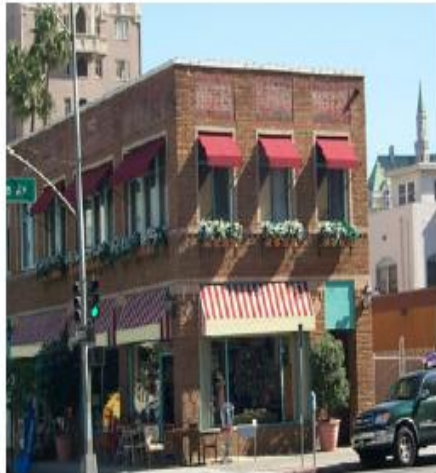
<p>H = 1.8 M = 3.4 L = 4.6</p>	<ul style="list-style-type: none"> ● These buildings often used weak lime mortar to bond the masonry units together. ● Arches are often an architectural characteristic of older brick bearing wall buildings. ● Other methods of spanning are also used, including steel and stone lintels. ● Unreinforced masonry usually shows header bricks in the wall surface. ● The performance of this type of construction is poor due to lack of anchorage of walls to floors and roof, soft mortar, and narrow piers between window openings.
