“Condition Assessment of Buildings using Rapid Visual Screening Procedure”

A Major Project Report

**MASTER OF TECHNOLOGY
in
STRUCTURAL ENGINEERING**

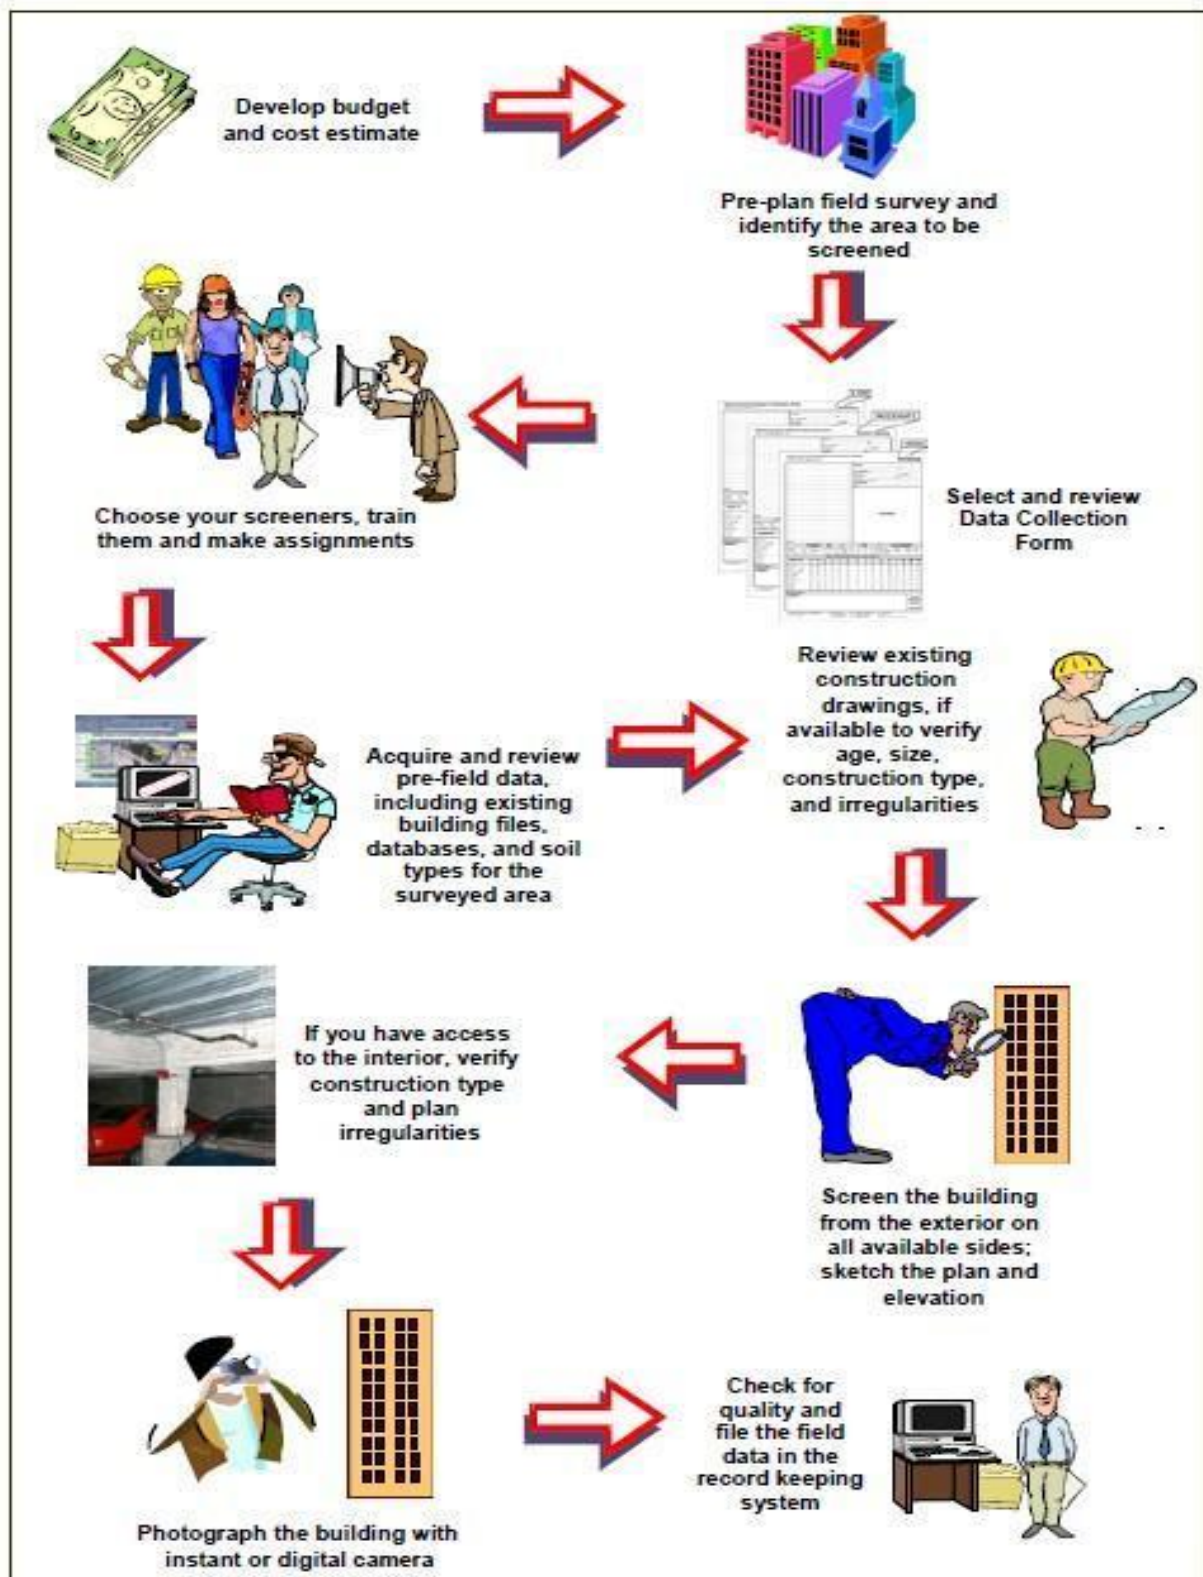
Fig.1:- A flow chart showing the steps involved in RVS implementation sequence

2.4.2. RVS PROCEDURE OUTLINE

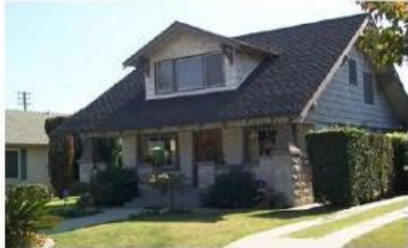
<i>Building Identifier</i>	<i>Photograph</i>	<i>Basic Structural Hazard Score</i>	<i>Characteristics and Performance</i>
<p>W1 Light wood frame residential and commercial buildings equal to or smaller than 5,000 square feet</p>

<p>H = 2.8 M = 5.2 L = 7.4</p>	<ul style="list-style-type: none"> • Wood stud walls are typically constructed of 2-inch by 4-inch vertical wood members set about 16 inches apart (2-inch by 6-inch for multiple stories). • Most common exterior finish materials are wood siding, metal siding, or stucco. • Buildings of this type performed very well in past earthquakes due to inherent qualities of the structural system and because they are lightweight and low rise. • Earthquake-induced cracks in the plaster and stucco (if any) may appear, but are classified as non-structural damage. • The most common type of structural damage in older buildings results from a lack of connection between the superstructure and the foundation, and inadequate chimney support.

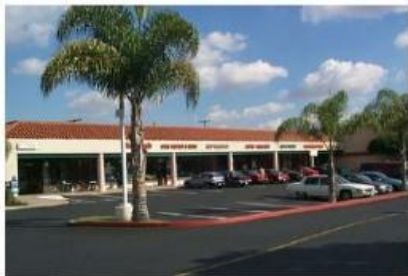
<p>W2 Light wood frame buildings greater than 5,000 square feet</p>

<p>H = 3.8 M = 4.8 L = 6.0</p>	<ul style="list-style-type: none"> • These are large apartment buildings, commercial buildings or industrial structures usually of one to three stories, and, rarely, as tall as six stories.

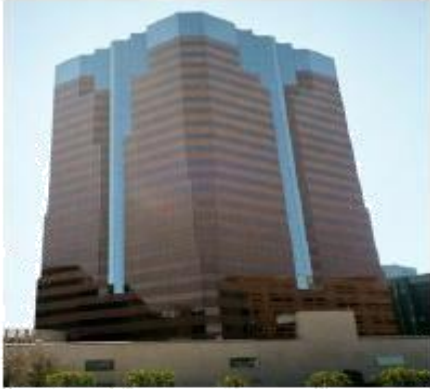
Building Identifier	Photograph	Basic Structural Hazard Score	Characteristics and Performance
<p>S1 Steel moment-resisting frame</p>

<p>H = 2.8 M = 3.6 L = 4.6</p>	<ul style="list-style-type: none"> • Typical steel moment-resisting frame structures usually have similar bay widths in both the transverse and longitudinal directions, around 20-30 ft. • The floor diaphragms are usually concrete, sometimes over steel decking. This structural type is used for commercial, institutional and public buildings. • The 1994 Northridge and 1995 Kobe earthquakes showed that the welds in steel moment-frame buildings were vulnerable to severe damage. The damage took the form of broken connections between the beams and columns.
<p>S2 Braced steel frame</p>

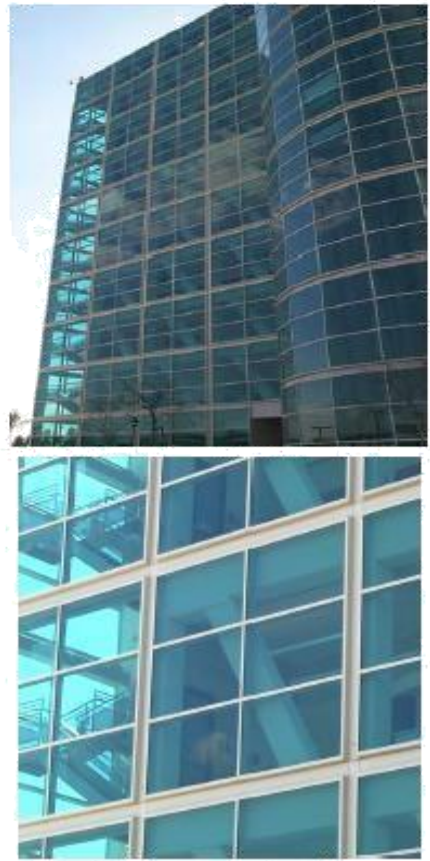
Fig.2:- Types of building codes with hazard score and its earthquake history

<p>Zoom-in of upper photo</p>	<p>H = 3.0 M = 3.6 L = 4.8</p>	<ul style="list-style-type: none"> • These buildings are braced with diagonal members, which usually cannot be detected from the building exterior. • Braced frames are sometimes used for long and narrow buildings because of their stiffness. • From the building exterior, it is difficult to tell the difference between steel moment frames, steel braced frames, and steel frames with interior concrete shear walls. • In recent earthquakes, braced frames were found to have damage to brace connections, especially at the lower levels.

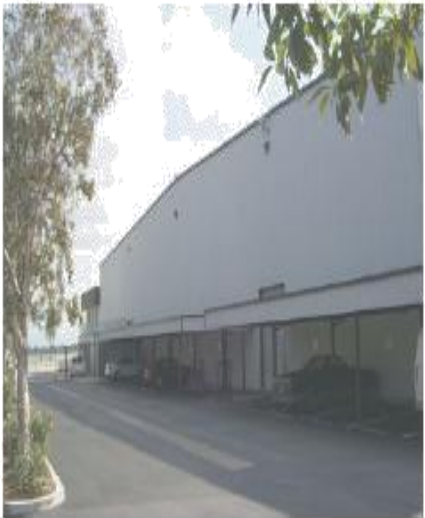
<i>Building Identifier</i>	<i>Photograph</i>	<i>Basic Structural Hazard Score</i>	<i>Characteristics and Performance</i>
<p>S3 Light metal building</p>

<p>H = 3.2 M = 3.8 L = 4.6</p>	<ul style="list-style-type: none"> • The structural system usually consists of moment frames in the transverse direction and braced frames in the longitudinal direction, with corrugated sheet-metal siding. In some regions, light metal buildings may have partial-height masonry walls. • The interiors of most of these buildings do not have interior finishes and their structural skeleton can be seen easily. • Insufficient capacity of tension braces can lead to their elongation and consequent building damage during earthquakes. • Inadequate connection to a slab foundation can allow the building columns to slide on the slab. • Loss of the cladding can occur.
<p>S4 Steel frames with cast-in-place concrete shear walls</p>

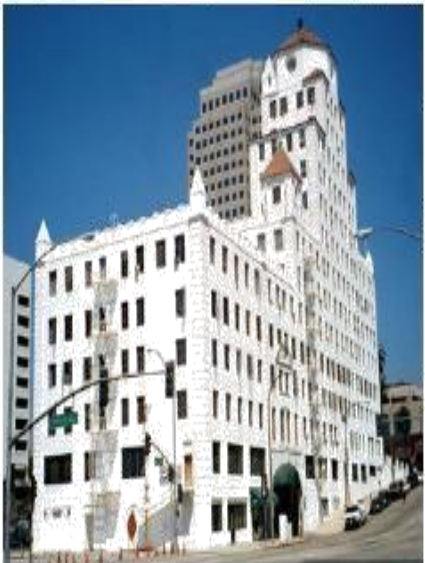
<p>H = 2.8 M = 3.6 L = 4.8</p>	<ul style="list-style-type: none"> • Lateral loads are resisted by shear walls, which usually surround elevator cores and stairwells, and are covered by finish materials. • An interior investigation will permit a wall thickness check. More than six inches in thickness usually indicates a concrete wall. • Shear cracking and distress can occur around openings in concrete shear walls during earthquakes. • Wall construction joints can be weak planes, resulting in wall shear failure below expected capacity.

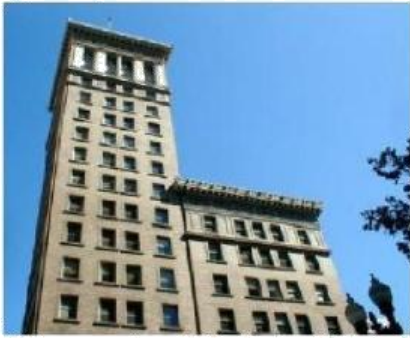
<i>Building Identifier</i>	<i>Photograph</i>	<i>Basic Structural Hazard Score</i>	<i>Characteristics and Performance</i>
S5 Steel frames with unreinforced masonry infill walls

H = 2.0 M = 3.6 L = 5.0	<ul style="list-style-type: none"> Steel columns are relatively thin and may be hidden in walls. Usually masonry is exposed on exterior with narrow piers (less than 4 ft wide) between windows. Portions of solid walls will align vertically. Infill walls are usually two to three wythes thick. Veneer masonry around columns or beams is usually poorly anchored and detaches easily.
C1 Concrete moment-resisting frames

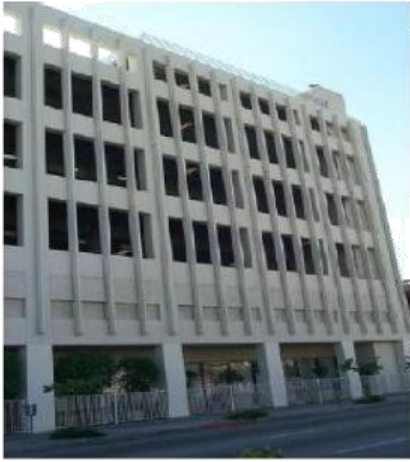
H = 2.5 M = 3.0 L = 4.4	<ul style="list-style-type: none"> All exposed concrete frames are reinforced concrete (not steel frames encased in concrete). A fundamental factor governing the performance of concrete moment-resisting frames is the level of ductile detailing. Large spacing of ties in columns can lead to a lack of concrete confinement and shear failure. Lack of continuous beam reinforcement can result in hinge formation during load reversal. The relatively low stiffness of the frame can lead to substantial nonstructural damage. Column damage due to pounding with adjacent buildings can occur.

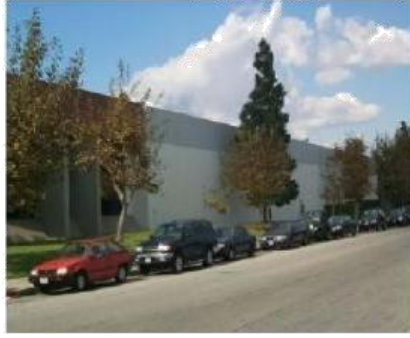
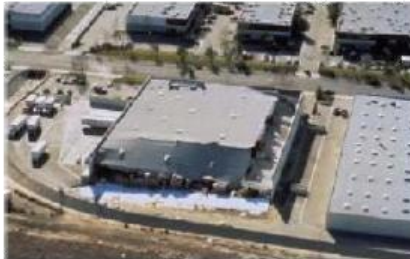
<i>Building Identifier</i>	<i>Photograph</i>	<i>Basic Structural Hazard Score</i>	<i>Characteristics and Performance</i>
PC1 Tilt-up buildings

<p>Partial roof collapse due to failed diaphragm-to-wall connection</p>	H = 2.6 M = 3.2 L = 4.4	<ul style="list-style-type: none"> Tilt-ups are typically one or two stories high and are basically rectangular in plan. Exterior walls were traditionally formed and cast on the ground adjacent to their final position, and then "tilted-up" and attached to the floor slab. The roof can be a plywood diaphragm carried on wood purlins and glulam beams or a light steel deck and joist system, supported in the interior of the building on steel pipe columns. Weak diaphragm-to-wall anchorage results in the wall panels falling and the collapse of the supported diaphragm (or roof).

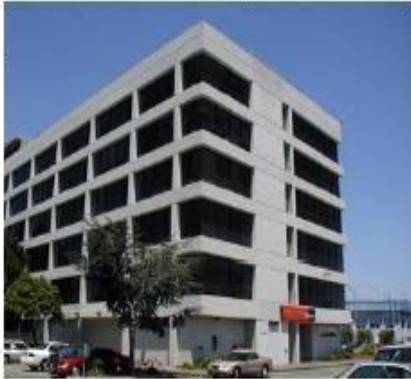
<i>Building Identifier</i>	<i>Photograph</i>	<i>Basic Structural Hazard Score</i>	<i>Characteristics and Performance</i>
<p>C2 Concrete shear wall buildings</p>

<p>H = 2.8 M = 3.6 L = 4.8</p>	<ul style="list-style-type: none"> • Concrete shear-wall buildings are usually cast in place, and show typical signs of cast-in-place concrete. • Shear-wall thickness ranges from 6 to 10 inches. • These buildings generally perform better than concrete frame buildings. • They are heavier than steel-frame buildings but more rigid due to the shear walls. • Damage commonly observed in taller buildings is caused by vertical discontinuities, pounding, and irregular configuration.
<p>C3 Concrete frames with unreinforced masonry infill walls</p>

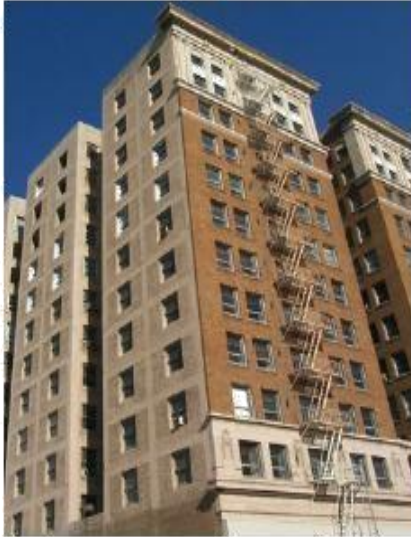
Fig.3:- Types of building codes with hazard score and its earthquake history

<p>H = 1.6 M = 3.2 L = 4.4</p>	<ul style="list-style-type: none"> • Concrete columns and beams may be full wall thickness and may be exposed for viewing on the sides and rear of the building. • Usually masonry is exposed on the exterior with narrow piers (less than 4 ft wide) between windows. • Portions of solid walls will align vertically. • This type of construction was generally built before 1940 in high-seismicity regions but continues to be built in other regions. • Infill walls tend to buckle and fall out-of-plane when subjected to strong lateral out-of-plane forces. • Veneer masonry around columns or beams is usually poorly anchored and detaches easily.

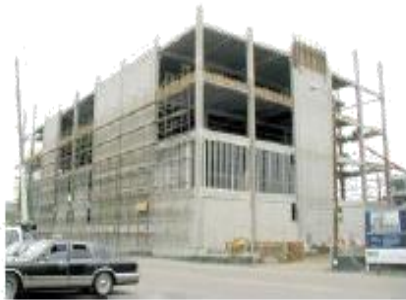
<i>Building Identifier</i>	<i>Photograph</i>	<i>Basic Structural Hazard Score</i>	<i>Characteristics and Performance</i>
<p>PC2 Precast concrete frame buildings</p>

<p>Building under construction</p>

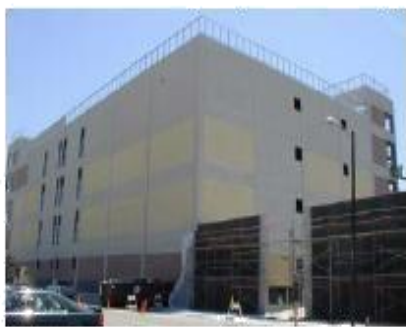
Fig.4:- Types of building codes with hazard score and its earthquake history

<p>Building nearing completion</p>	<p>H = 2.4 M = 3.2 L = 4.6</p>	<ul style="list-style-type: none"> ● Precast concrete frames are, in essence, post and beam construction in concrete. ● Structures often employ concrete or reinforced masonry (brick or block) shear walls. ● The performance varies widely and is sometimes poor. ● They experience the same types of damage as shear wall buildings (C2). ● Poorly designed connections between prefabricated elements can fail. ● Loss of vertical support can occur due to inadequate bearing area and insufficient connection between floor elements and columns. ● Corrosion of metal connectors between prefabricated elements can occur.

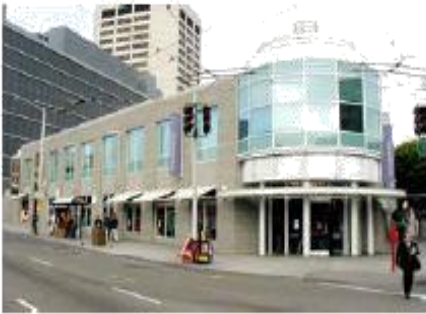
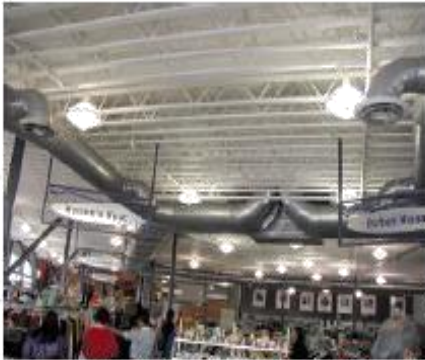
<i>Building Identifier</i>	<i>Photograph</i>	<i>Basic Structural Hazard Score</i>	<i>Characteristics and Performance</i>
<p>RM1 Reinforced masonry buildings with flexible diaphragms</p>

<p>Truss-joists support plywood and light-weight concrete slab</p>

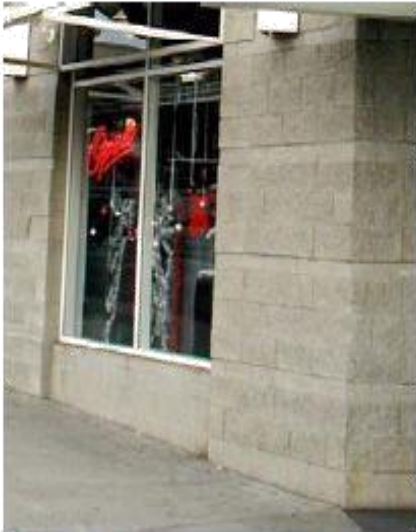
Fig.5:- Types of building codes with hazard score and its earthquake history

<p>Detail showing reinforced masonry</p>	<p>H = 2.8 M = 3.6 L = 4.8</p>	<ul style="list-style-type: none"> ● Walls are either brick or concrete block. ● Wall thickness is usually 8 inches to 12 inches. ● Interior inspection is required to determine if diaphragms are flexible or rigid. ● The most common floor and roof systems are wood, light steel, or precast concrete. ● These buildings can perform well in moderate earthquakes if they are adequately reinforced and grouted, with sufficient diaphragm anchorage. ● Poor construction practice can result in ungrouted and unreinforced walls, which will fail easily.

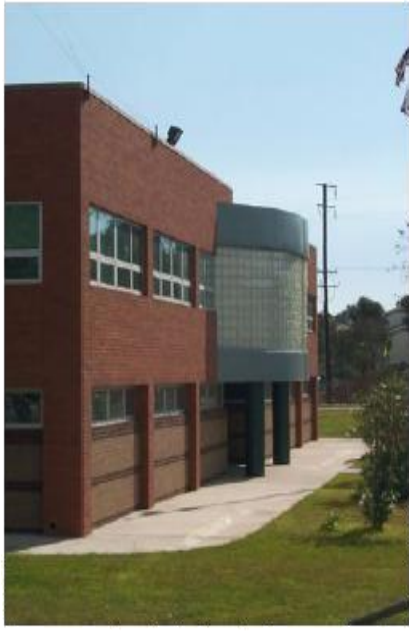
<i>Building Identifier</i>	<i>Photograph</i>	<i>Basic Structural Hazard Score</i>	<i>Characteristics and Performance</i>
<p>RM2 Reinforced masonry buildings with rigid diaphragms</p>

<p>H = 2.8 M = 3.4 L = 4.6</p>	<ul style="list-style-type: none"> ● Walls are either brick or concrete block. ● Wall thickness is usually 8 inches to 12 inches. ● Interior inspection is required to determine if diaphragms are flexible or rigid. ● The most common floor and roof systems are wood, light steel, or precast concrete. ● These buildings can perform well in moderate earthquakes if they are adequately reinforced and grouted, with sufficient diaphragm anchorage. ● Poor construction practice can result in ungrouted and unreinforced walls, which will fail easily.
<p>URM Unreinforced masonry buildings</p>

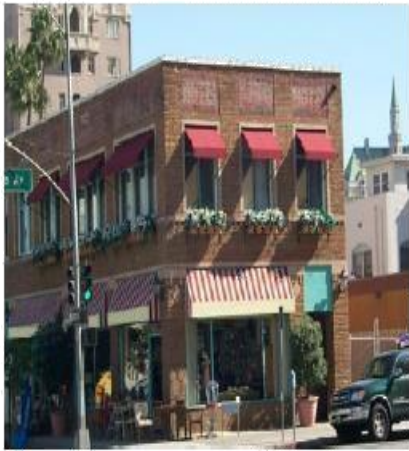
Fig.6:- Types of building codes with hazard score and its earthquake history

<p>H = 1.8 M = 3.4 L = 4.6</p>	<ul style="list-style-type: none"> ● These buildings often used weak lime mortar to bond the masonry units together. ● Arches are often an architectural characteristic of older brick bearing wall buildings. ● Other methods of spanning are also used, including steel and stone lintels. ● Unreinforced masonry usually shows header bricks in the wall surface. ● The performance of this type of construction is poor due to lack of anchorage of walls to floors and roof, soft mortar, and narrow piers between window openings.

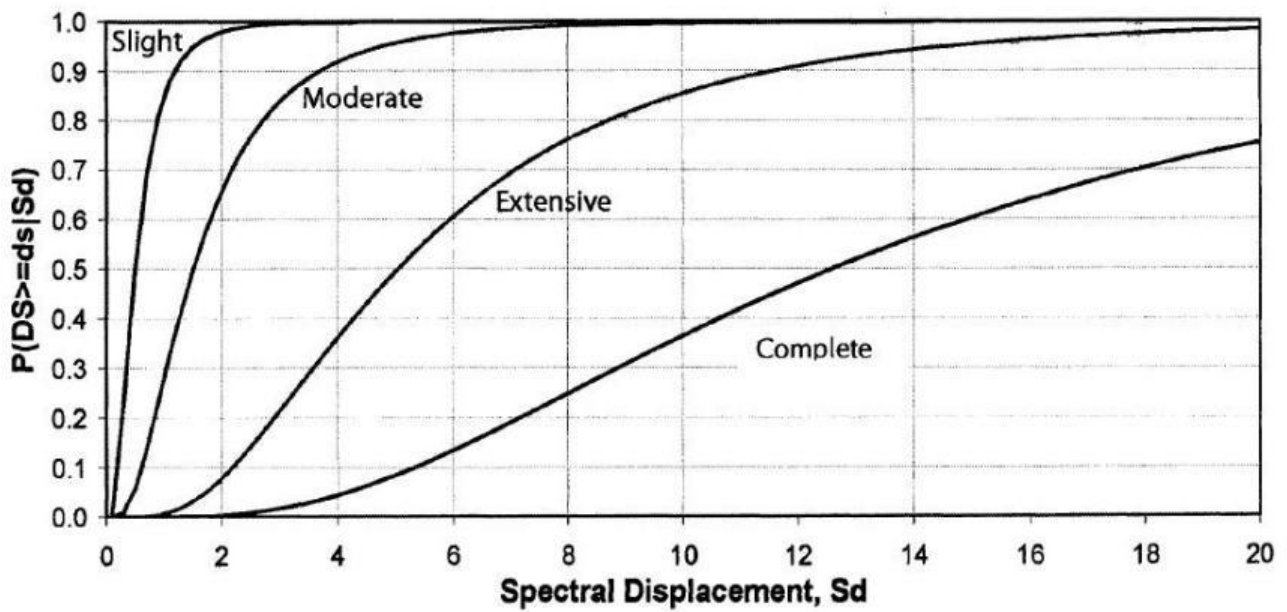
Graph 2:- Fragility curves HAZUS99 (For W1 wood frame buildings) It shows the probability of damage state exceeded for the given level of ground shaking (NIBS 1999)

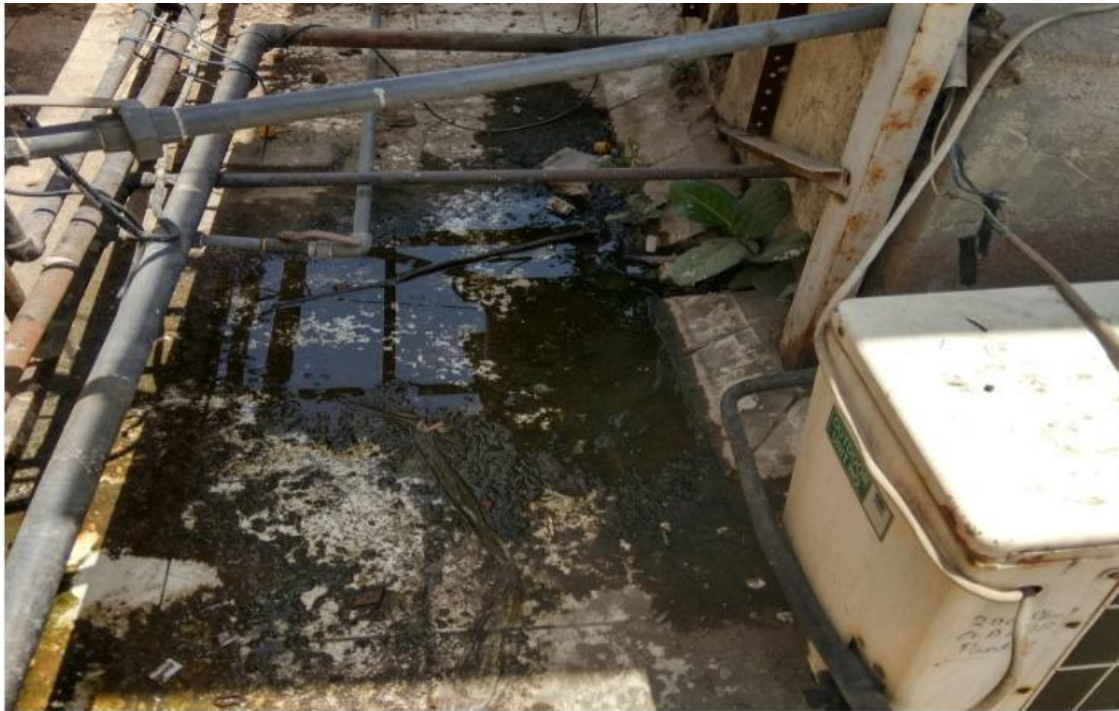
On visual inspection, it has been found that there is water accumulation on terrace. In spite of this, there are no visible signs of any signage below the top floor slab (this cannot be corroborated completely, as the slab soffit is not visible because of false ceiling). However, the water accumulation on terrace needs to be taken care of immediately.

Fig. 8(a):- Showing water leakage at terrace

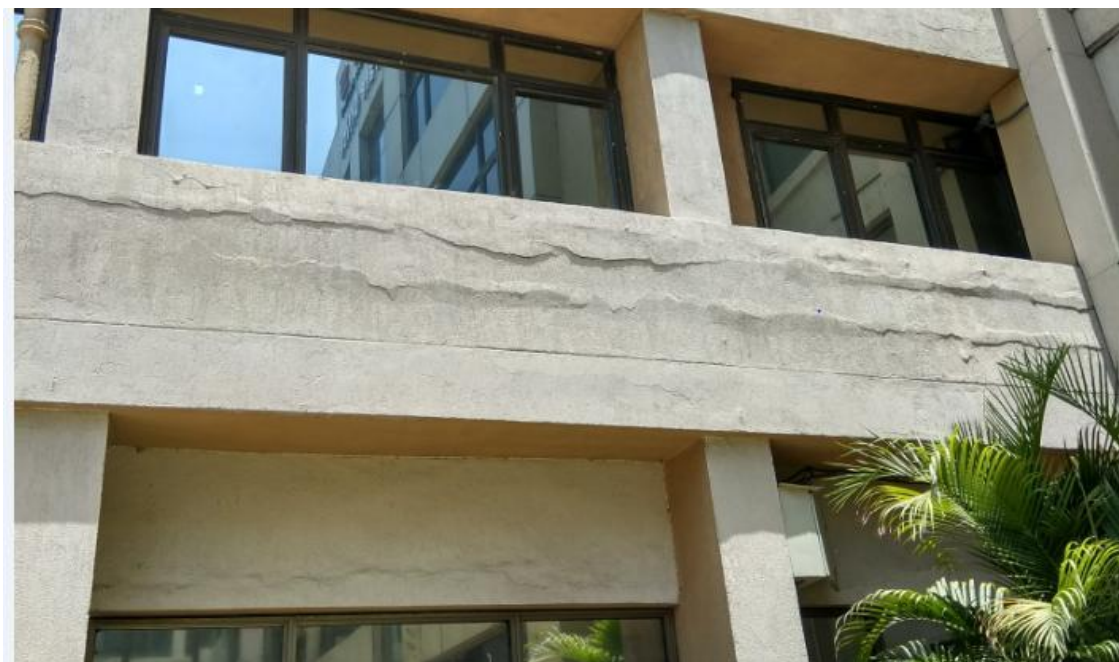
Fig. 8(b) Showing Cracks in plaster with some swelling

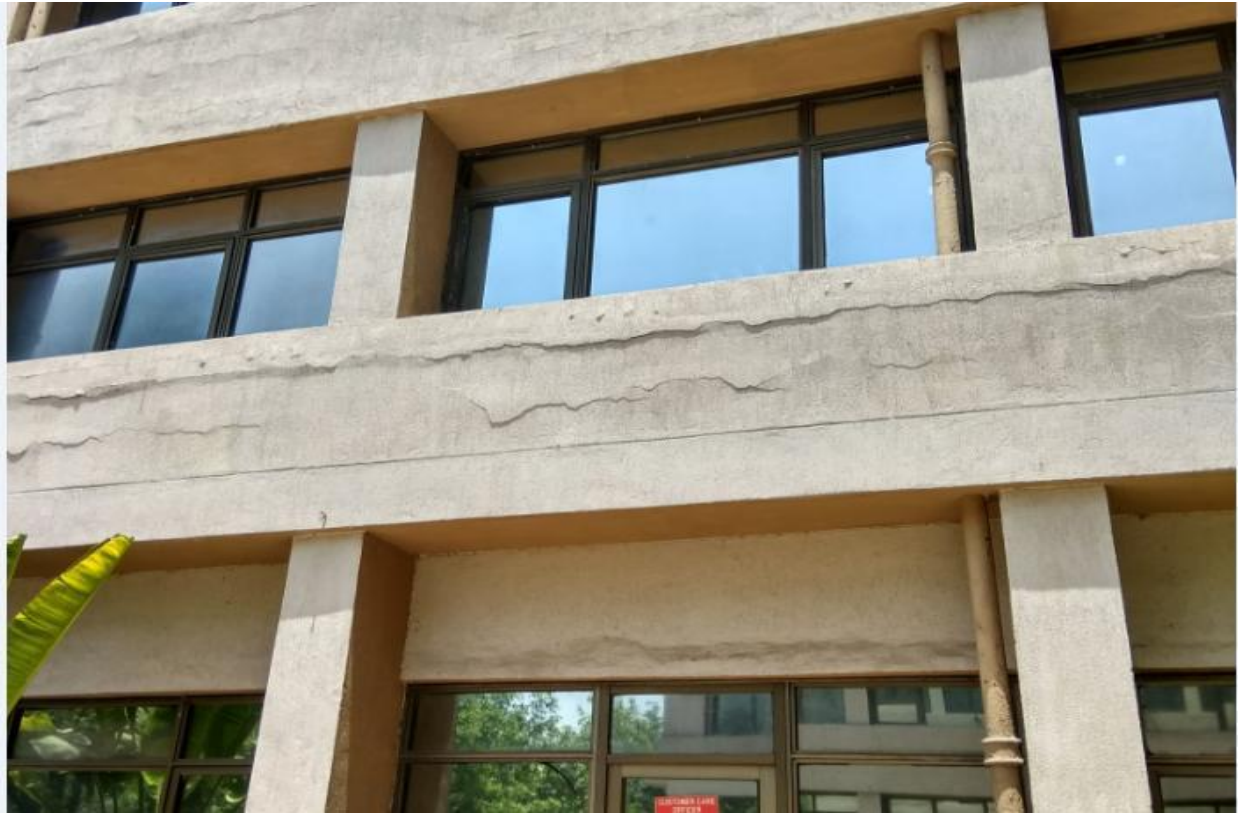
Fig.8(c):- Showing Cracks in plaster and probably in beam

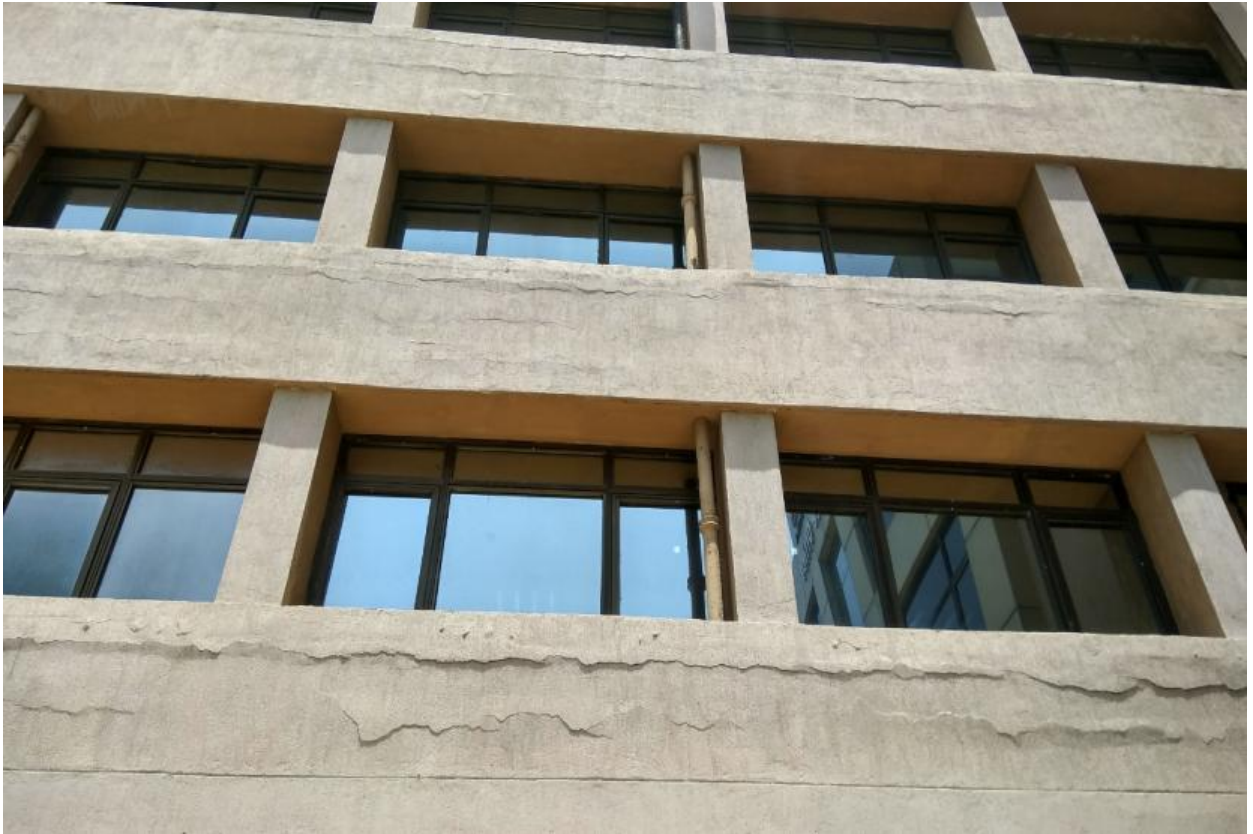
Fig. 8(d):- Showing Cracks in plaster and probably in beam
