**DAMAGE DETECTION IN CONCRETE BEAMS UNDER
IMPACT LOAD USING PIEZO SENSORS**

MASTER OF TECHNOLOGY
IN
STRUCTURAL ENGINEERING

Submitted by
ARYA SAJITH
2K20/STE/05

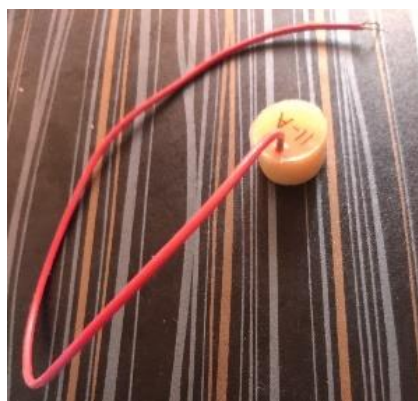
Fig.3.4. PZT patch covered with epoxy

Once PZT patches are soldered, it is then covered with epoxy adhesives, here araldite was used as the adhesive. This is done to ensure that the sensor is protected from any disturbance that might happen during the casting or vibration. For this, a plastic mould was used and it was made sure that the patches were in the middle and evenly coated. Once it is dried, the plastic mould is removed and the sensor are ready for casting as shown in Fig. 3.4.

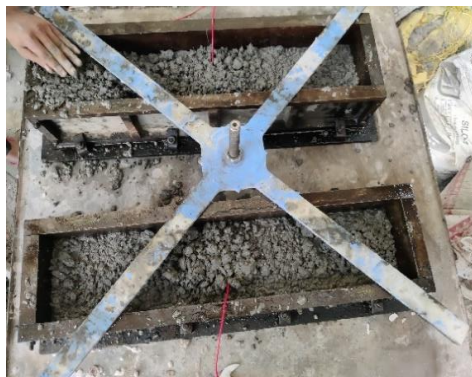
Fig. 3.5 Placing the PZT patch in the concrete

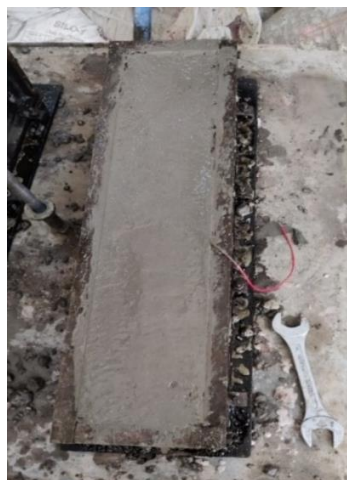
Fig. 3.6 Casting the beams

M30 grade concrete has been used for the casting of beams. Mix design was done in accordance with IS:10262 (2009) . Portland pozzolana cement or PPC was used for the concrete. Compressive strength was tested to confirm the ratio. During the casting procedure, the mould is marked to where the sensor has to be placed i.e., the centre of the mould and once the mould is filled halfway with the concrete, the sensor that is covered in epoxy resin is placed in position as shown in Fig. 3.5 and the rest of it is filled as shown in Fig. 3.6. The beams are demoulded after 24 hrs and placed in a curing tank for 28 days to gain strength. After 28 days, the beams are taken out and the test was carried out.

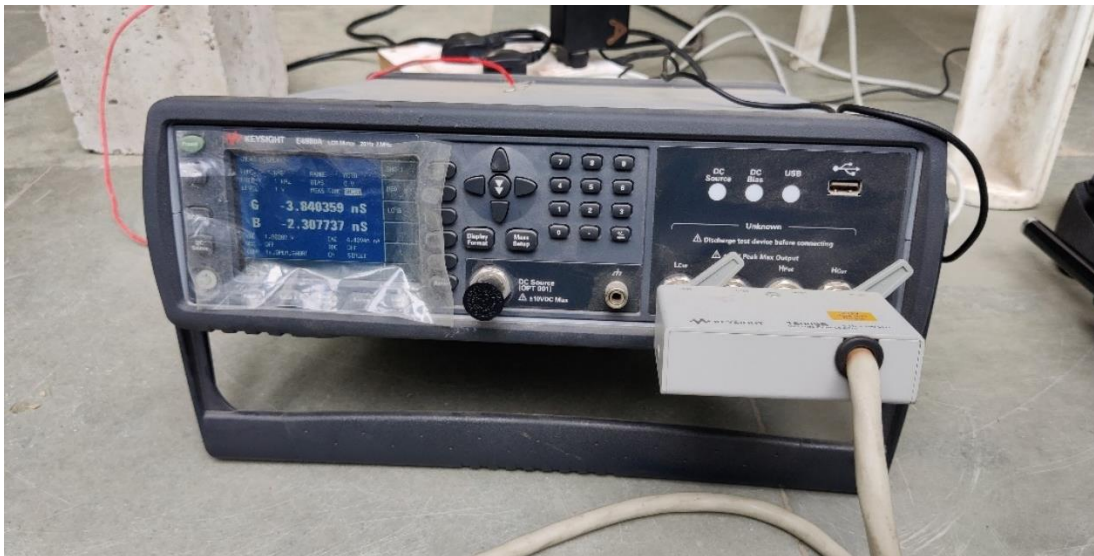
Fig 3.7 LCR meter

LCR meter is an instrument used for measuring the impedance of a material. Impedance is the measure of resistance to the electric flow. In this study, Keysight technologies, E4980A LCR meter is used. This LCR meter offers excellent speed, accuracy and versatility. The frequency range offered by this instrument is from 20 Hz to 2MHz. It even provides a LAN,USB and GPIB interface to copy the data recorded. It is very light weight and easy to use. Some properties of the Keysight E4980A LCR meter is mentioned in the Table 3.2 below.

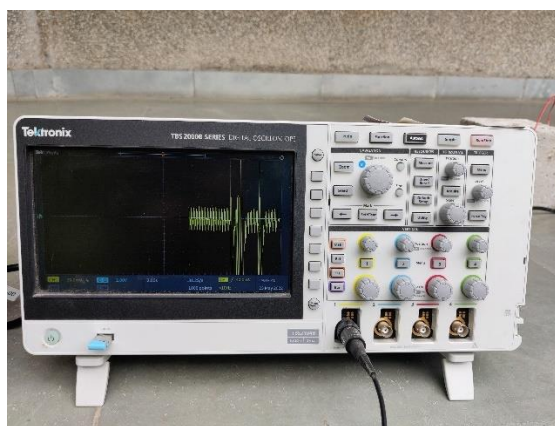
Fig. 3.8 Oscilloscope

An oscilloscope is an electronic device which displays the varying electronic voltages graphically. The oscilloscope used for this experiment was Tektronix TBS2000B digital oscilloscope. It has 4 analog channel models and a 5 million point record length. The TBS2000B series is easy to operate and gives accurate results.

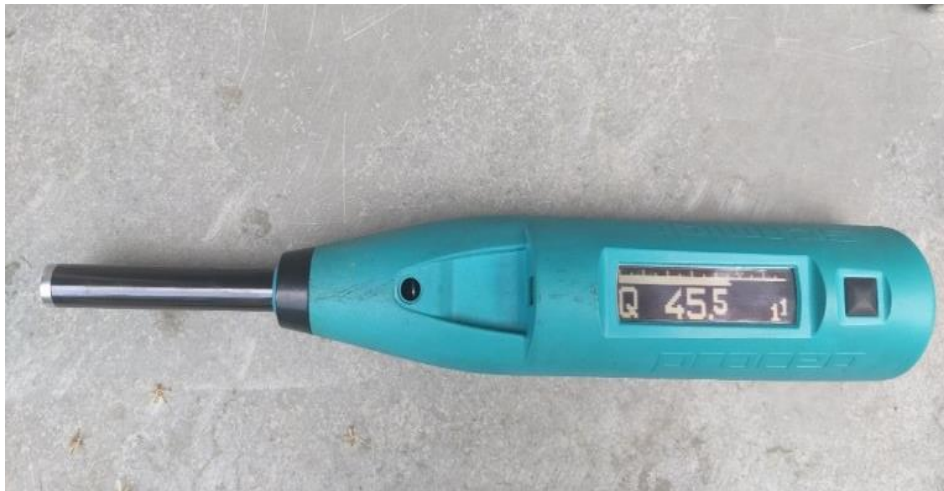
Fig. 3.9. Rebound hammer

Rebound hammer test is one of the non- destructive technique evaluation which gives a rapid value of compressive strength of the concrete. This method is very easy and convenient to use. In order to test, the plunger is pushed into the concrete perpendicular to its surface, and the force causes the latch to release and makes an impact on the

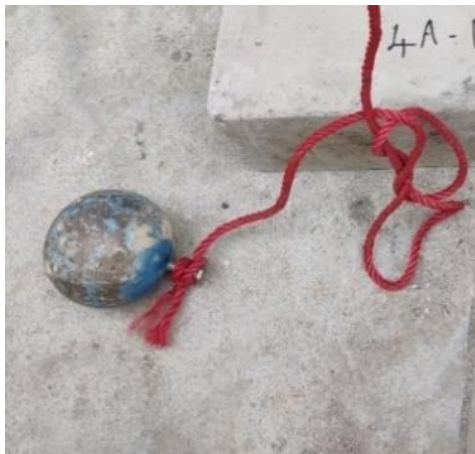
Fig. 3.11 Impact Ball

The setup used for the impact test is as shown in Fig. 3.10. The vertical pipe has been used to guide the ball that is being dropped from a height of 3m. The impact ball is a steel ball of 13 cm diameter and weighs 5 kg and is tied with the help of a rope for dropping as shown in Fig. 3.11. One end of the LCR meter is connected to the laptop to record the data and save it for future references and the other end is connected to the PZT patch inside the sample to obtain the admittance signature as shown in Fig. 3.12 before and after impact. The oscilloscope records the voltage during the impact.

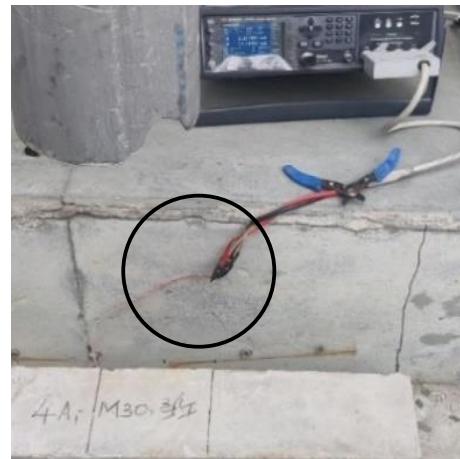
Fig. 3.12 Connection point

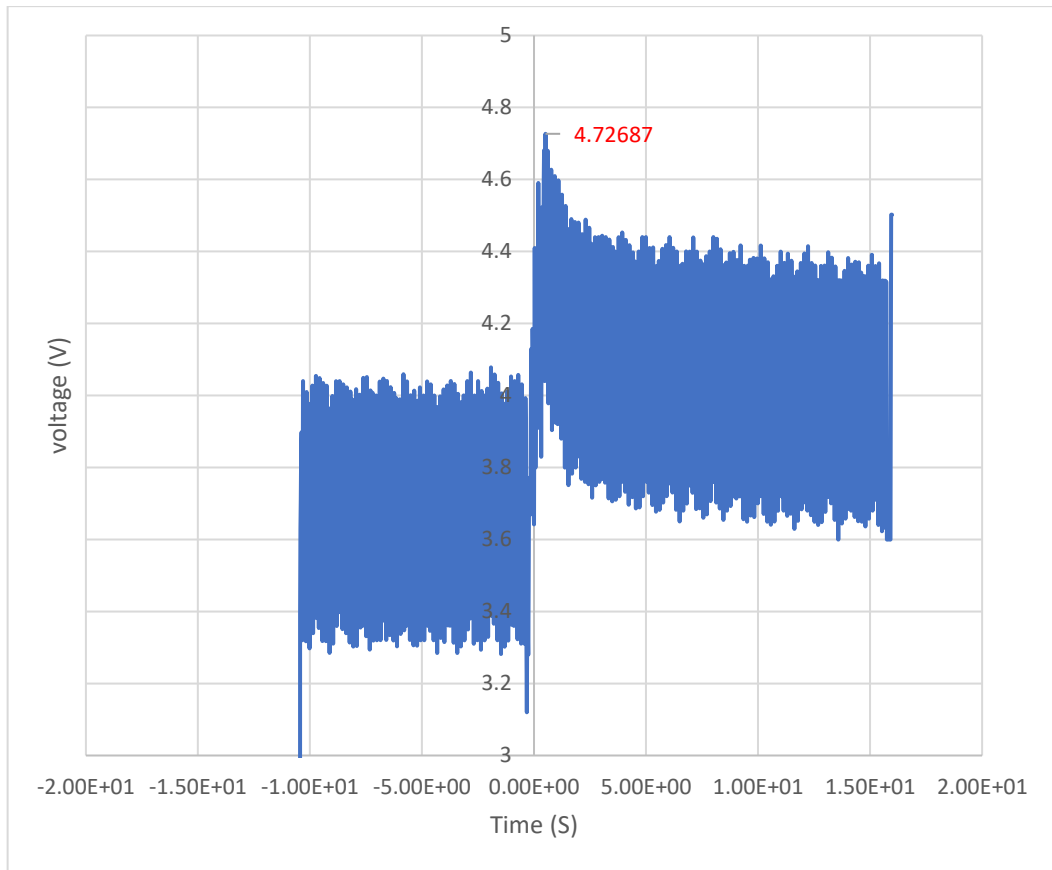
Fig. 4.2 Peak value of voltage

Since, the PZT patch is embedded in the concrete beam, d_{31} is substituted with d_{33} [1] and from Table 3.1, the properties of the piezo sensors are substituted in the above formula and peak voltage obtained from the oscilloscope which is 4.726 V from Fig. 4.2 is substituted to obtain the value of strain as:

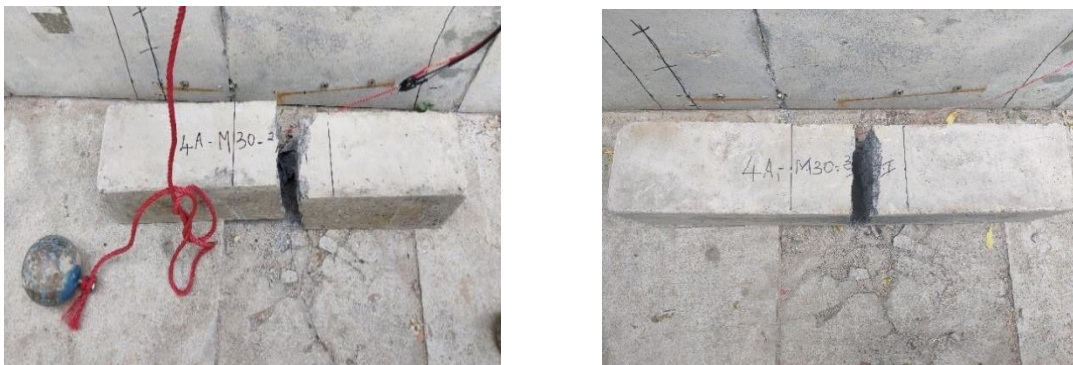
Fig. 4.3 Crack due to impact height of 3m and 2.5 m respectively

Parametric study of height of drop if the impactor was studied at 2 heights , namely 2.5m and 3m for M30 grade of concrete with embedded sensor at the centre. The crack pattern is shown in Fig. 4.3 .The admittance signatures and the damage indices were compared and it was observed that the peak of the signature is increasing before and after impact.

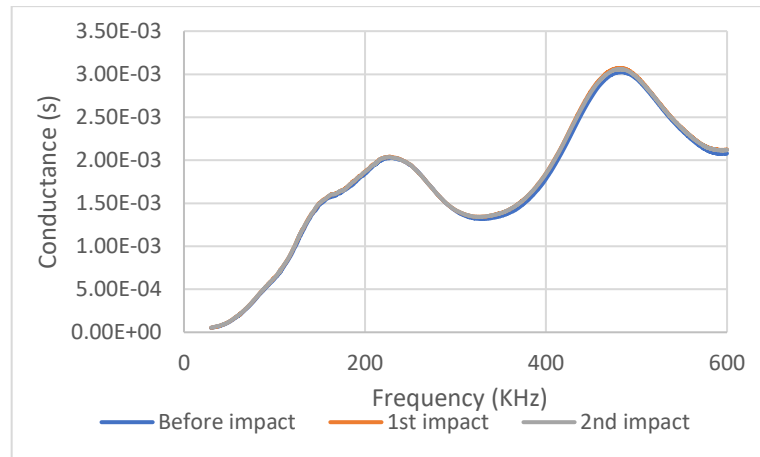
Fig. 4.4 Conductance v/s frequency for impact height of 3m

The signature has been compared for before and after impact and the graph is shown in Fig. 4.4.

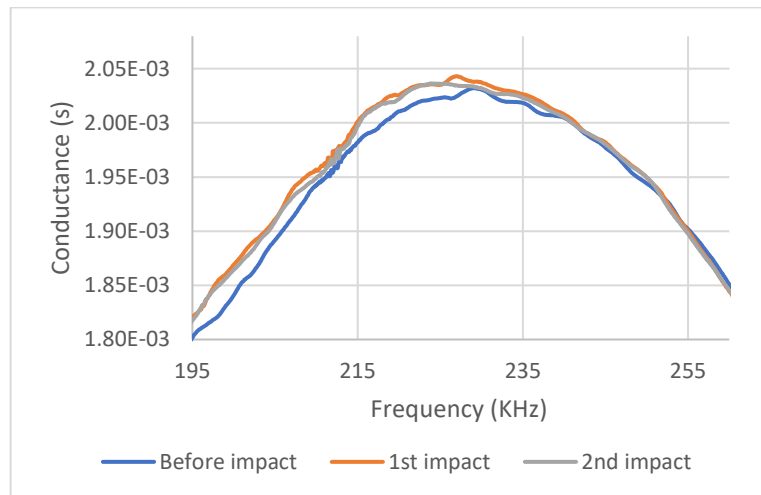
Fig. 4.5 Enhanced peak of signature for impact height of 3m

From Fig 4.5 and 4.7 , it can be observed that the admittance signature is changing before and after impact with the peak value increasing which indicates that there is an increase in damage in the structural element after impact .A comparison of peak value for both height is shown in Table 4.3.

The percentage difference for the peak value for height 3m which is 2.29 % is much more compared to 2.5m, which is around 1.82% . This is because the force of impact is very high when the ball is dropped from a height of 3m, hence the damage is more and the

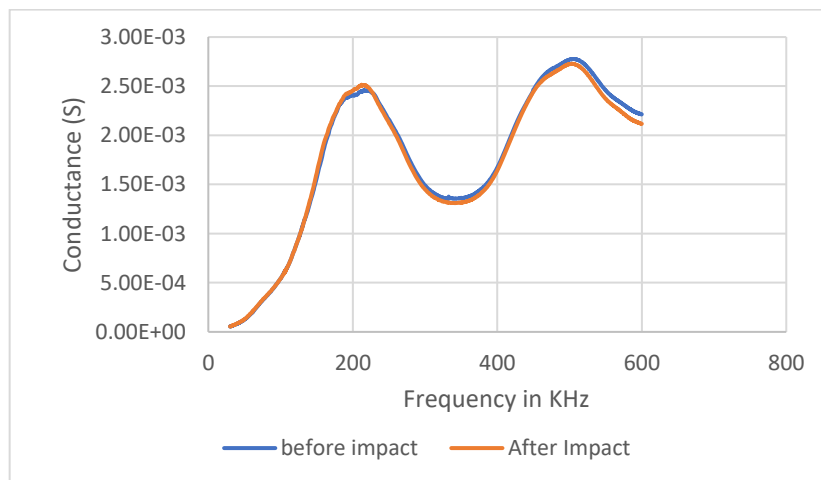
Fig. 4.6 Conductance v/s frequency for impact height of 2.5m

The admittance signature graphs for M30 grade at 2.5 m height is shown in Fig. 4.6,4.7,4.10 and 4.11. The admittance signatures for M25 grade is shown in Fig 4.13.

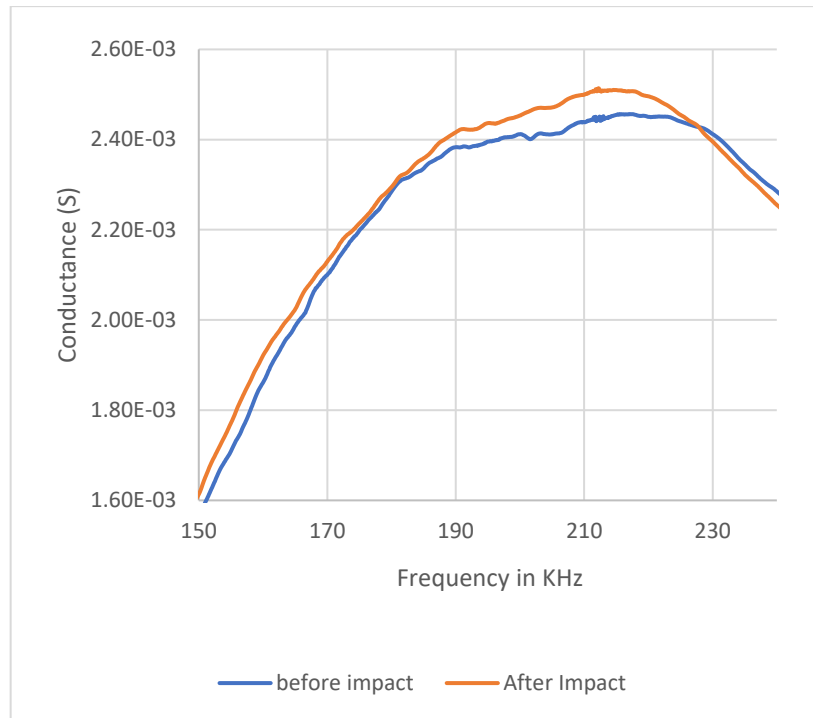
Fig. 4.7 Enhanced peak of signature for impact height of 2.5m

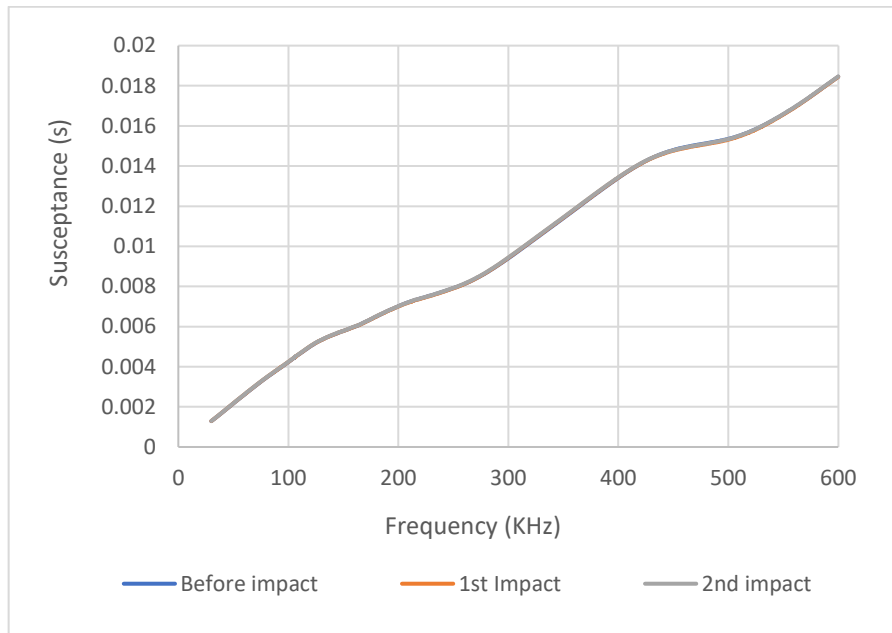
Fig. 4.8 Susceptance v/s frequency for impact height of 3m

The straight line in the susceptance v/s frequency graph indicates that the PZT patch was in working condition and intact to the structure.

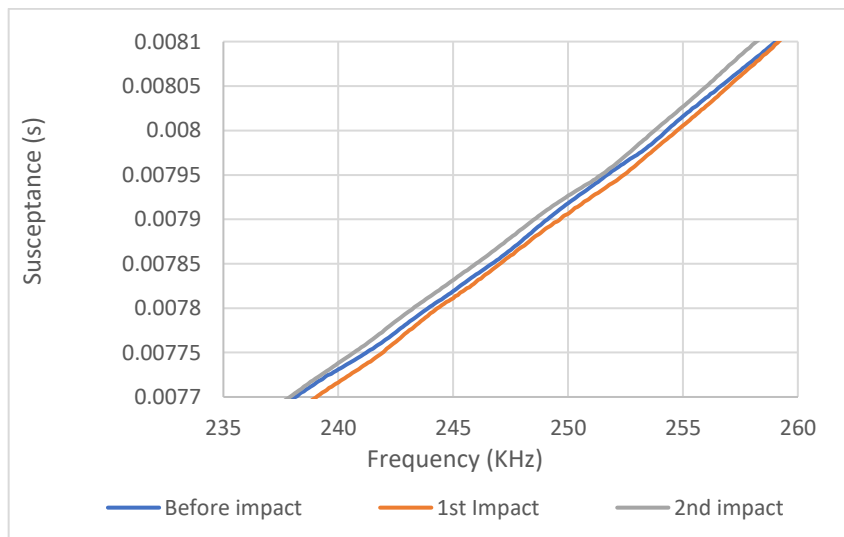
Fig. 4.9 Enhanced peak of susceptance signature for impact height of 3 m

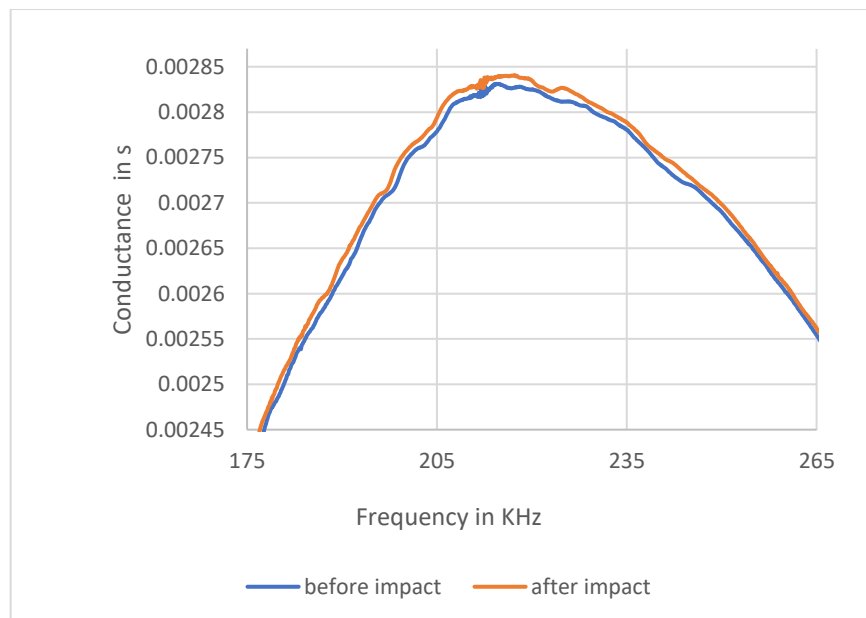
Fig. 4.14 Enhanced peak of signature for M25 grade

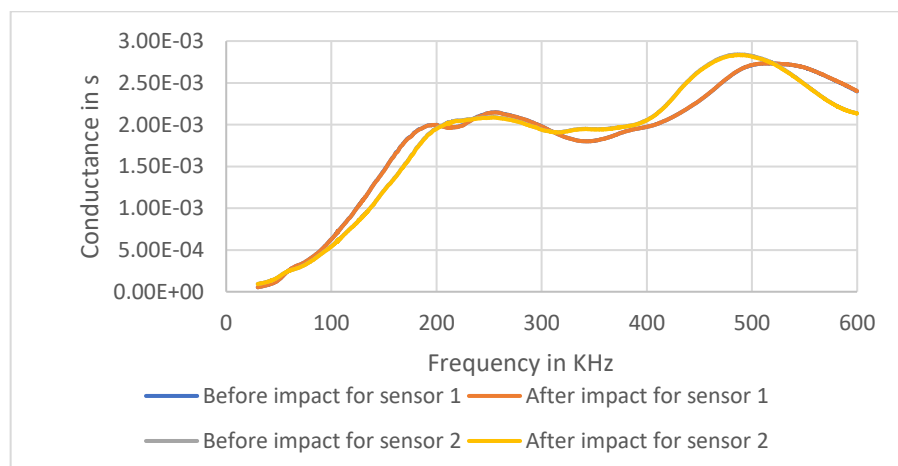
Fig. 4.16 Conductance v/s frequency for PZT patch at $1/3^{\text{rd}}$ distance from the ends

The height of impact was considered as 2.5m height and the position of impact was at centre. The admittance signature was taken for both the sensors before and after impact with LCR meter separately. The signature is shown below in Fig 4.16.

From the admittance signature, it can be seen that there is a change in the pattern followed before and after impact compared to all other parameters. The signature after impact is having a peak lower compared to before impact. Since the sensors are placed at 1/3rd distance from the ends, the damage due to impact at centre has not been properly recognised by the sensors compared to how the sensors placed in the centre position recorded the signature after impact. This is because, the sensors placed near the edges are not near the position of impact and this might have affected the pattern followed but it can be observed that there is still a difference in the admittance signature recorded before and after impact, which indicates that the damage is still being recorded.

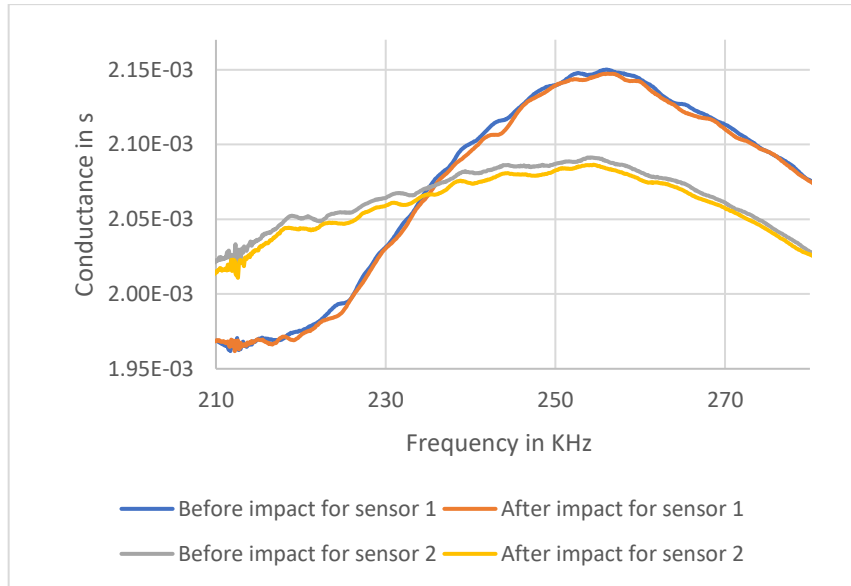
Fig. 4.17 Enhanced peak of signature for PZT patch at 1/3rd distance from the ends

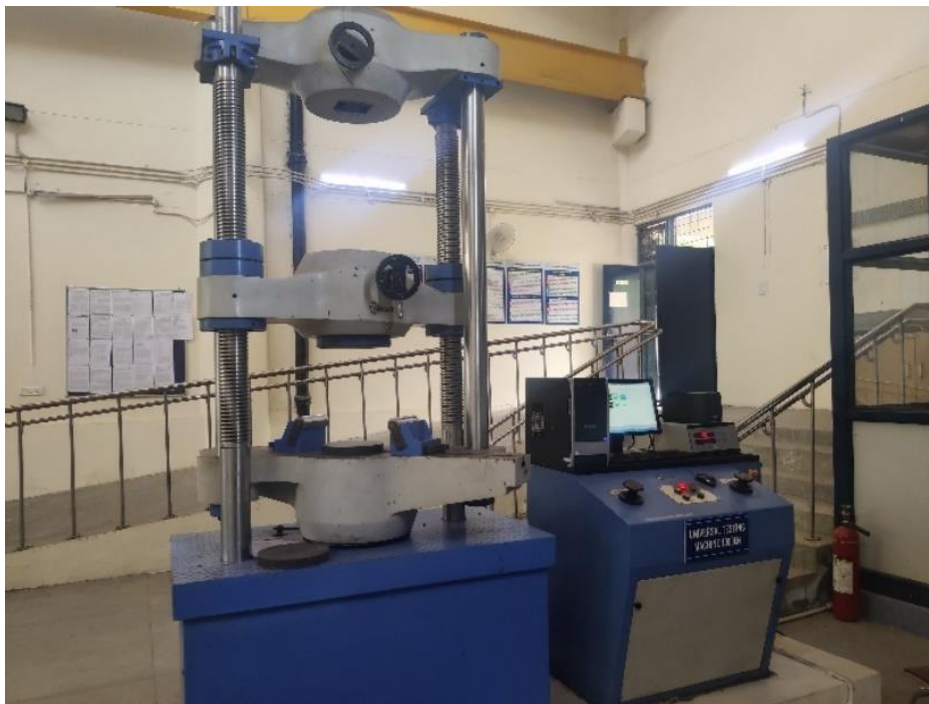
Fig. 4.18 Universal testing machine

In this study, Flexure test was done with the help of a UTM or universal testing machine.

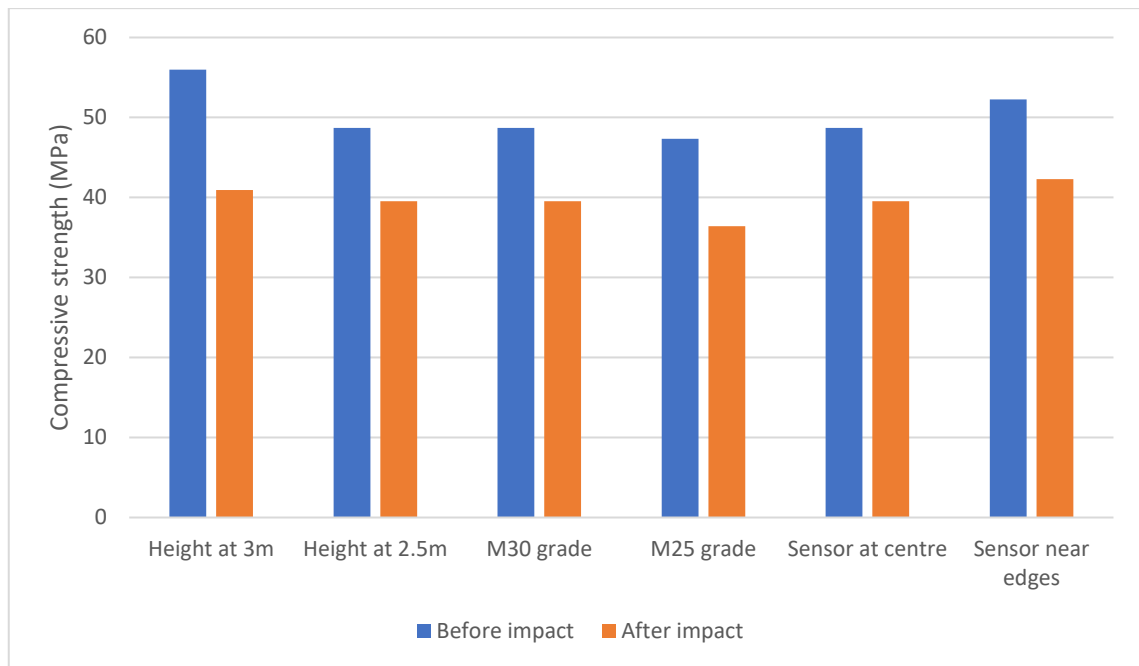
Fig. 4.19 Comparison of compressive Strength before and after impact

Fig. 4.19 shows the graphical representation of Table 4.10, and it can be seen that compressive strength is decreasing after impact for all the cases. It can be observed that the same trend is being followed, where for different height of impact, percentage difference in compressive strength before and after impact is higher for 3m height, by 10.26% because the force of impact when the ball is dropped from 3m height is more compared to 2.5 m height, hence more damage is occurred. Similarly, for M25 grade of concrete, it is observed that the percentage difference of compressive strength is more by 5.28% as M25 has less strength to withstand the impact compared to M30. For different position of sensors, the percentage difference in compressive strength is very less by 0.27 % because this parameter does not affect the property or impact force for the beam.
