STABILITY ANALYSIS OF CUT SLOPE ALONG THE ROAD ALIGNMENT

A DISSERTATION SUBMITTED
IN PARTIAL FULFILLMENT OF THE REQUIREMENTS FOR
THE AWARD OF DEGREE
OF
MASTER OF TECHNOLOGY
IN
GEOTECHNICAL ENGINEERING

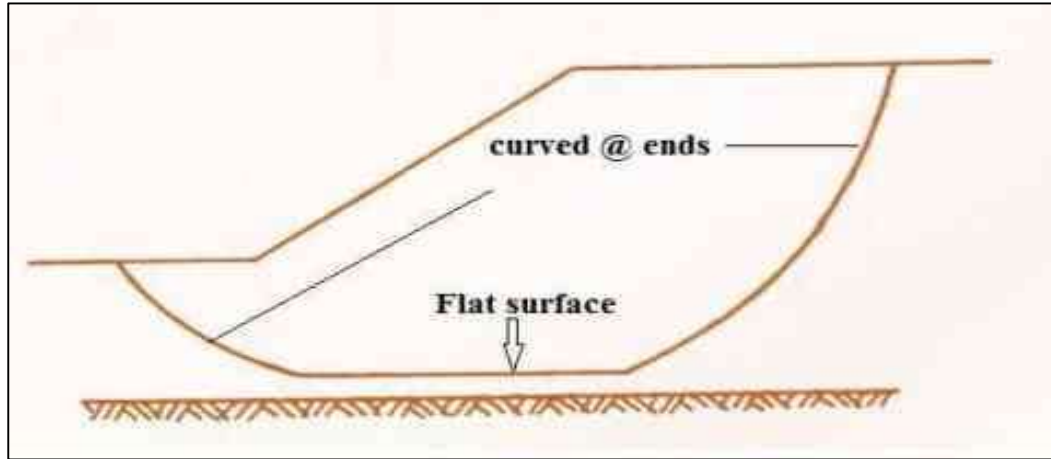
Figure-3: Compound failure

Compound failure is formed due to a combination of rotation and translation sliding failures. As the name implies, failure occurs when the slip surfaces curves both at ends but has a uniform or flat center point. When a firm soil grade develops from a sufficient depth from the toe, the slip surface may become flat.

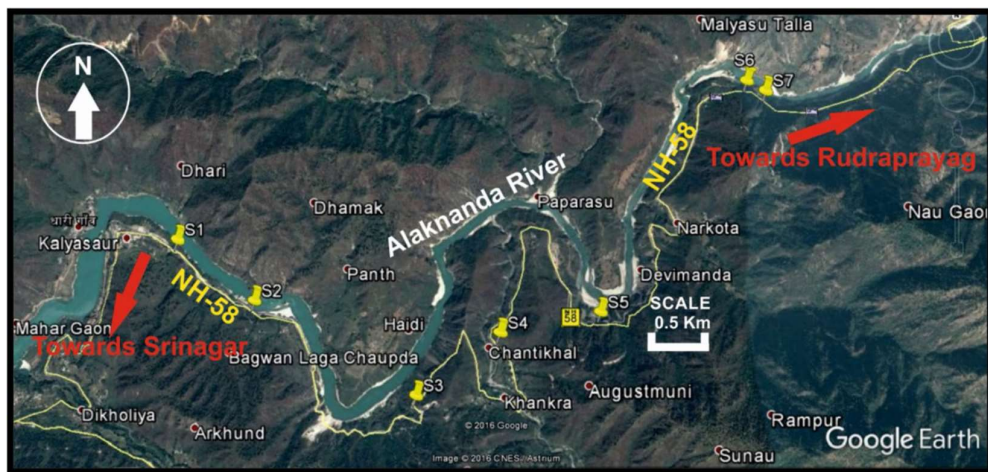
The research area lies in district of Rudraprayag, which is having land area of approximately 25000 km and comes between latitude 30° 19' 00" and 30° 49' N and longitude 78° 49' and 79° 21' 13" E. This location can be reached from Rishikesh and Dehradun via transit. Whereas, railway are constructing railway line and tunnel to Badrinath Dham. However, this public transport is undergoing project. The research road cut slopes exciting along NH-58 from Kaliyasaur to Rudraprayag in Alaknanda valley. This road is extremely important for getting from one location to another. The geology of the examined area is located on the Garhwal Syncline's northeastern flank. Google imagery was used to indicate the study locations from S1 through S7 (Figure-5).

Figure-5: Google imagery representing the research area along NH-58 from Srinagar to Rudraprayag

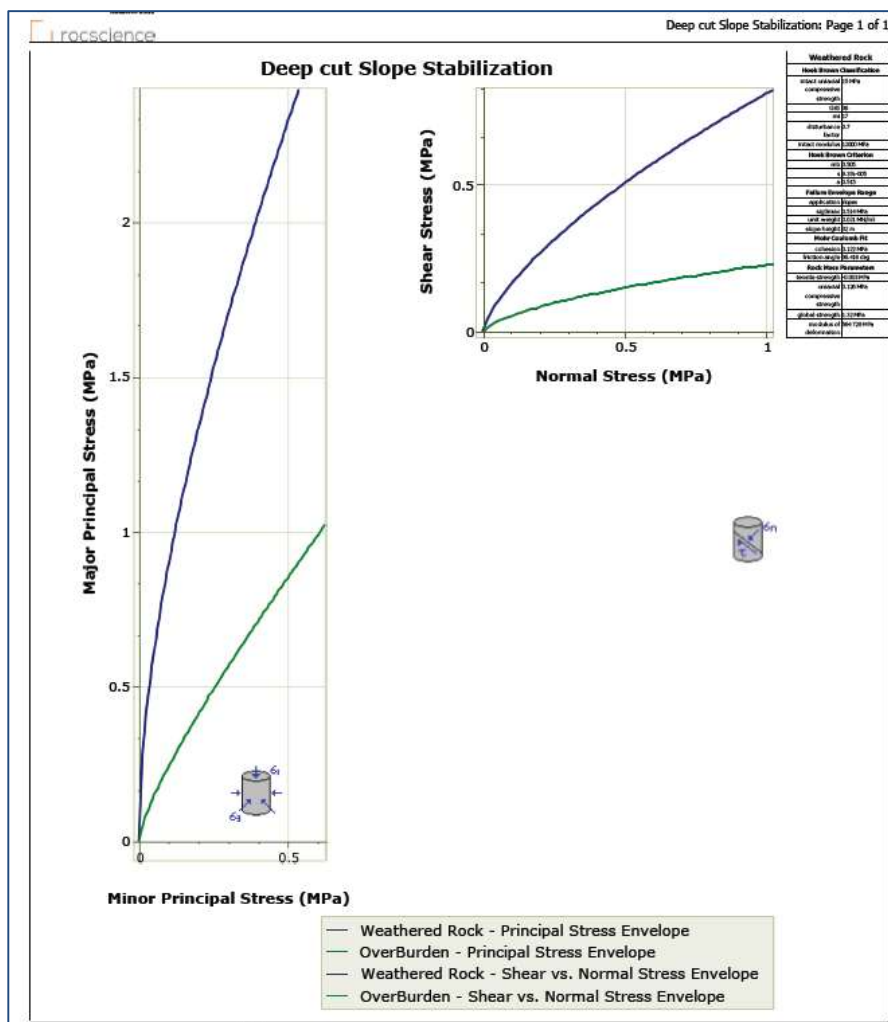
Figure-7: Weathered/ Phyllite Rock Mass Properties

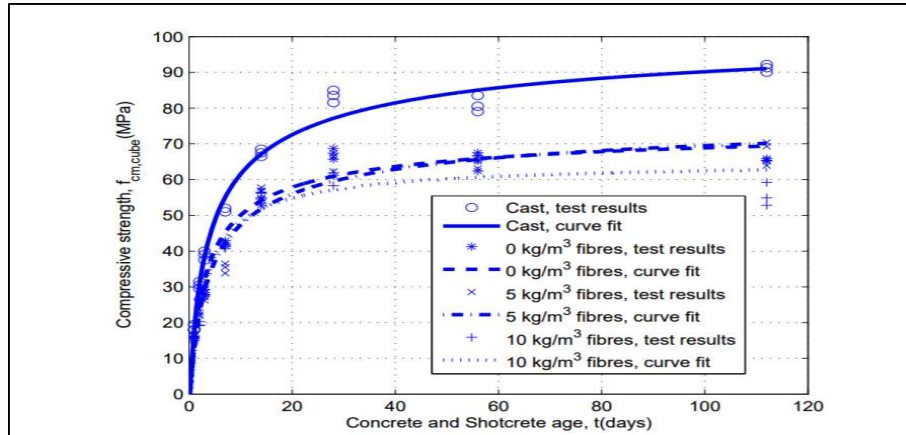
Figure-9: Shotcrete Compressive Strength

Above Figures, (Figure-9, Figure-10 and Figure-11) shows the short-term property of shotcrete for 1hour and 24 Hour. It is clear that short term property of shotcrete (SFRS) such as Elastic Modulus, cracking strength and compressive strength are 80%, 60% and 40% of design capacity respectively.

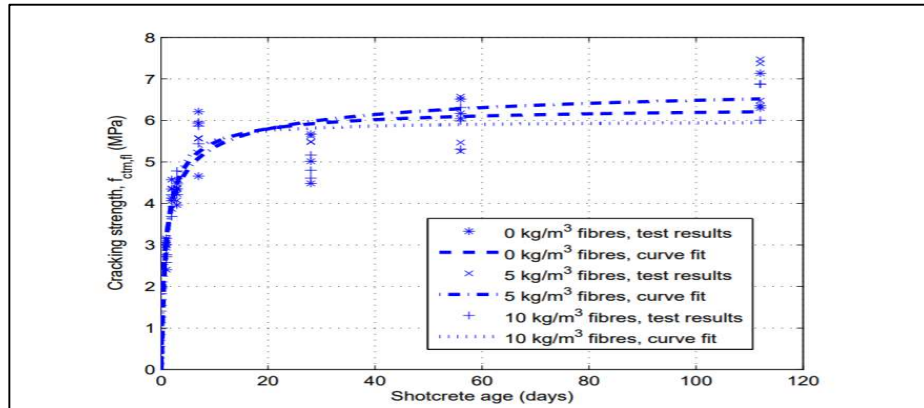
Figure-10: Shotcrete Cracking Strength

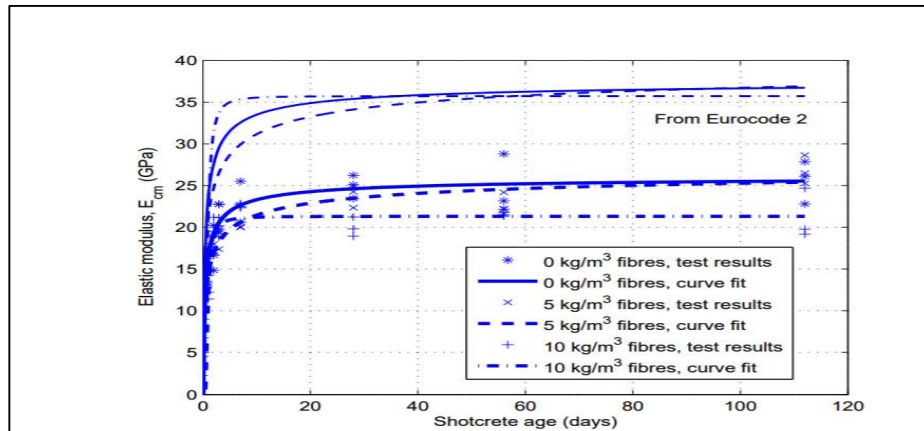
Figure-11: Shotcrete Elastic Modulus

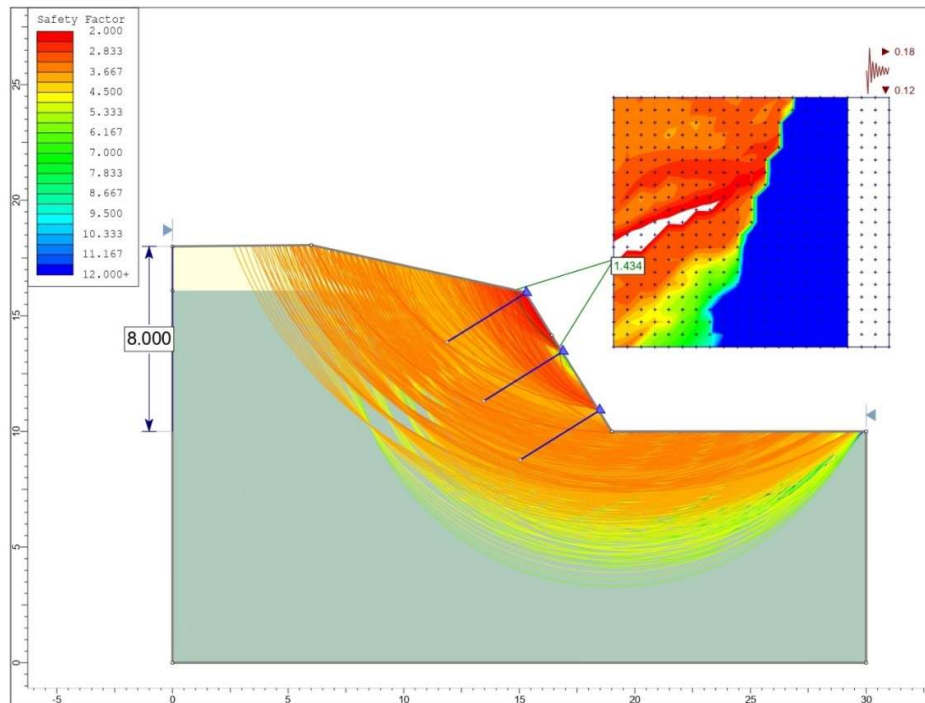
Figure-19: FOS Contours of rock mass in seismic condition with support system on hill slope obtained FOS 1.434>1.0 (Stable) in Overburden and highly to moderate weathered Phyllite Rock

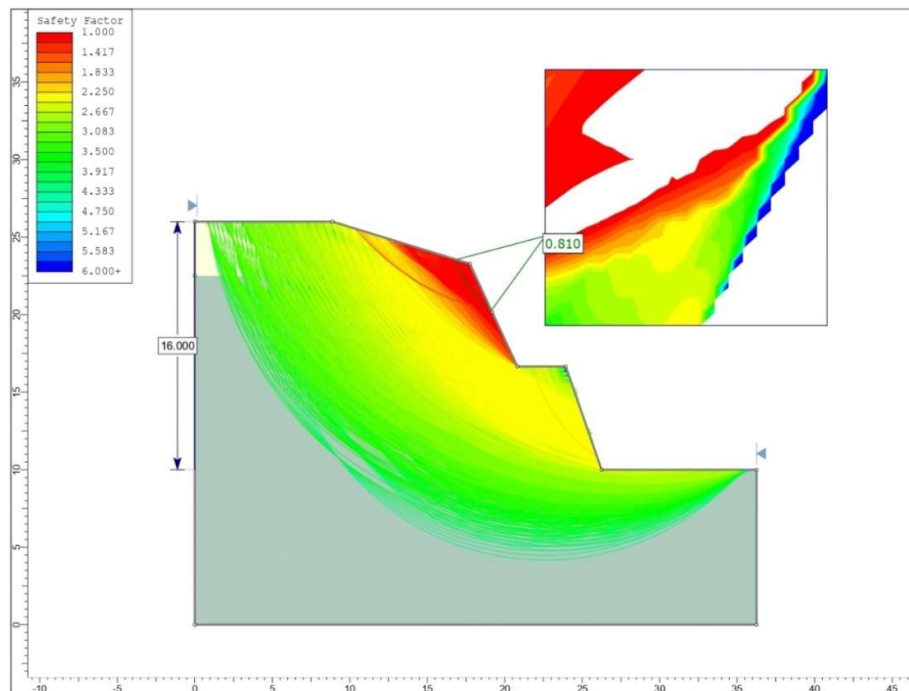
Figure-21: FOS Contours of hill slope analysis without support system in Static condition obtained FOS 0.810 < 1.5 (unstable)

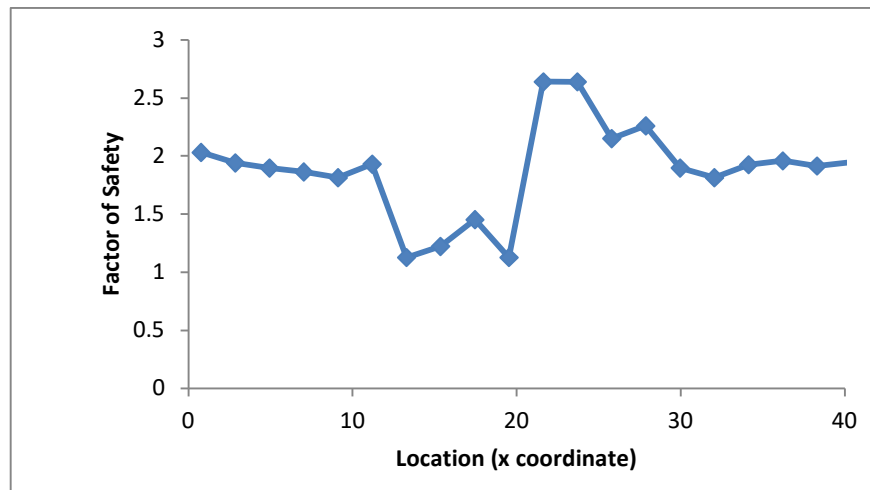
GRAPH 6: Variation of FoS for different coordinates towards Cut slope surface (supported -seismic 24m)

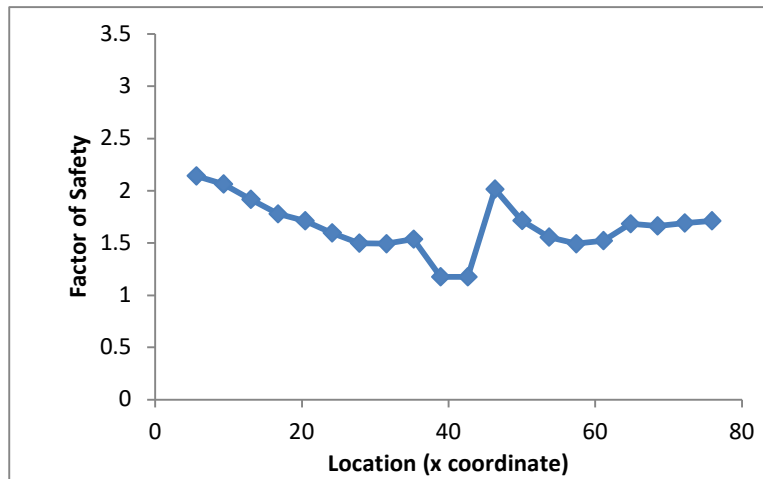
GRAPH 8: Variation of FoS for different coordinates towards Cut slope surface (supported-seismic 32m)
