**RISK EVALUATION OF EXISTING BUILDINGS BY USING  
RAPID VISUAL SCREENING**

A DISSERTATION

MASTER OF TECHNOLOGY

**CIVIL ENGINEERING**

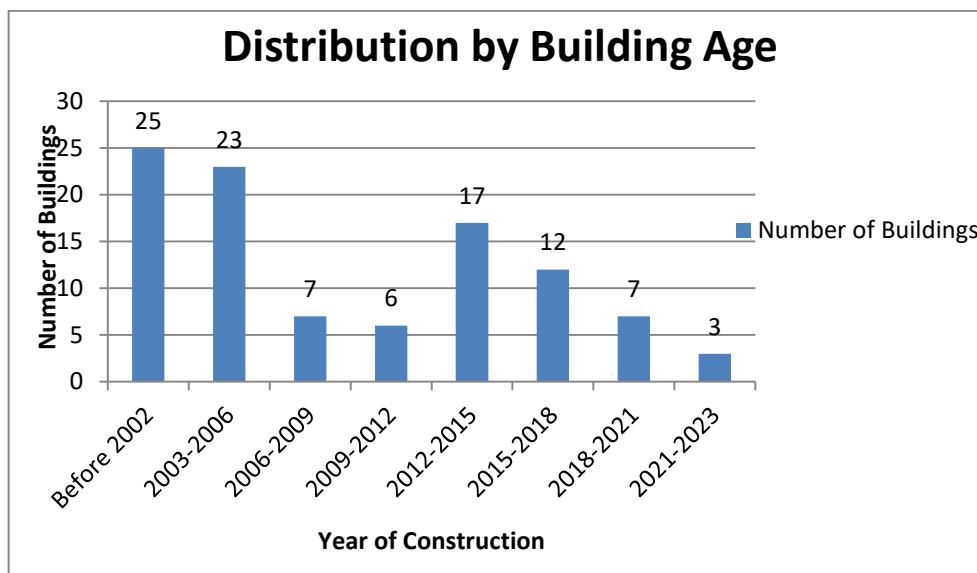
One of the most crucial considerations while researching the seismic hazard assessment is the age of the structure. Fig 4.2 shows that 10 buildings are new, 29 buildings are of about 10 years, 23 buildings are of about 20 years, and 25 buildings are constructed before 2002 because IS 1893 was amended in 2002, 2002 has been used as the benchmark year because structures built after 2002 can withstand earthquakes.

**Figure 4.2 Year of construction**

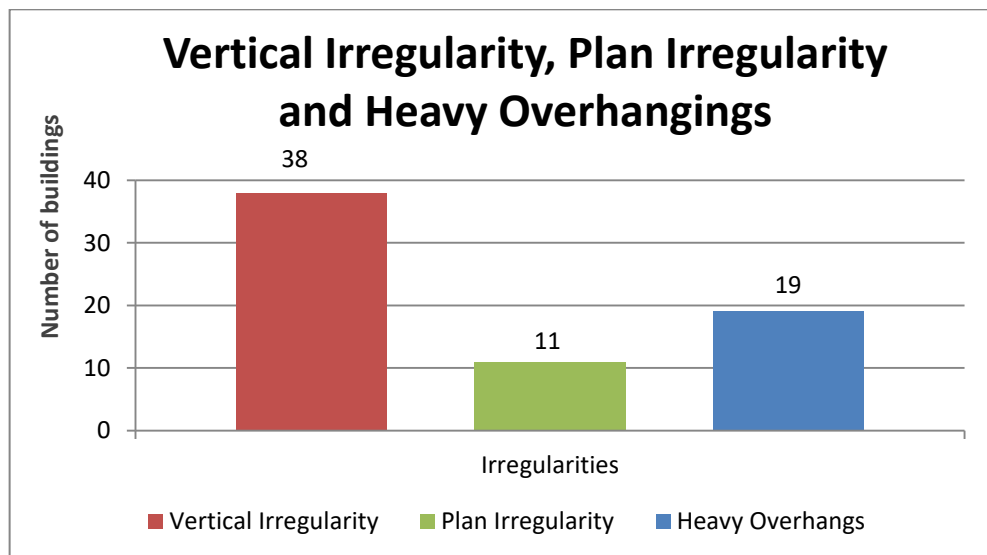
Fig 4.3 shows the number of buildings having Heavy overhangs, Plan irregularity and Vertical irregularity.

**Figure 4.3 Buildings having Vertical irregularities, Plan irregularities and Heavy overhangs**

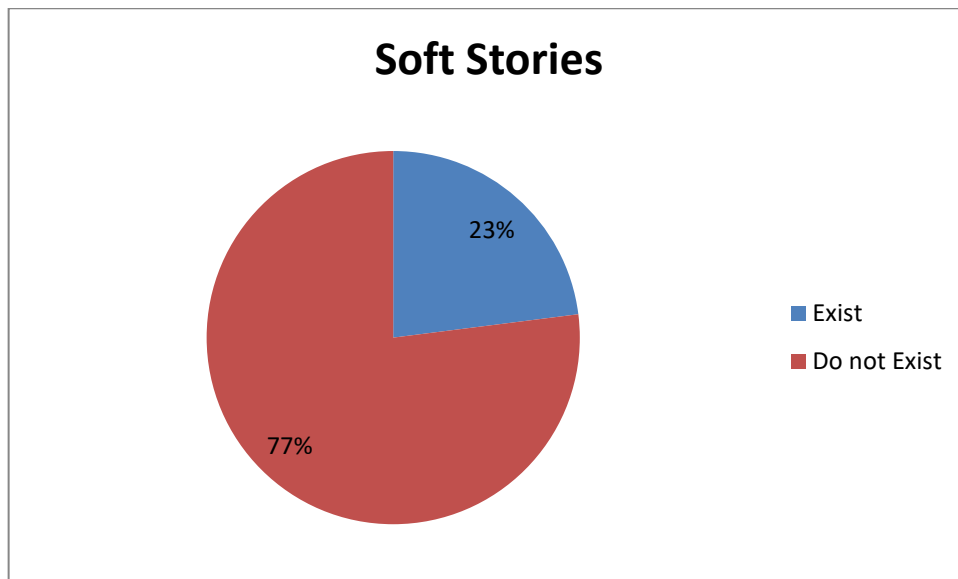
Fig 4.4 shows the percentage of buildings having Soft Storey.

**Figure 4.4 Percentage of buildings having Soft Stories**

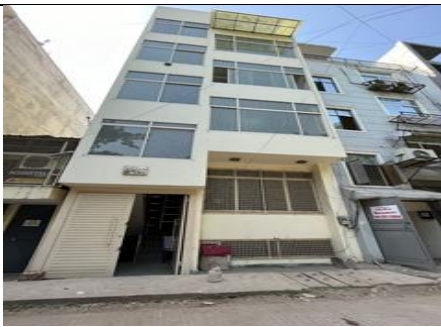
S.no.	Type of Buildings	Building's Photograph	Value of RVS Score	Probability of Collapse of the Buildings
1.	G+3 C1 type Building

3.7	0.02% probability, i.e., 1 in 5000

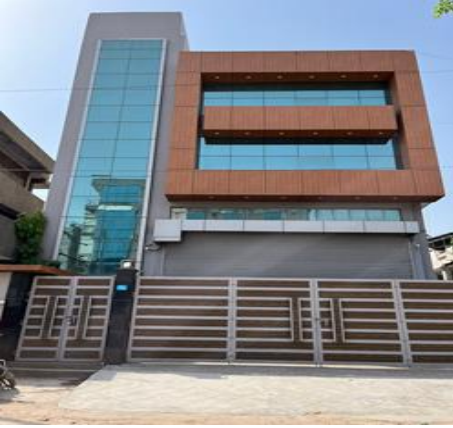
2.	G+2 C1 type Building

2.2	0.63% probability, i.e., 1 in 158
3.	G+3 C2 type Building	 	4.4	0.004% probability, i.e., 1 in 25000
4.	G+3 C2 type Building

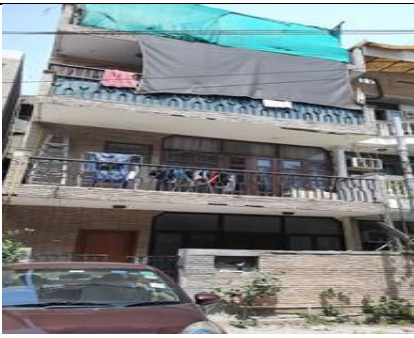
1.4	4% probability, i.e., 1 in 25
5.	G+2 C3 type Building	 	1.2	3.2% probability, i.e., 1 in 32

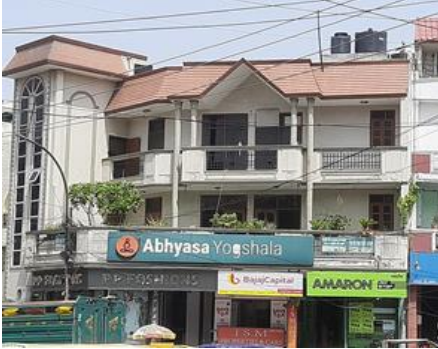
6.	G+2 C3 type Building

-0.1	100% probability, i.e., 1 in 1
7.	G+1 URM Building

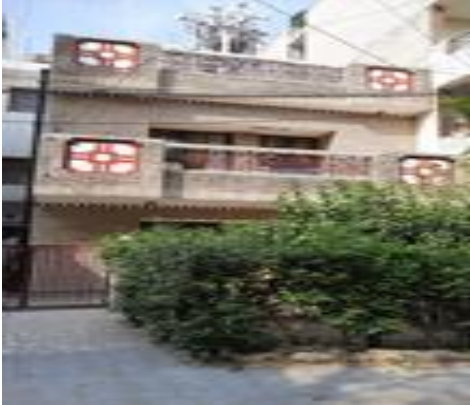
1.3	5% probability, i.e., 1 in 20
8.	G+2 URM Building

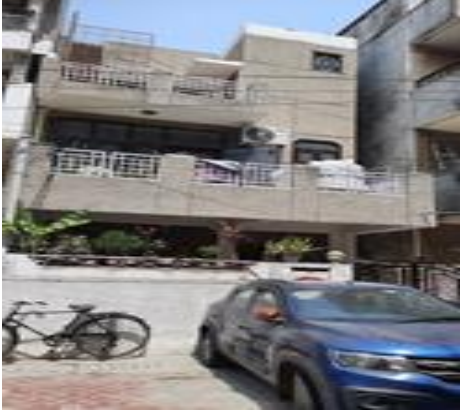
0.2	63% probability, i.e., 1 in 1.58

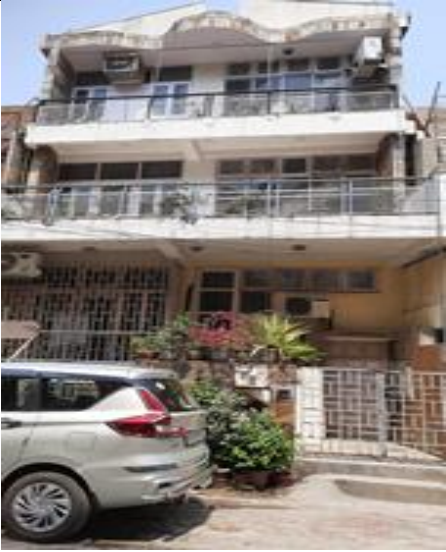
S.No.	Type of Structure	Building's Photograph	Risk Score ( $S_R$ )	Possibility of earthquake leading failure $R(t)$	Remarks
1.	G+2 Storied C3 type Building

1.2	6.11% i.e., 1 in 16	<p>1. <math>R(t)</math> exceeds the chance of MCE, hence the building is regarded as being unsafe.</p> <p>2. The existing structure is 100 times more deadly than a new one, a thorough technical examination and extensive retrofitting are necessary.</p>
2.	G+2 storied URM Building

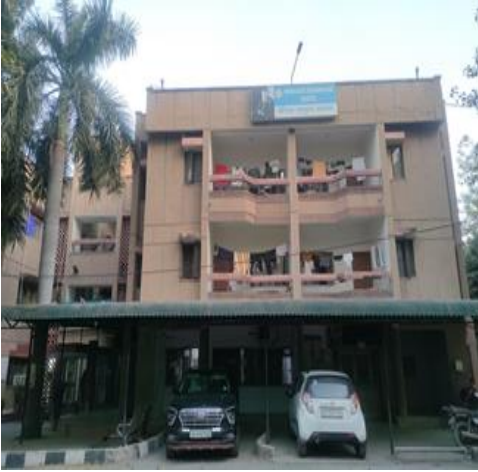
1.5	3.11% i.e., 1 in 32	<p>1 <math>R(t)</math> exceeds the chance of MCE, hence the building is regarded as being unsafe.</p> <p>2. The existing structure is 100 times more deadly than a new one, a thorough technical examination and extensive retrofitting are necessary.</p>
