Development of a Generalised Method for Seismic Retrofitting of Masonry Structures

**A Dissertation Submitted
in Partial Fulfillment of the Requirement for the Award of the
Degree of**

**in
Structural Engineering
by**

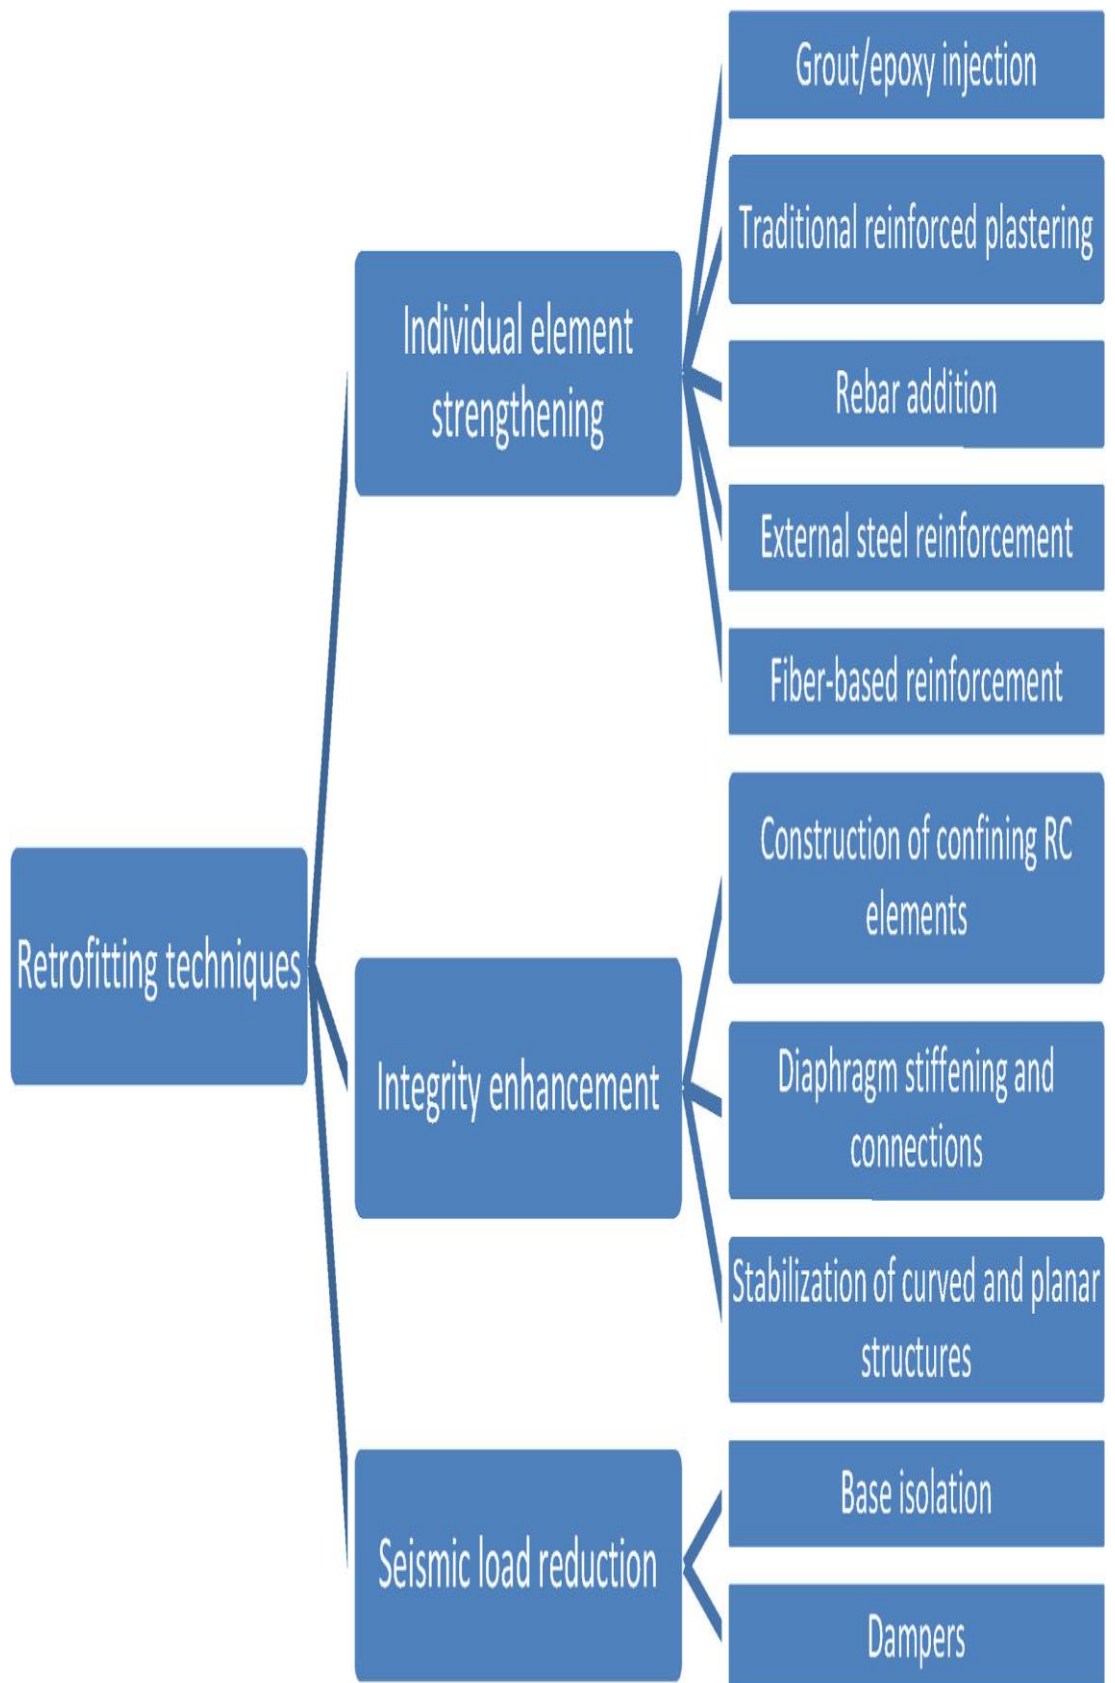
Figure 0.1.1 Retrofitting Techniques

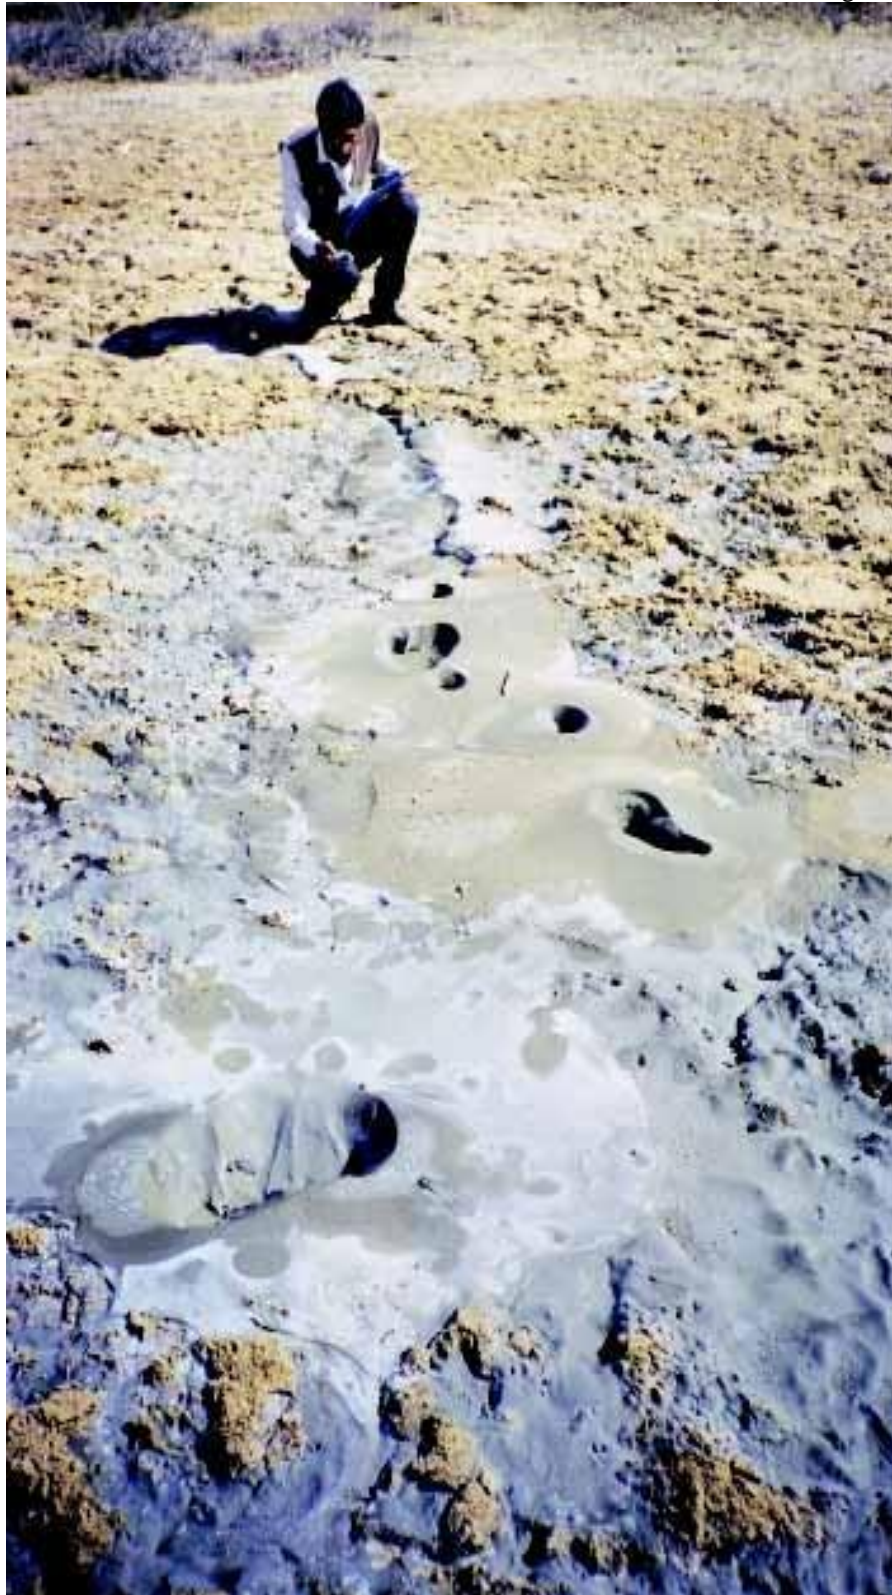
Figure1.8 A Site of Liquefaction

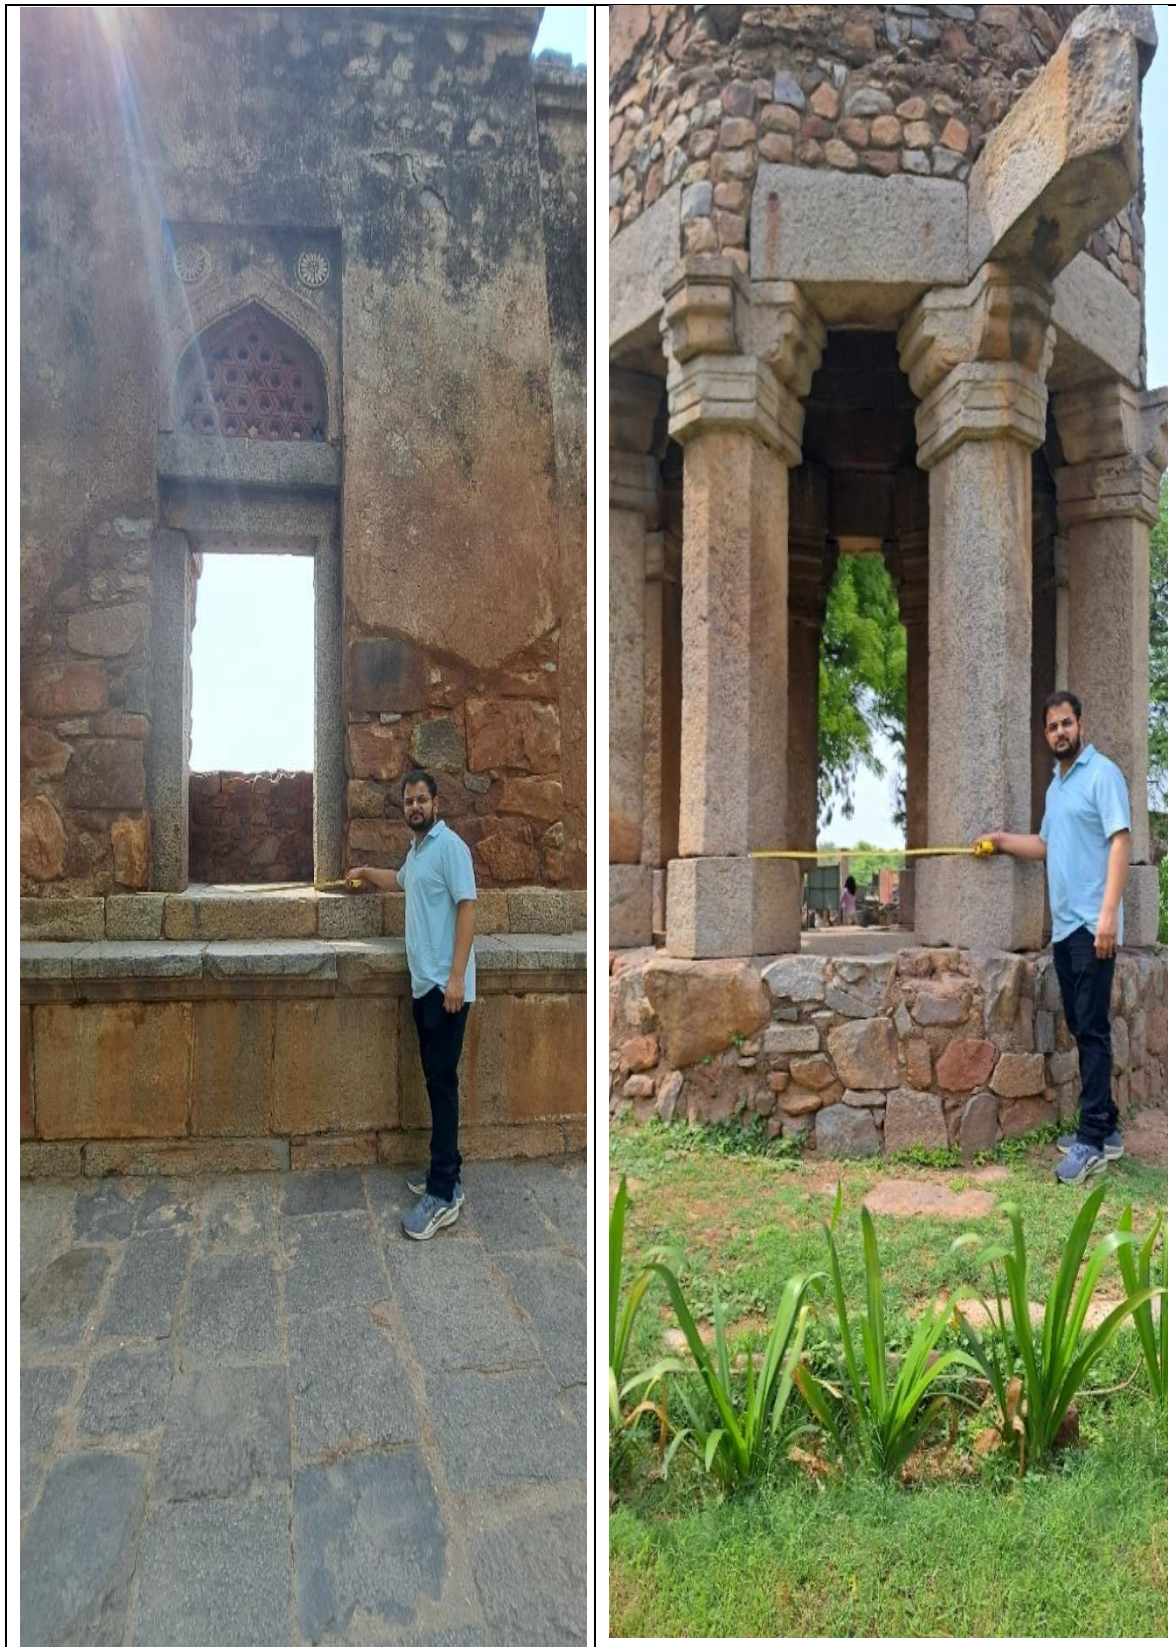
Figure4.1 Field Survey and Data Collection

Table 4.1 Field Survey and Data Collection

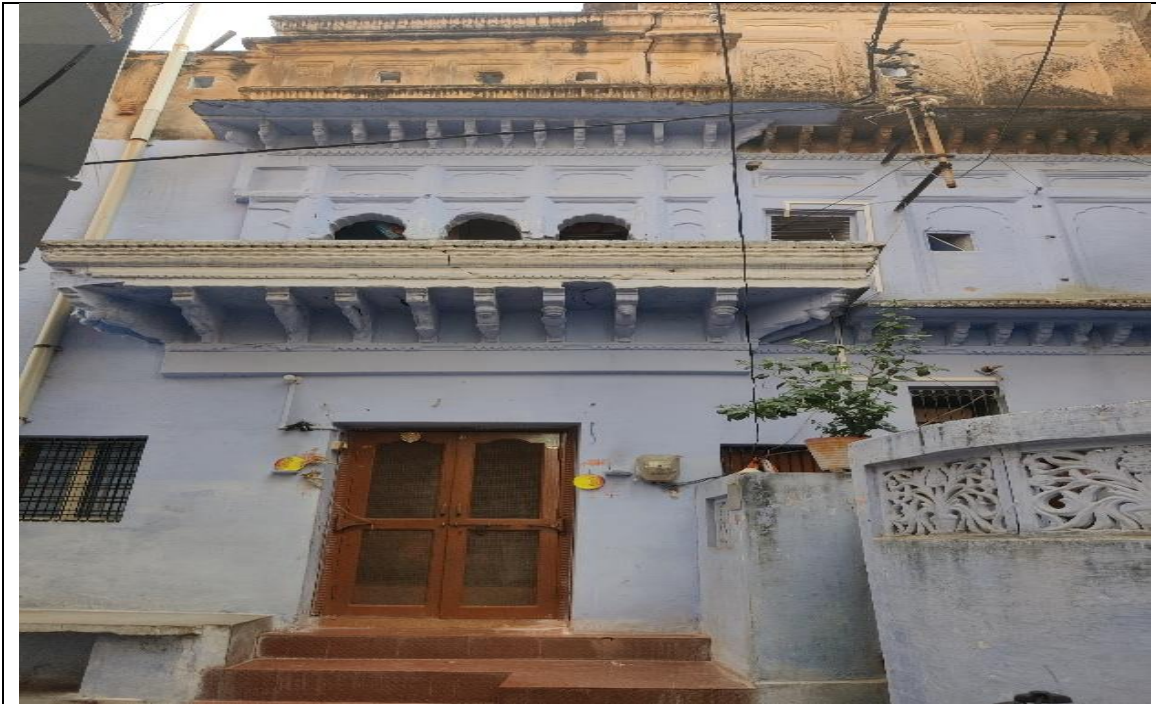
Figure 4.2 Manik chowk, jhansi

Manik chowk, jhansi			
	Seismic Zone	II	
	Building use	Ordinary	
	Building category	B: Table no 2 IS 13935	
	Soil Type	Type I (Rock)	
	Foundation type	Isolated	
	Mortars	C:L:S – 1:2:9	
	Type of masonry	confined masonry	
	Masonry as per Load bearing	A: Rubble (Field stone) in mud mortar or without mortar usually with sloping wooden roof Mud walls, Adobe walls of two storeys UCR masonry without adequate through stones Masonry with rounded (undress) stones	
	Dimensions	B1=.8m, B2=.5m, B3=.3m, B4=.5m ,B5= 1.5m, L=8m, H= 3m

- 1) b4- Increase by build-up or reinforce with belt.
- 2) b5- Increase by build-up or reinforce with belt.
- 3) Mortar- Change of mortar not feasible. Hollowness may be filled by grouting or walls may be strengthened by ferro-cement plating or fibre-wrapping.
- 4) Door window lintel level- Provide seismic belt on both sides
- 5) Ceiling or Eave Level- Provide seismic belt on both sides

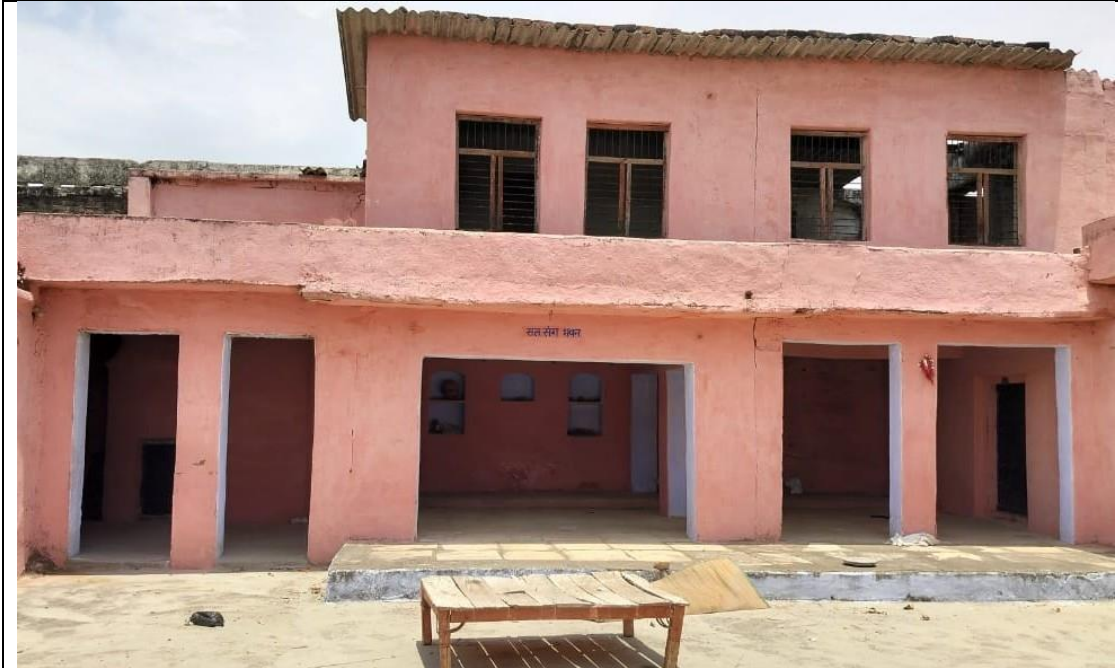
Figure 4.3 Temple, Jhansi

Seismic Zone	II	
	Building use	Important	
	Building category	C: Table no 2 IS 13935	
	Soil Type	Type II (medium)	
	Foundation type	Isolated	
	Mortars	C:L:S – 1:1:6	
	Type of masonry	confined masonry	
	Masonry as per Load bearing	D: Masonry construction with vertical and horizontal reinforcing of walls	
	Dimensions	B1=1.25m, B2=1m, B3=2.5m, B4=.5m, B5=.5m ,L=10 m, H=3.5m	
	Damageability	G1 a) Structural hair line cracks in very few walls. b)Non-structural Fall of small pieces of plaster only. Fall of loose stones from

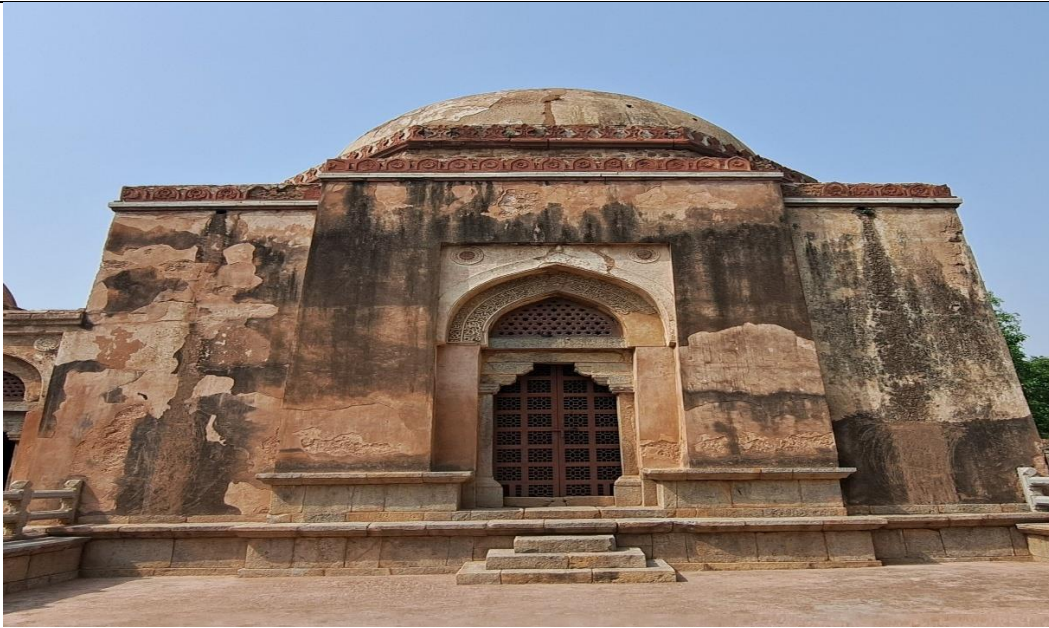
Figure 4.4 Feroz Shah Tomb, Delhi

Seismic Zone	IV	
	Building use	Important	
	Building category	E: Table no 2 IS 13935	
	Soil Type	Type III (soft)	
	Foundation type	Isolated	
	Mortars	Lime mortar	
	Type of masonry	rubble masonry finished with lime plaster	
	Masonry as per Load bearing	C: Unreinforced masonry walls built from fully dressed (Ashlar) stone masonry using good lime with sloping roof .	
	Dimensions	B1=1.75m, B2=0, B3=0 ,L=11 m, H= 7.5 m, B4=0, B5= 4.625m.	
	Damageability	G1 : a) Structural hair line cracks in very few walls. b)Non-structural Fall of small pieces of plaster only. Fall of loose stones from upper parts of building in very few cases	
	No of floors	1

Falling hazard	No	
	Special hazard	No	
	Item of roof/floor	Boulder rocks	
Retrofitting Measures -: <ol style="list-style-type: none"> 1) b5- Increase by build-up or reinforce with belt. 2) Mortar- Change of mortar not feasible. Hollowness may be filled by grouting or walls may be strengthened by ferro-cement plating or fibre-wrapping. 3) Length of wall between cross walls- Provide plaster or buttress 4) Height of wall from floor to ceiling- Add plaster to increase effective thickness 5) Plinth Level- Provide seismic belt 6) Plinth Level (Soft soil)- Provide seismic belt on both sides 7) Door window lintel level- Provide lintel band 8) Ceiling or Eave Level- Provide lintel band 9) Vertical bar at corner and T-junction of wall-Needed in all buildings (4 storeys not permitted) 10) Vertical bar at jambs of doors and windows- Needed in all buildings (4 storeys not permitted)
