EXPERIMENTAL ⁵STUDY OF TRIBOLOGICAL PERFORMANCE OF LASER TREATED ⁵STEEL
SURFACE ⁵WITH SMART COATING UNDER THE VIBRATIONAL LOADING

MASTER OF TECHNOLOGY

COMPUTER AIDED ANALYSIS AND DESIGN

⁷ DELHI TECHNOLOGICAL UNIVERSITY

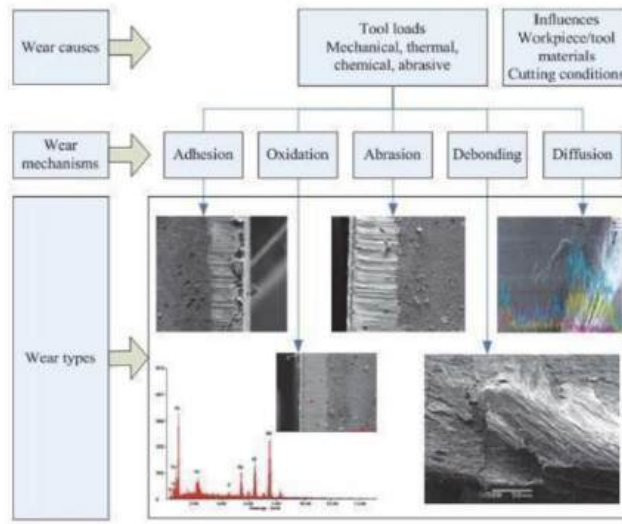
Figure 6: Schematic diagram of wear causes, mechanism, and types in nickel based super alloys cutting [40]

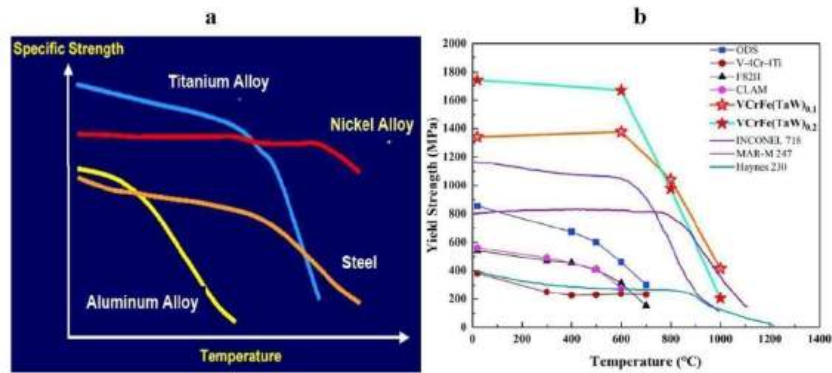
Figure 10: The variation of (a) specific strength [75] and (b) compressive yield strength [76] with temperature for super alloys

properties. Figure 10 shows the variation of specific strength and compressive yield strength of super alloys as a function of temperature.

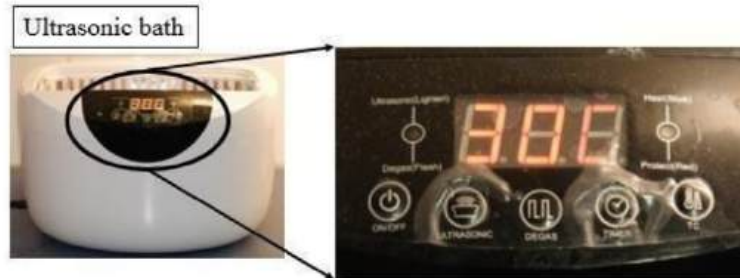
Figure 14: Ultrasonic bath for cleaning purpose

In this study, the test equipment's samples and sample holders employed in the tribological test are first cleaned with acetone, heptane followed by ethanol to remove any contaminants from the surfaces. Then, the test specimens and sample holders are placed in a glass beaker separately and cleaned with the help of heptane in an ultrasonic bath whose running time spanned to 480 seconds shown in Figure 14.

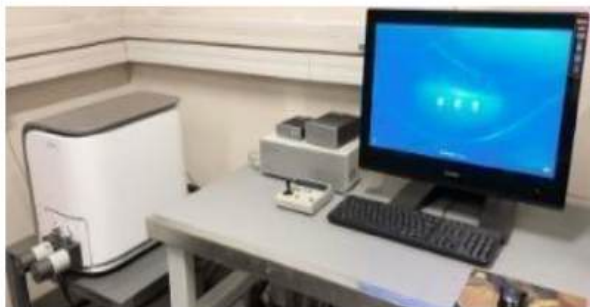
Figure 17: Jeol JCM-6000 PLUS SEM/EDS

The energy dispersive x-ray spectroscopy is an analytical technique usually works in conjunction with SEM to analyse the elemental composition of the surface and chemical analysis of the specimen. In this study, EDS has been used to confirm the presence of the adhered or transferred material as well as the rupture of the coatings from the TiAlN coated discs. Figure 17 shows the Jeol JCM-6000 PLUS SEM/EDS used in this study.

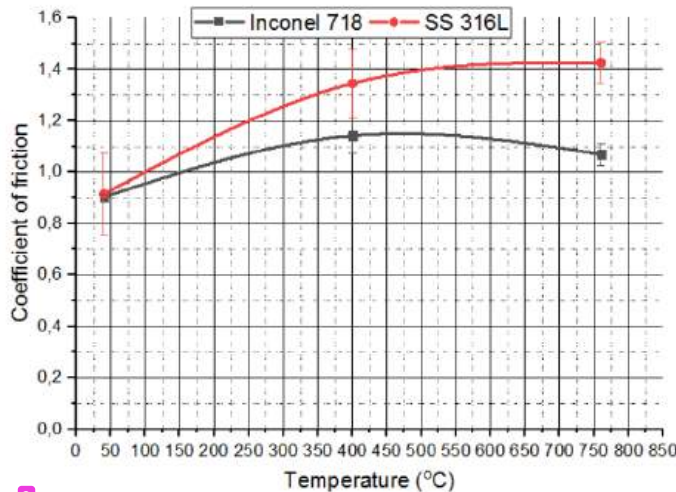
Figure 20: The average steady state coefficient of friction for Inconel 718 and SS 316L during sliding wear against $Ti_{60}Al_{40}N$

The steady state average coefficient of friction with error bars showing standard deviation for Inconel 718 and SS 316L are given in Figure 20. The graph demonstrate that Inconel 718 and SS 316L response towards Ti₆₀Al₄₀N coating shows a radical difference. The room temperature (i.e. 40 °C) COF values for both material are very close to each other. Contrary to it, at 760 °C the values are drastically different with opposite trend. The overall trend for both of materials is quite similar with less increment in friction value for Inconel 718 in comparison to SS 316L.

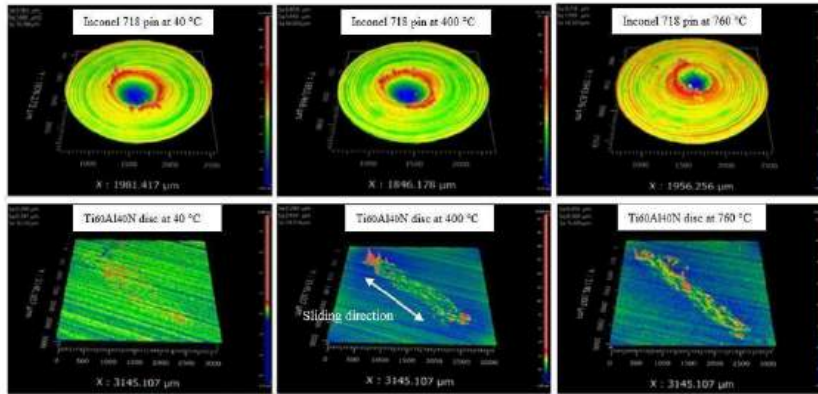
Figure 22: The worn surface topography images for the Inconel 718 and $\text{Ti}_{60}\text{Al}_{40}\text{N}$ coating at 40 °C, 400 °C and 760 °C

Furthermore, the worn surfaces on the coated disc depicts the transferred material accumulation on the edges at 400 °C while material is transferred uniformly on the disc at 760 °C. Conversely, Inconel 718 pins manifest more deep grooves formation and excessively damaged surface at 760 °C confirmed by the Zygo images in Figure 22. However, the worn pin surfaces at 40 °C and 400 °C looks pretty similar with more deformed surface at 400 °C. The transferred material area got enhanced with rise in temperature on coated disc which is perfectly in line with the volumetric gain of the transferred material on the coated disc as mentioned in Figure 21.
