Fatigue Failure Analysis of Low-Pressure Steam Turbine Blade

A Ph.D. Thesis Submitted
in Partial Fulfillment of the Requirements
for the Degree of

Mechanical Engineering

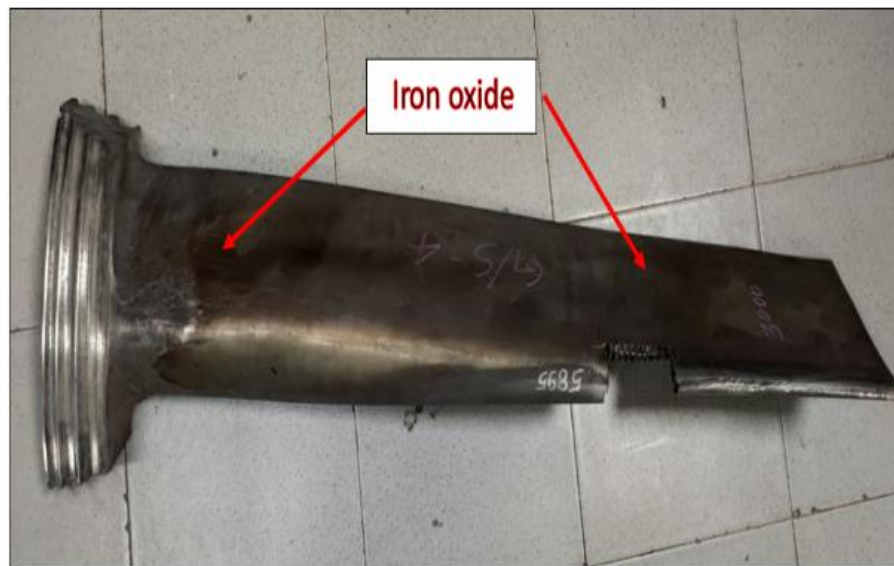
(Fe_3O_4) are also found on the blade's surface from tip to root of the blade as shown in Fig. 3.2 and presence of iron oxide (Fe_3O_4) can make the blade material weak and ductile. Further, water droplet erosion creates erosion pits on the aerofoil-leading edge but these are away from the transverse crack as shown in Fig. 3.3, which concludes that the erosion pits are not the reason for the failure of the blade.

Figure 3.2: Black patches (Iron Oxide (Fe_3O_4)) observed on the blade's surface

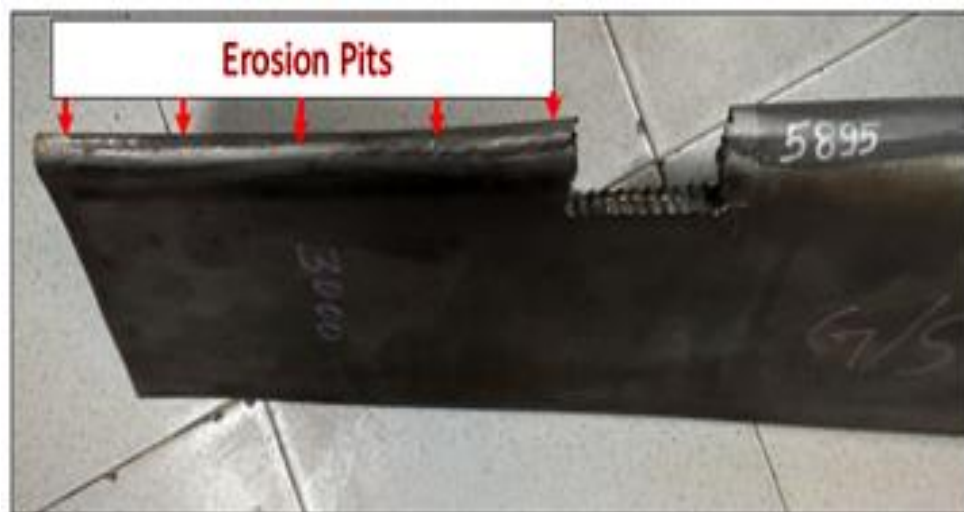
Figure 3.3: Erosion pits at the blade aerofoil-leading edge.

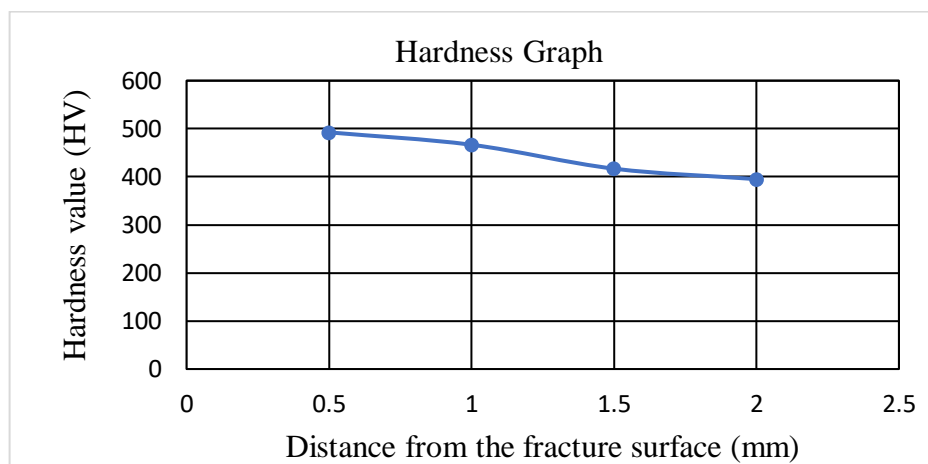
Distance from the fracture surface (mm)	Hardness (HV)
0.5	492.43 HV0.5
1	466.63 HV0.5
1.5	416.89 HV0.5
2	395.08 HV0.5

Figure 3.11: Graphical plot of hardness value vs distance from the fracture surface.

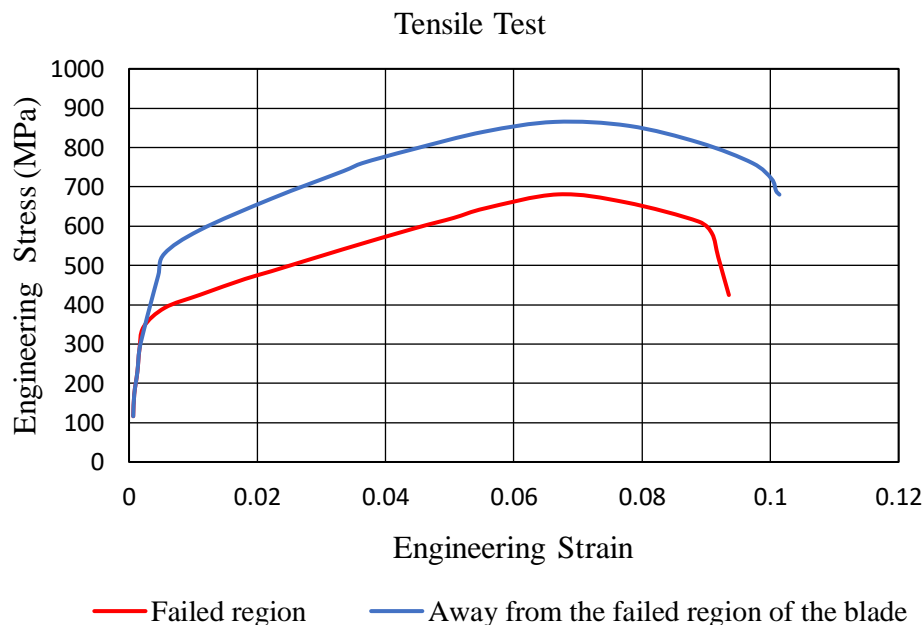
Tensile tests were conducted on the blade's failed and un-failed regions of the blade. The stress-strain curve is shown in Fig. 3.12. The un-failed region of the blade has a yield strength of 530 MPa and an ultimate tensile strength of 865 MPa, while the failed region has a yield strength of 343 MPa and an ultimate tensile strength of 680 MPa. The reason for the lower value of the failed region is as it has undergone significant deformation and damage & which reduces the strength and ductility of the material.

Figure 3.12: Stress-strain curve for the failed and the un-failed region of the blade

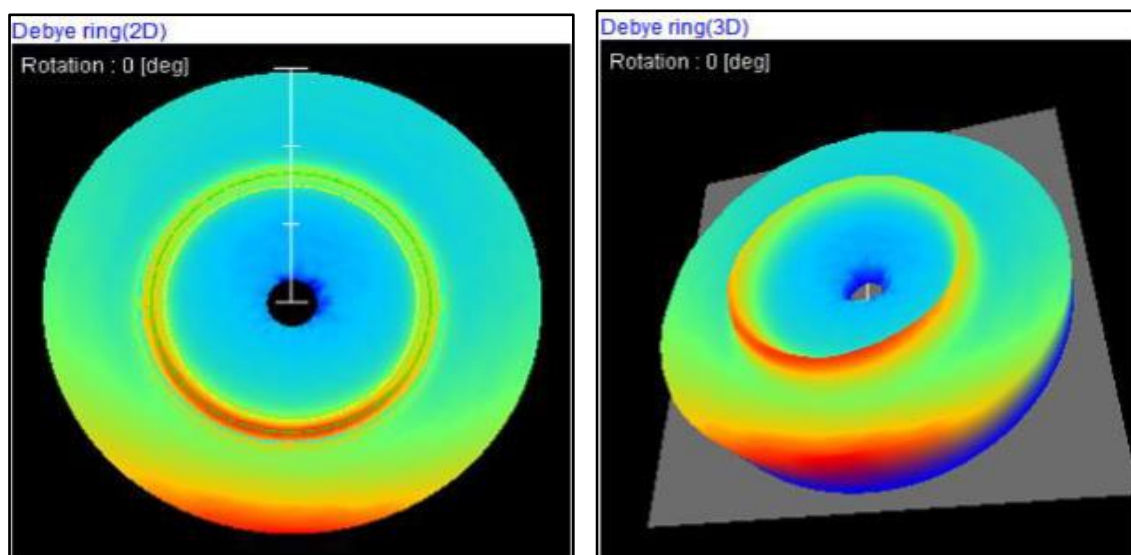
An analysis of the diffraction intensity has been conducted from the center of the Debye ring to its outer perimeter. Observations indicate that the diffraction intensity exhibits a gradual and uneven variation along the Debye ring. This variation is attributed to the differing depths of X-ray absorption caused by the varying properties of the blade surface. The Debye ring displays a 'spotty' distribution across its surface, suggesting the presence of coarse and randomly oriented crystal grains on the blade surface, indicating an inhomogeneous deformation of the blade.

Figure 4.3: Debye-Scherrer ring in 2 Dimensions and 3 Dimensions

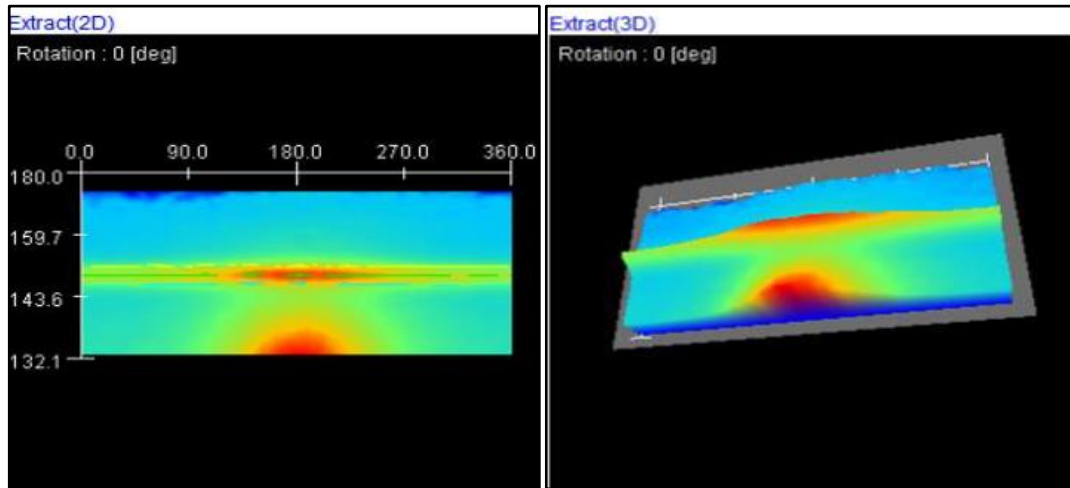
Figure 4.4: Open Debye-Scherrer ring in 2 Dimensions and 3 Dimensions

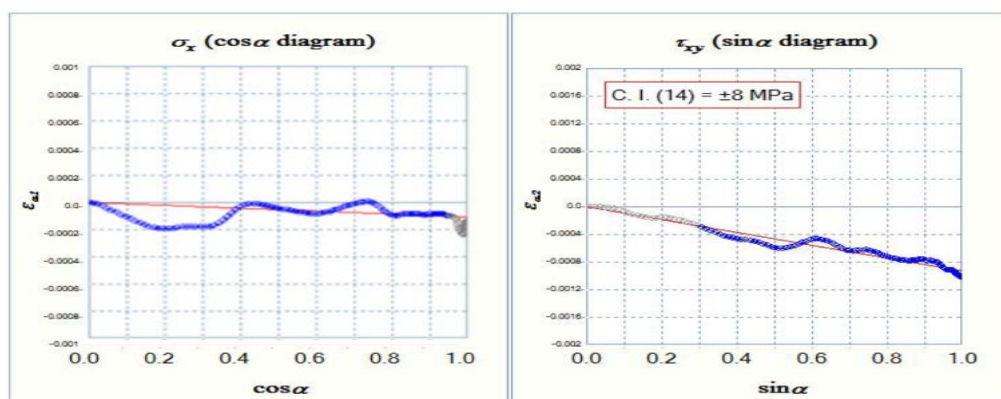
Fig. 4.5 displays the plots of $\epsilon_{a1} - \cos \alpha$ and $\epsilon_{a2} - \sin \alpha$, which have been analyzed to ascertain the residual stress (σ_x) and shear stress (τ_{xy}) in MPa. The red line in the $\epsilon_{a1} - \cos \alpha$ and $\epsilon_{a2} - \sin \alpha$ diagrams represent the collinear approximation used to determine the slope, which is the variation in $a1$ concerning $\cos \alpha$ and variation in $a2$ concerning $\sin \alpha$. These slopes have been utilized to calculate the residual stress and shear stress using Eqn. 4.3 and 4.4. Table 4.2 presents the results of the stress measurement using the μ -360 equipment. It is evident that the Residual stress (σ_x) and shear stress (τ_{xy}) are 46 MPa and -225 MPa, respectively, indicating the presence of non-zero residual stresses in the volume where X-rays are diffracted. The positive value of residual stress suggests that it is tensile in nature.

Figure 4.5: Stress analysis results for ($\cos \alpha$) and τ_{xy} ($\sin \alpha$) diagram

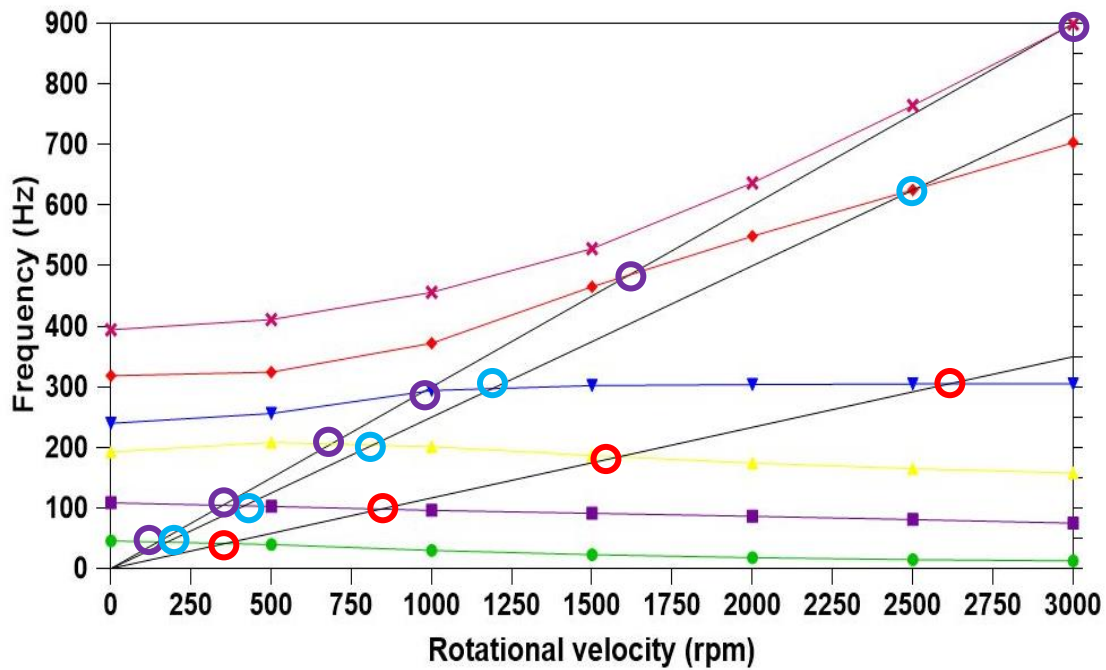
Mode	0 rpm	500 rpm	1000 rpm	1500 rpm	2000 rpm	2500 rpm	3000 rpm
First Natural frequency	45.984 Hz	39.788 Hz	30.006 Hz	22.884 Hz	18.173 Hz	14.964 Hz	12.676 Hz
Second Natural frequency	108.625 Hz	102.642 Hz	96.375 Hz	91.390 Hz	86.275 Hz	80.810 Hz	75.211 Hz
Third Natural frequency	192.752 Hz	208.534 Hz	201.284 Hz	186.963 Hz	174.446 Hz	164.892 Hz	157.960 Hz
Fourth Natural frequency	240.199 Hz	255.954 Hz	294.068 Hz	302.082 Hz	304.015 Hz	304.776 Hz	305.157 Hz
Fifth Natural frequency	318.538 Hz	324.219 Hz	372.317 Hz	465.675 Hz	548.790 Hz	625.429 Hz	703.505 Hz
Sixth Natural frequency	394.538 Hz	411.251 Hz	453.053 Hz	528.410 Hz	636.922 Hz	764.685 Hz	898.966 Hz

Figure 5.16: Campbell Diagram of LP steam turbine blade

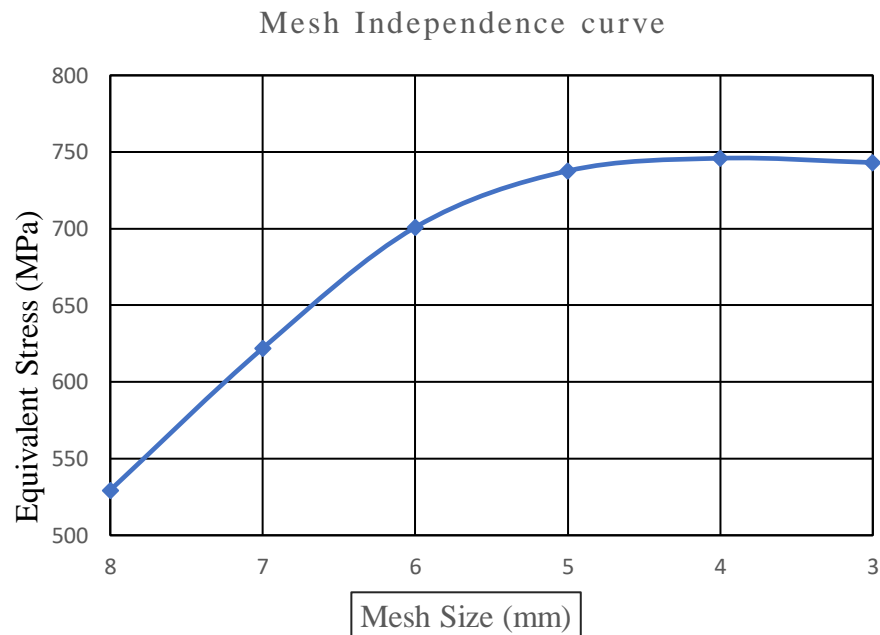
Figure 6.8: Grid Independence test

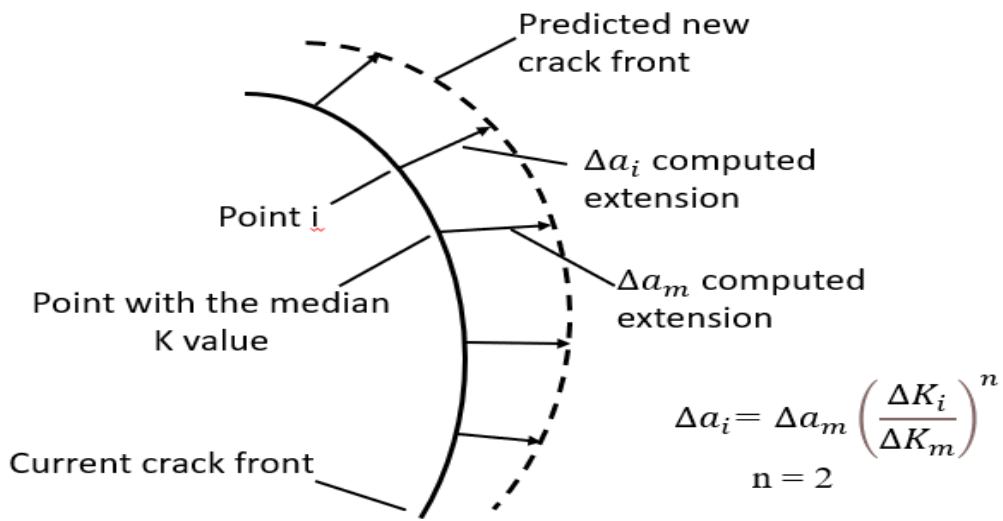
Figure 6.10: Crack Extension rule in Franc 3D

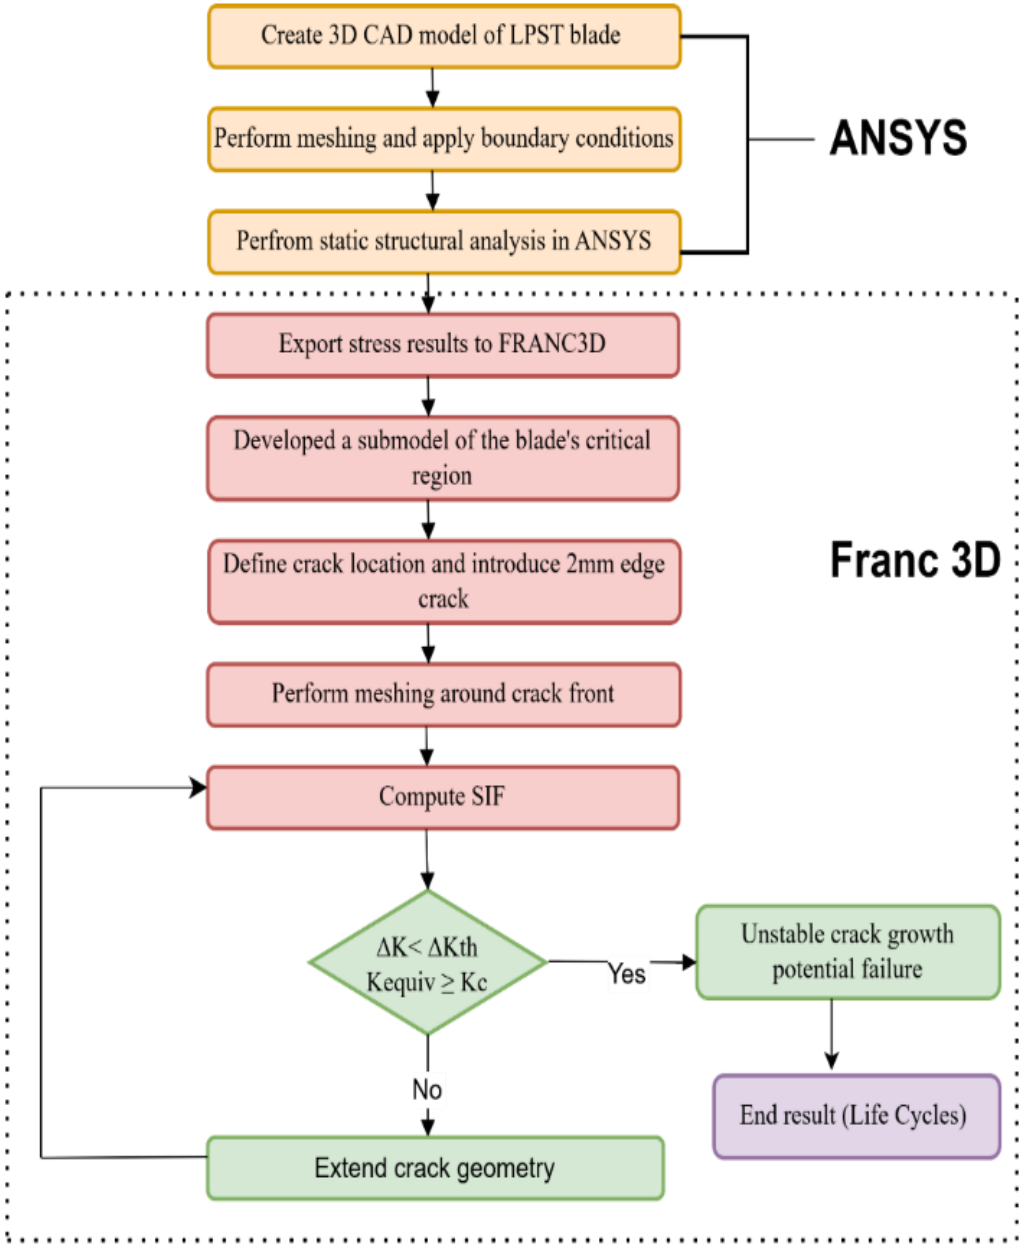
Figure 6.12: Flow chart for fatigue crack growth simulation

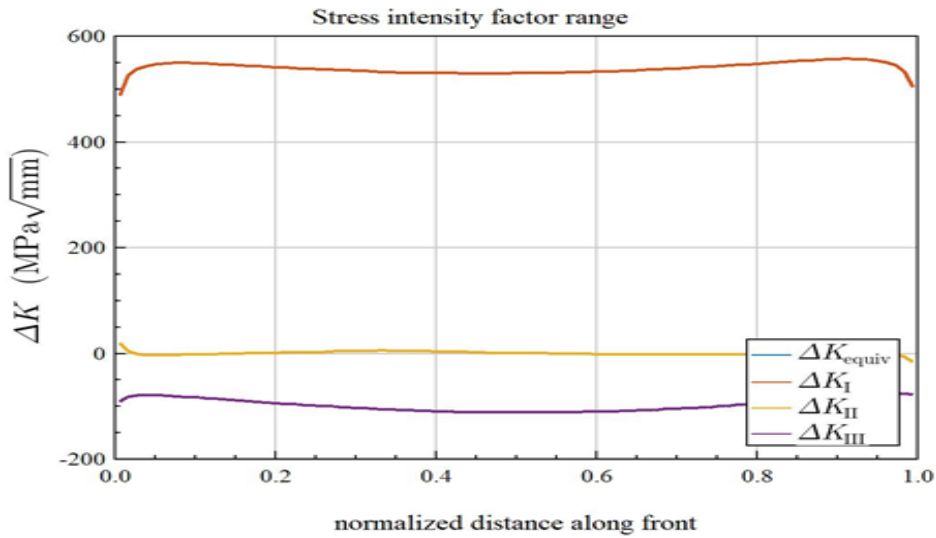
Figure 6.16: Average Stress Intensity Factors (SIFs) K_I , K_{II} and K_{III}

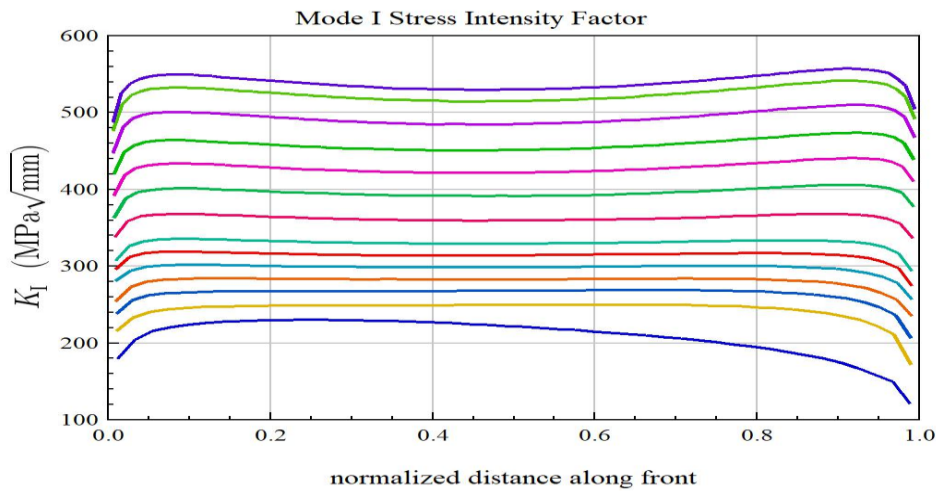
Figure 6.17: Stress intensity factor (K_I) at the crack front 2 mm to 6.5 mm

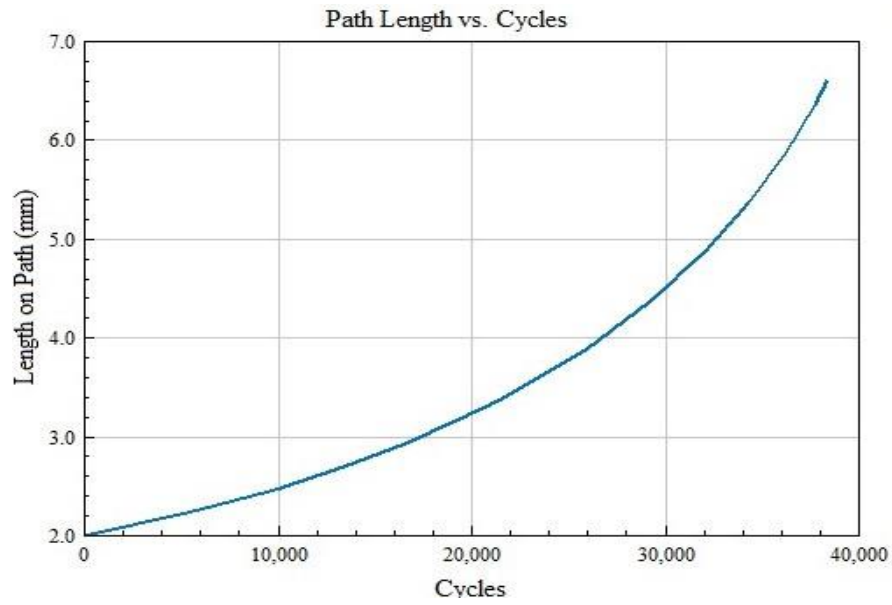
Figure 6.18: Crack Propagation Path Length vs. Cycles

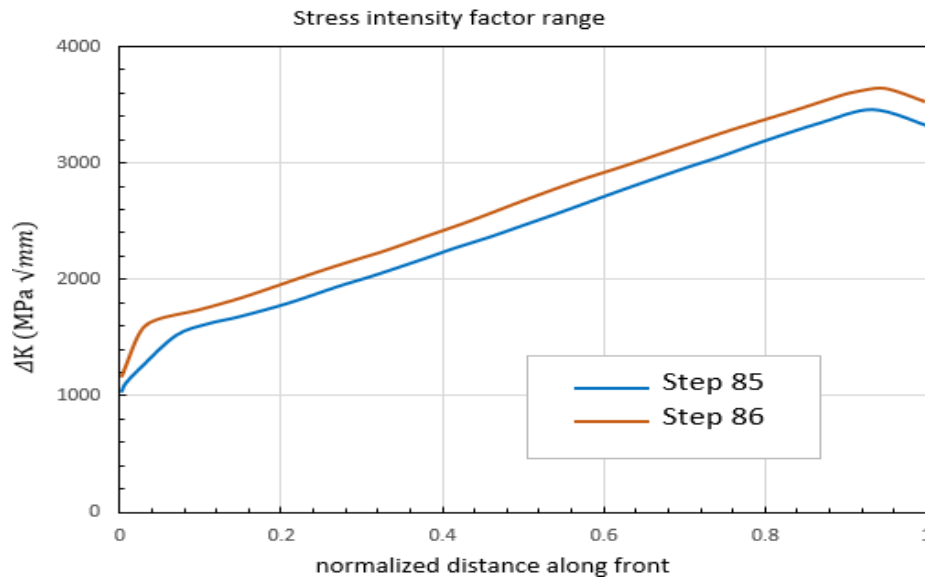
Figure 6.19: Mode I SIF (K_I) for 85th and 86th steps of crack propagation
