Rapid Visual Screening of Buildings

RAPID VISUAL SCREENING OF BUILDINGS

Pawan Tiwari
(2K24/STE/06)

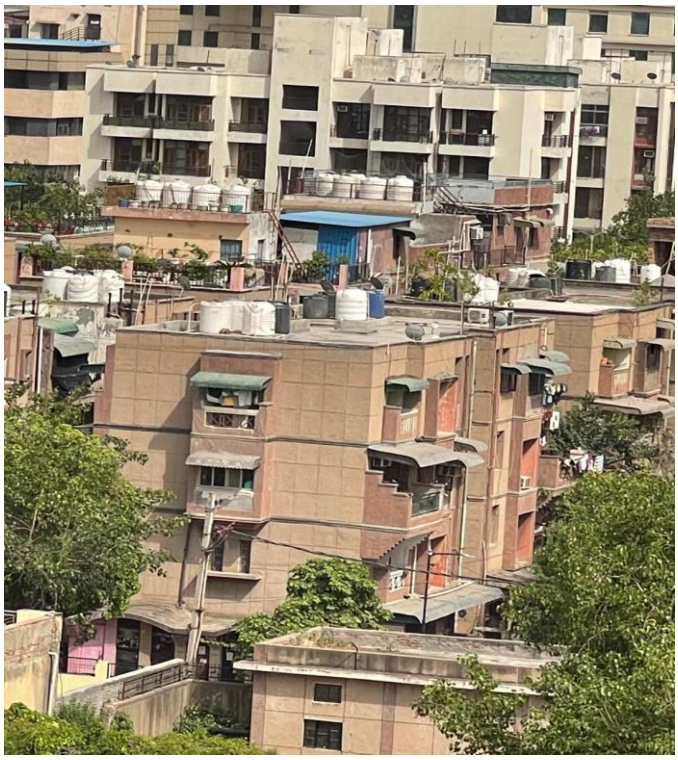
Figure 12 Wide Angle View at Haiderpur Badli Metro Station

Photographs for this RVS exercise were taken from the elevated viaduct of Haiderpur Badi Metro Station. The wide-angle photographcaptures the overall settlement morphology extending south from the metro line. The zoomed photograph focuses on a representative cluster of three- to four-storey residential buildings in the immediate foreground of the settlement and forms the primary basis for structural assessment in this report.

The wide-angle view (Figure 1) establishes the macro-urban context: a dense, predominantly low-rise (2–5 storey) informal and semi-formal residential fabric with heavy tree cover, broken by a drainage nullah running roughly east–west, and a single taller (~12–14 storey) commercial building visible in the mid-background. The sky shows a pronounced haze layer consistent with Delhi's pre-monsoon smog conditions. The trackside marker confirms the photograph was taken from an elevated metro structure.
