**“TPM APPROACH FOR ANALYSIS AND REDUCTION IN
ENGINE LEAKAGE FROM STATOR PLATE”**

**MASTER OF TECHNOLOGY
(PRODUCTION & INDUSTRIAL ENGINEERING)**

Submitted by:
ASHISH VASHISTHA
UNIVERSITY ROLL NO: 2K11/PIE/02

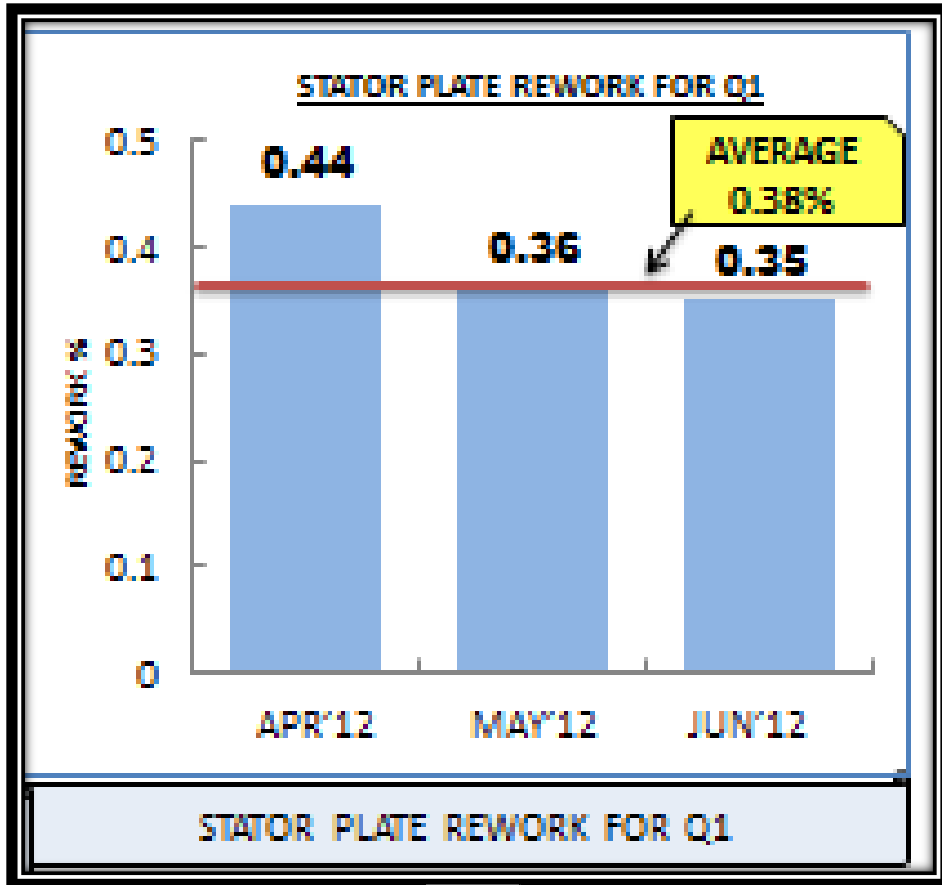
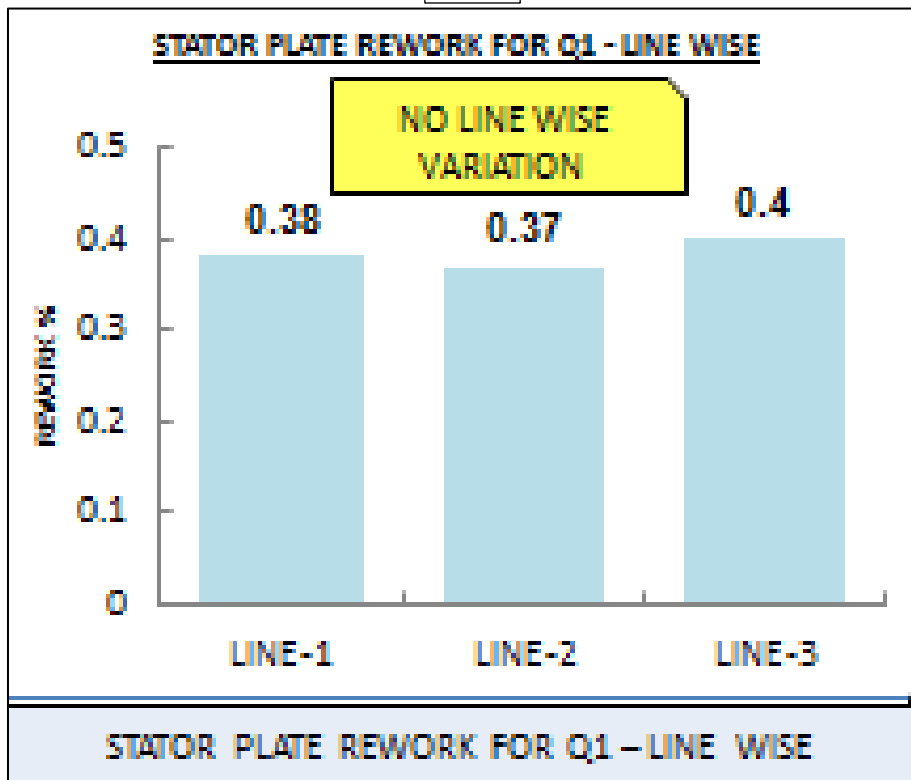
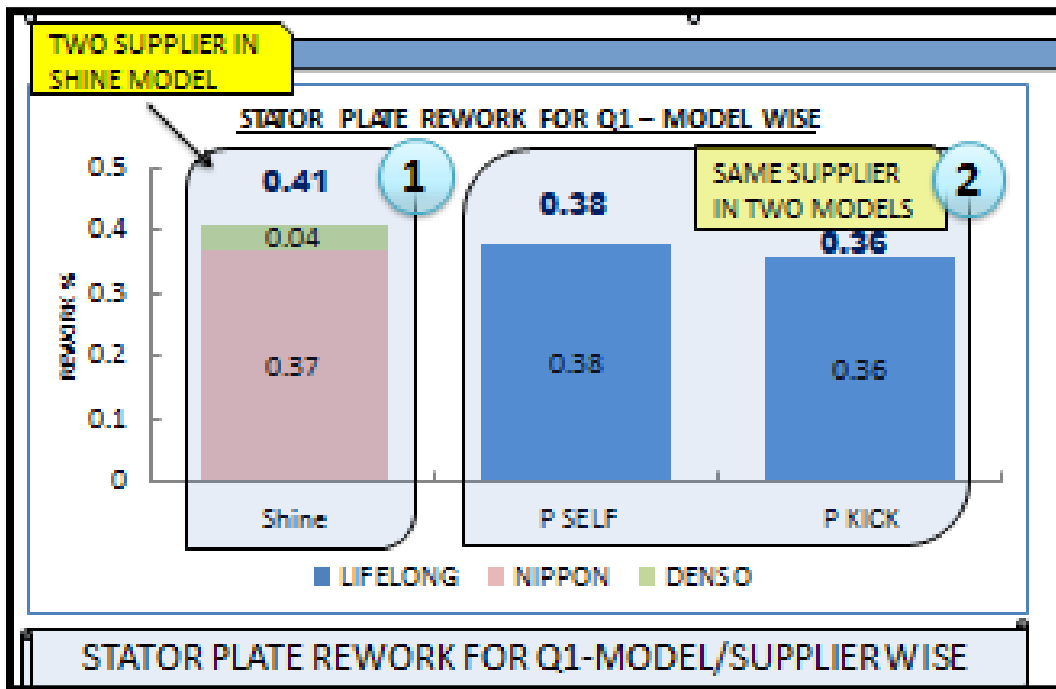
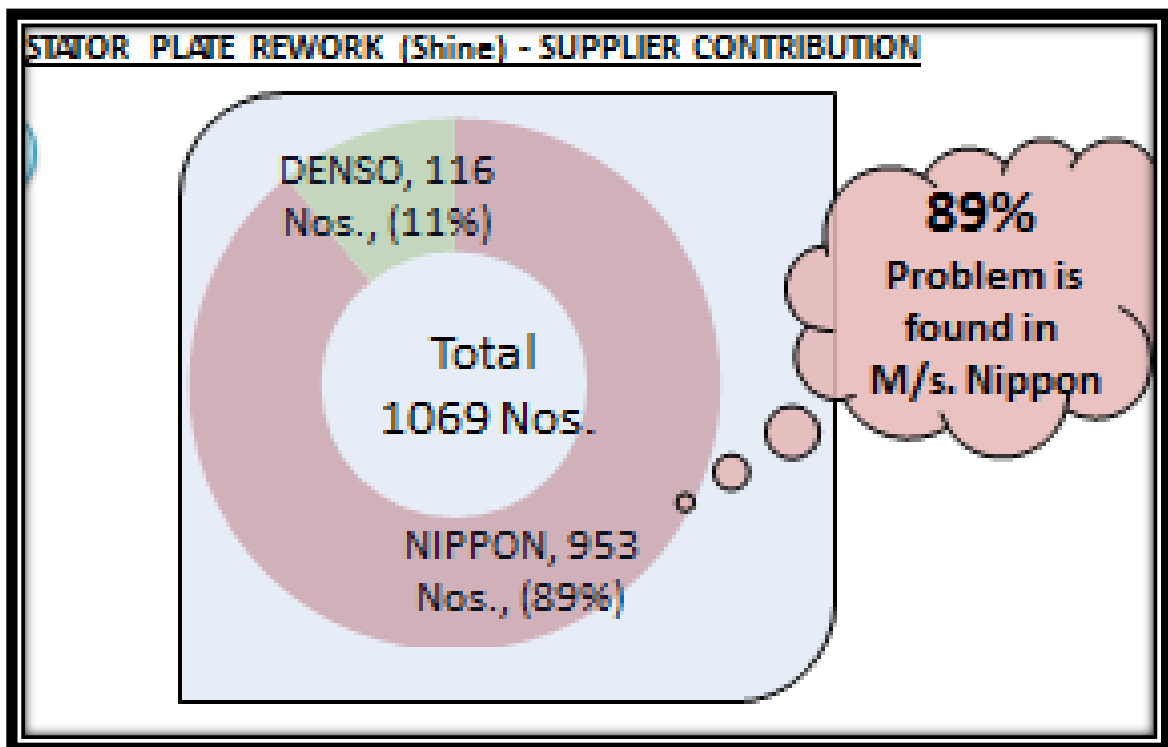
In first graph, it shows the percentage of stator plate defect in the month of April , May, June 2012. The Average of stator plate defect of these 3 months is 0.38 % in Quarter 1.

In second graph, it shows the stator plate defect of Quarter 1 line wise. In this graph it is very clear that the defect is coming on each line and almost in equal proportion.

Third Graph Shows the stator plate defect vehicle model wise. First one is for shine mode using two different vendors. Nipon and Denso are the two vendors who provides stator plate for the shine model. For shine model 0.41 % contribution of nipon vendor and 0.04% contribution of denso vendor.

In the last graph we can see clearly that for particular shine model, 89% leakage contribution is by nipon stator plate and only 11 % contribution is from denso stator plate.

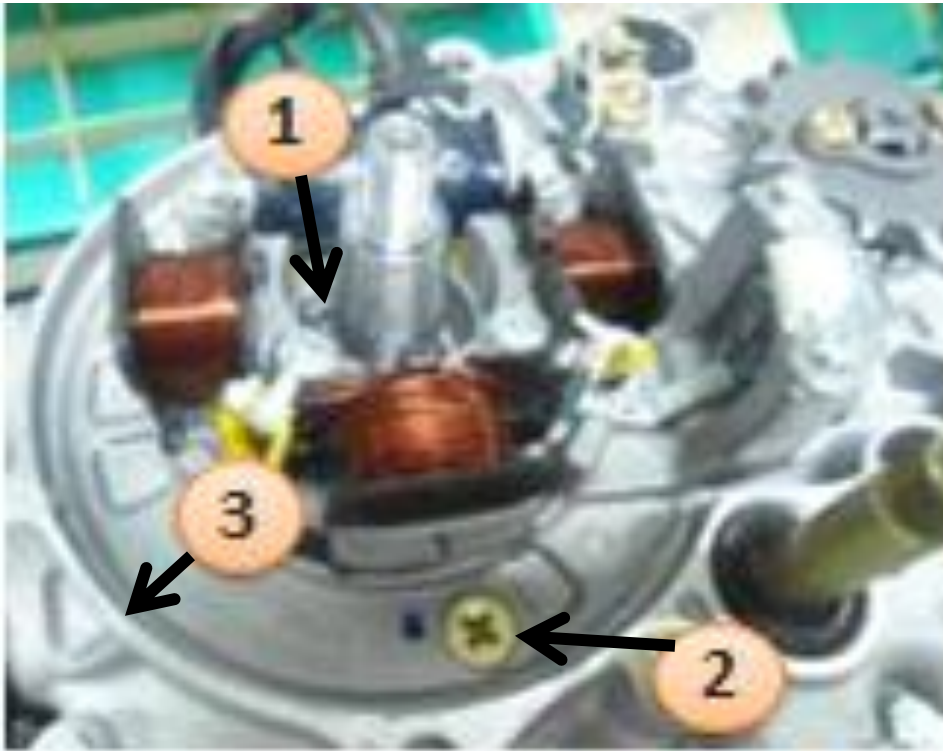
1. Represent the crankshaft and oil seal interface.
2. Represent the mounting bolt and lcc interface.
3. O'ring and LCC (left crak case) interface.

FROM THE SEALING POINT A 50 % OF LEAKAGE OBSERVED.

FROM THE SEALING POINT B 45 % OF LEAKAGE OBSERVED.

FROM THE SEALING POINT C 05 % OF LEAKAGE OBSERVED.

THIS DATA SHOWS THAT THE MAXIMUM LEAKAGE OBSERVED FROM THE O'RING AND LCC INTERFACE.

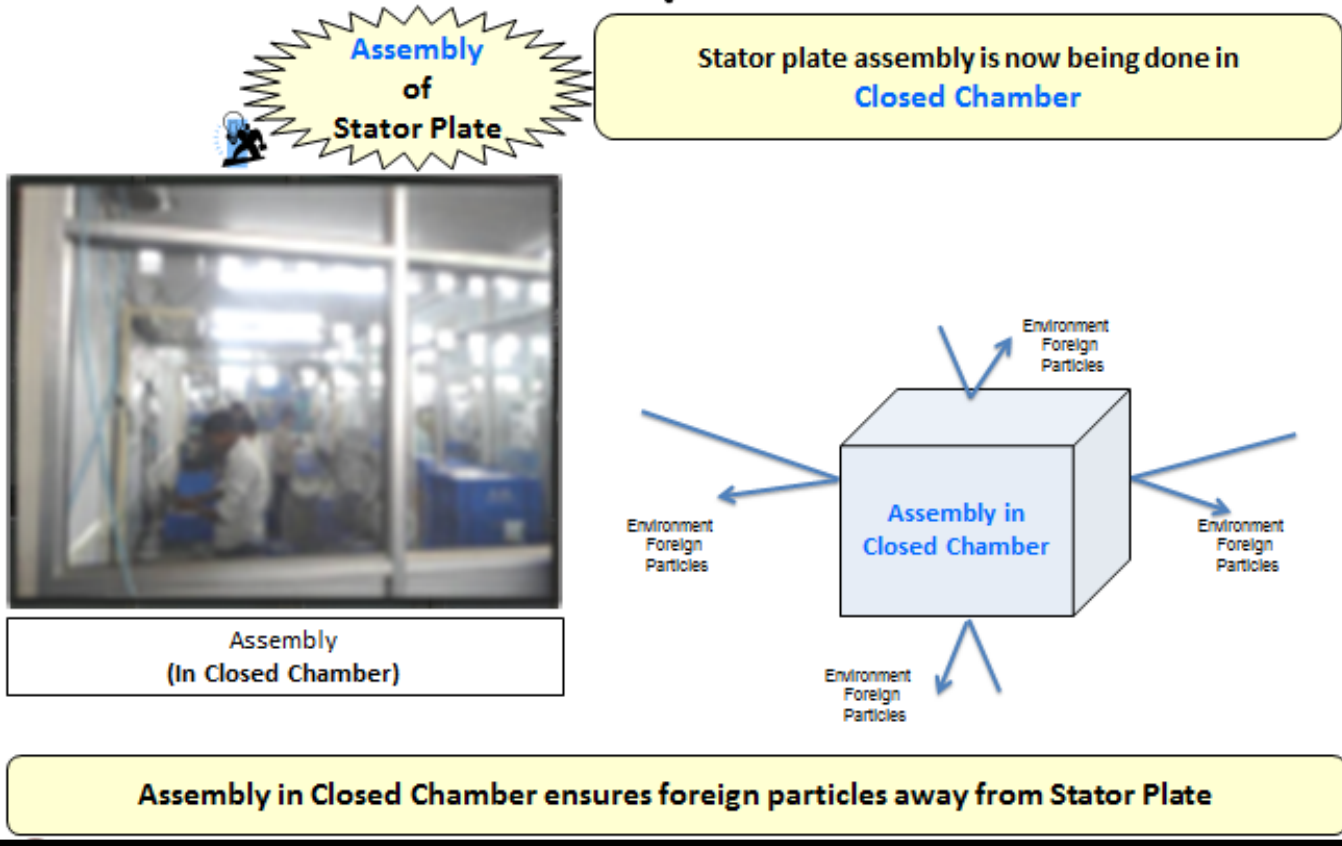
Countermeasure of foreign material in Oil seal, O ring and Stator Plate : -

For the foreign material in oil seal and o ring, we have done why why analysis and found that oil seal and o ring are being assembled in open area, exposed to environmental foreign material.

By this figure I am trying to show the close chamber of stator plate assembly , due to which o ring, oil seal and stator plate will be free from any type of foreign material.

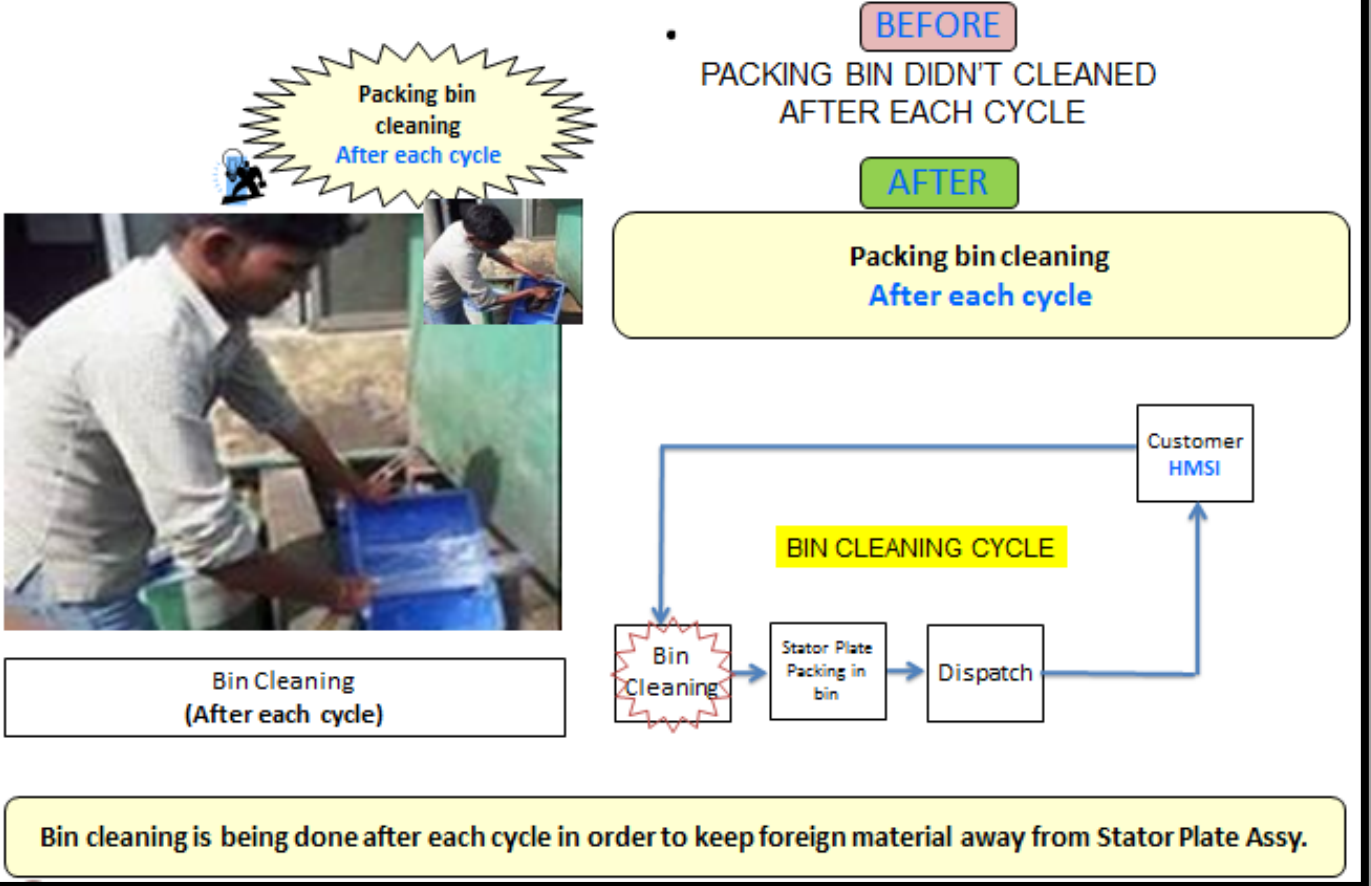
Countermeasure of foreign material/chips on stator plate O ring groove :-

Foreign Material/Chips on stator plate o ring groove is the another observation. After doing analysis we found that packing bins are not being cleaned regularly. Air cleaning processes doesn't ensures chips free stator plate to the next process.no check point fot the inspection of packed component for foreign material.

This picture shows the packing bin cleaning after each cycle. Flow chart of this process is also shown in this picture. As per flowchart after getting empty bin from vendor, bin has to be cleaned with water before feeding or packing the new stator plate. After washing the bins, stator plate is going to pack in washed bins and then move for dispatch to the customer.

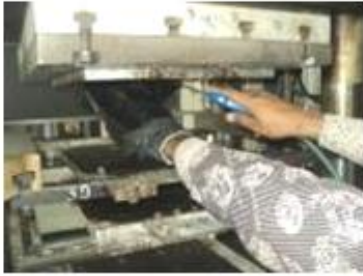
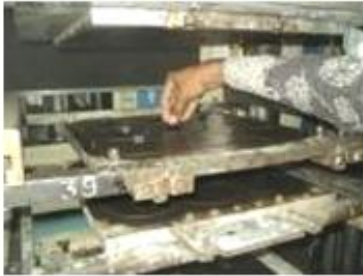
Against the phenomenon of O ring thickness less, when we have done why why analysis, we found that mould cleaning and polishing is not being done regularly. The second thing is Mould/cavity wise inspection was missing. As a countermeasure polishing/cleaning done and frequency of cleaning fixed and being adhered.

Flashes didn't tear off completely.	O ring parting line area thickness is more.	Mould notches worn out.	Notch and tool maintenance frequency not fixed.

O Ring Injection Moulding Machine **Polishing/Cleaning and tool notches re-shaped**

1. Flash rest groove cleaned and polished to maintain material run radius.
2. Tool and its notches re-shaped to cut away the flashes from O ring.
3. Batch/Mould/Cavity wise inspection started to monitor the parameters within specifications.

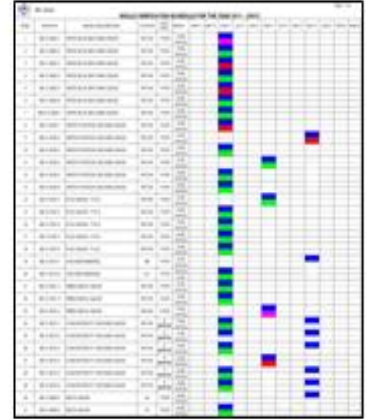
Tool maintenance Schedule

Now we have done why why for flashes on o ring. We found that notch and tool maintenance frequency not fixed. Operator was not able to detected minor flashes by naked eyes.

Tool maintenance schedule has been made and relay teaching done to detect and control the process conditions

Tool Life and its maintenance schedule has been made to control the process condition. In this figure we can easily understand that after sharpening the tool the generation of flashes is completely removed.

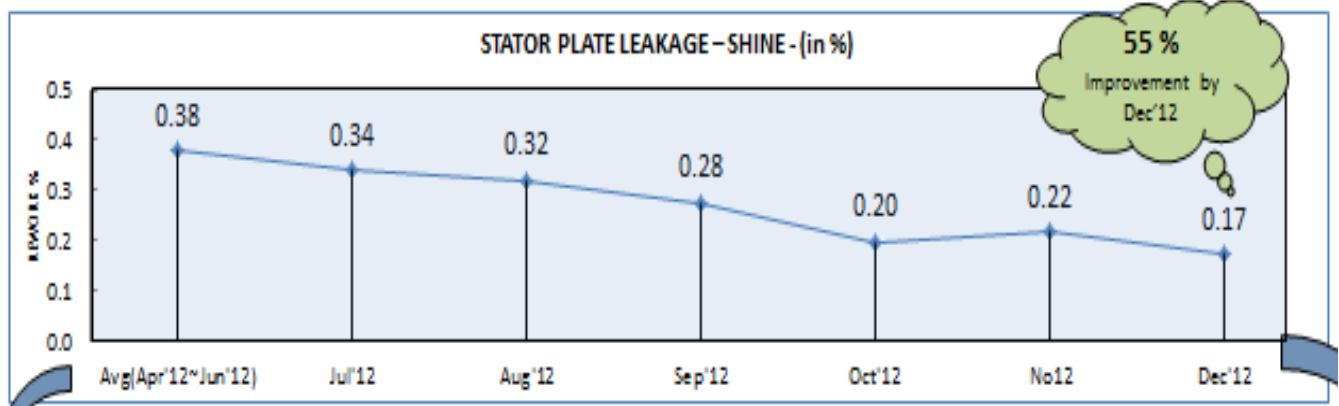
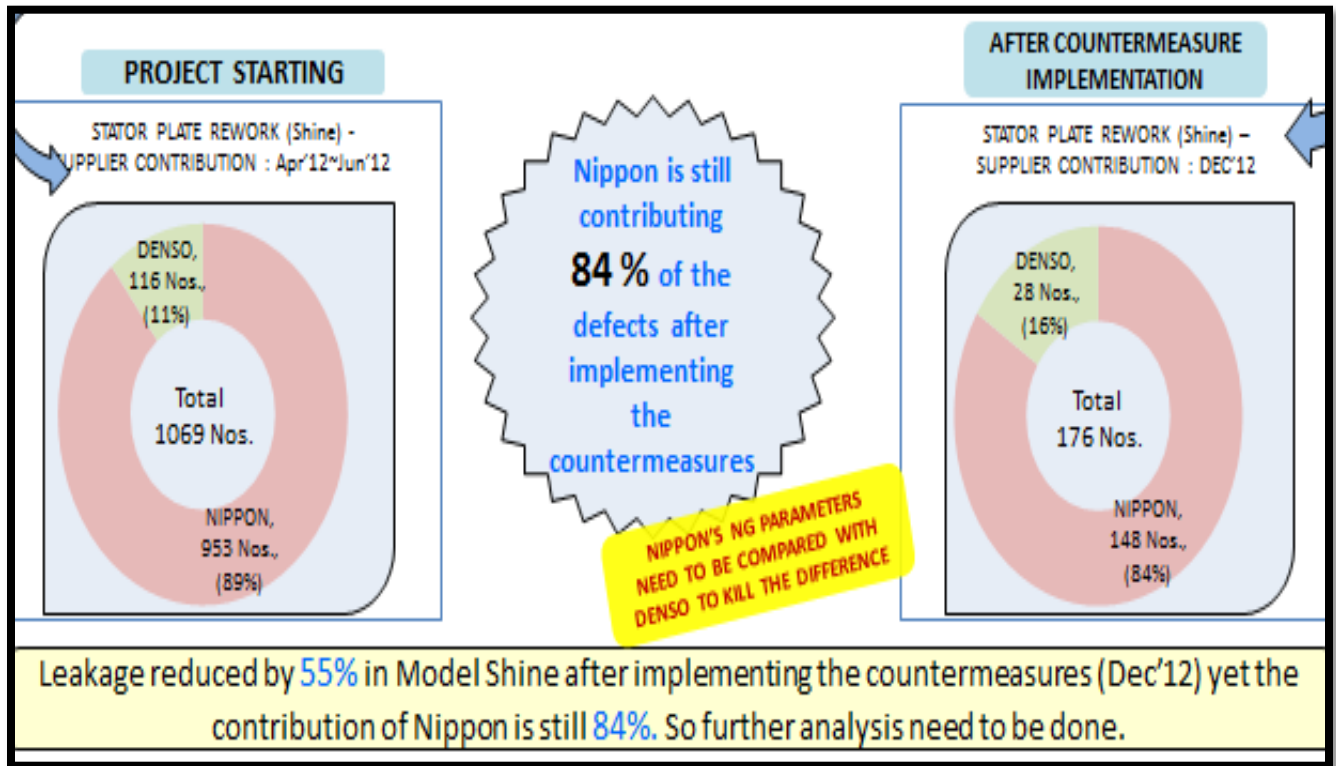
Effectiveness of : Model Shine – After Implementing the Countermeasures

Leakage reduced by 55% in model shine after implementing the countermeasure (Dec'12) yet the contribution of Nippon is still 84%.

So further analysis is required to achieve zero defect.

After taking these countermeasure we achieved 55% of improvement till the end of Dec'12.

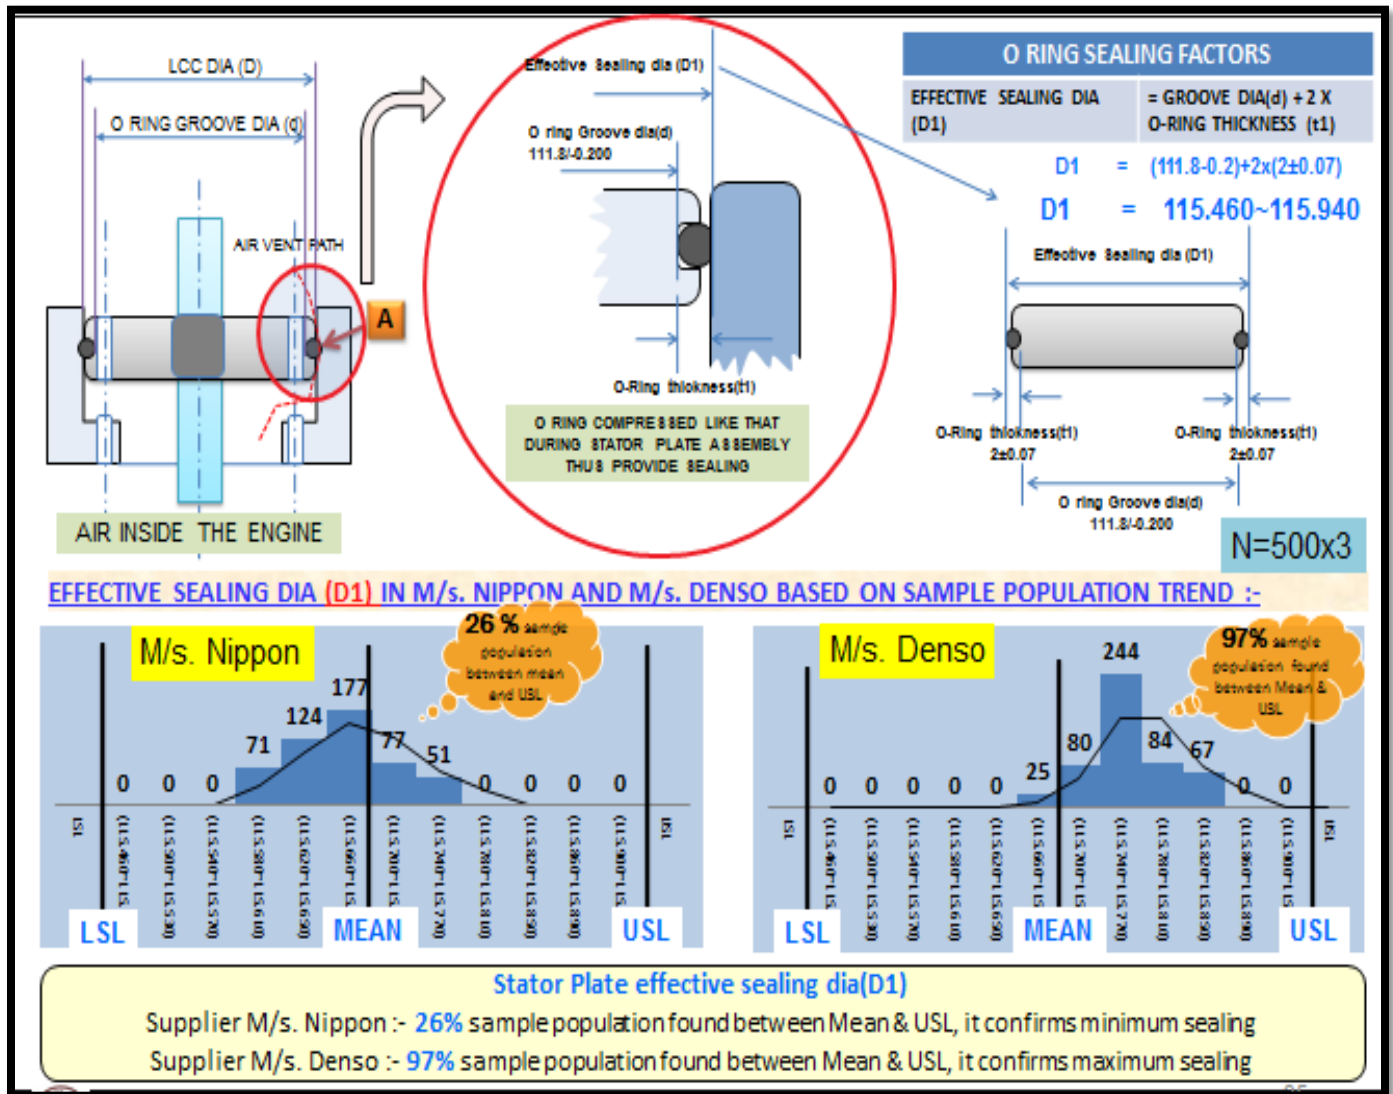
INVESTIGATE CHARACTERISTICS VALUE AND CURRENT SITUATION:

After doing further analysis of total 148 nos of defect, we found that leakage contribution from the sealing surface A is the highest which is 91%. Point C is having 2% of leakage which is from mounting and LCC interface. And 7% leakage is found from oil seal and crankshaft interface.

O ring between stator plate groove and crankcase interface provide sealing in such a manner so that there must be no leakage.

After doing comparison of two vendors Nippon and Denso based on the sample population trend we found that 26% sample population are found between Mean and USL in Nippon supplier.it confirm minimum sealing

In Denso vendor 97% sample population found between mean & USL. It confirm maximum sealing.

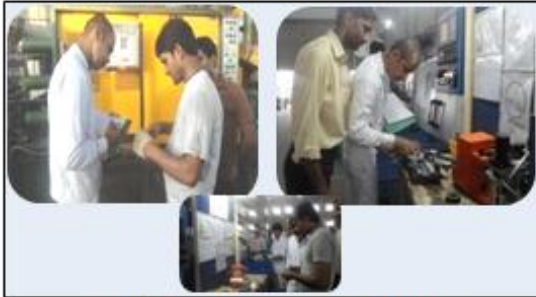
M/s. NIPPON – SUPPLIER VISIT

M/s. Nippon (Supplier) visit done to study the capability of machine for Stator Plate O ring groove diameter

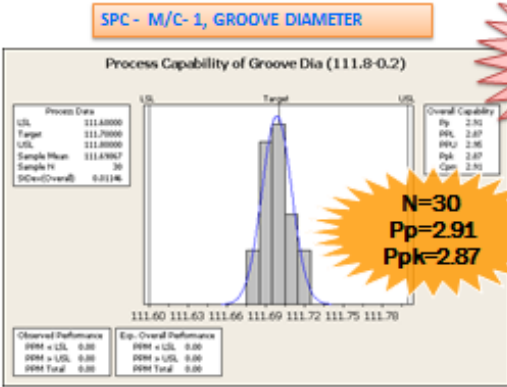
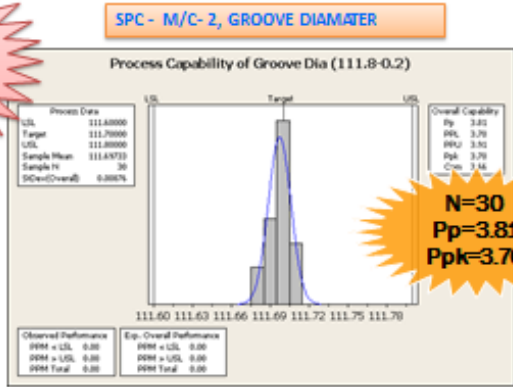
Short Term SPC
for continuous
30 Pieces

Short Term Process Capability Study of CNC Turning M/C-For Groove diameter 111.80-0.2

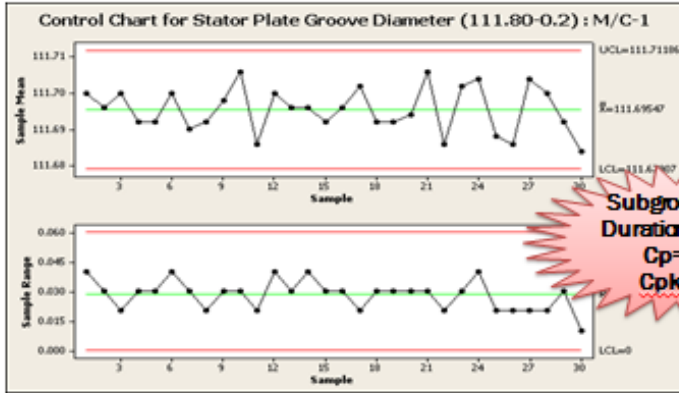
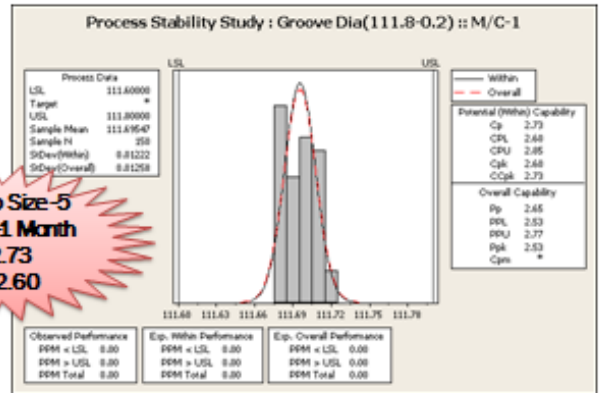
Long Term Process Capability Study of CNC Turning M/C-For Groove diameter 111.80-0.2

Subgroup Size-5
Duration-1 Month
Cp=2.73
Cpk=2.60

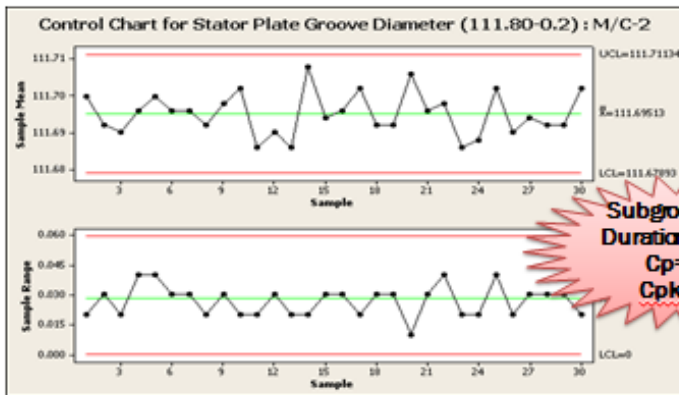
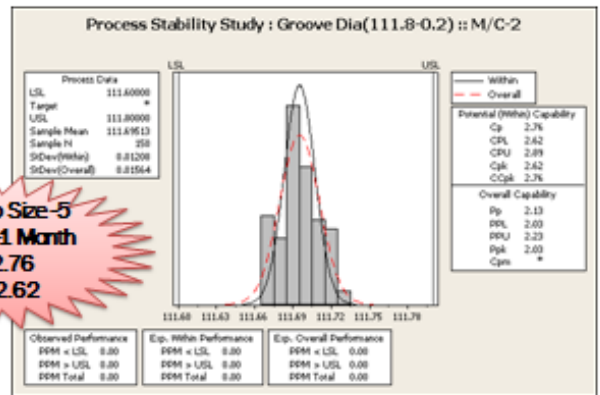
Subgroup Size-5
Duration-1 Month
Cp=2.76
Cpk=2.62

Further actions : 3 Lots of 10,000 Pieces was demanded from M/s. Nippon having groove dia between Mean and USL

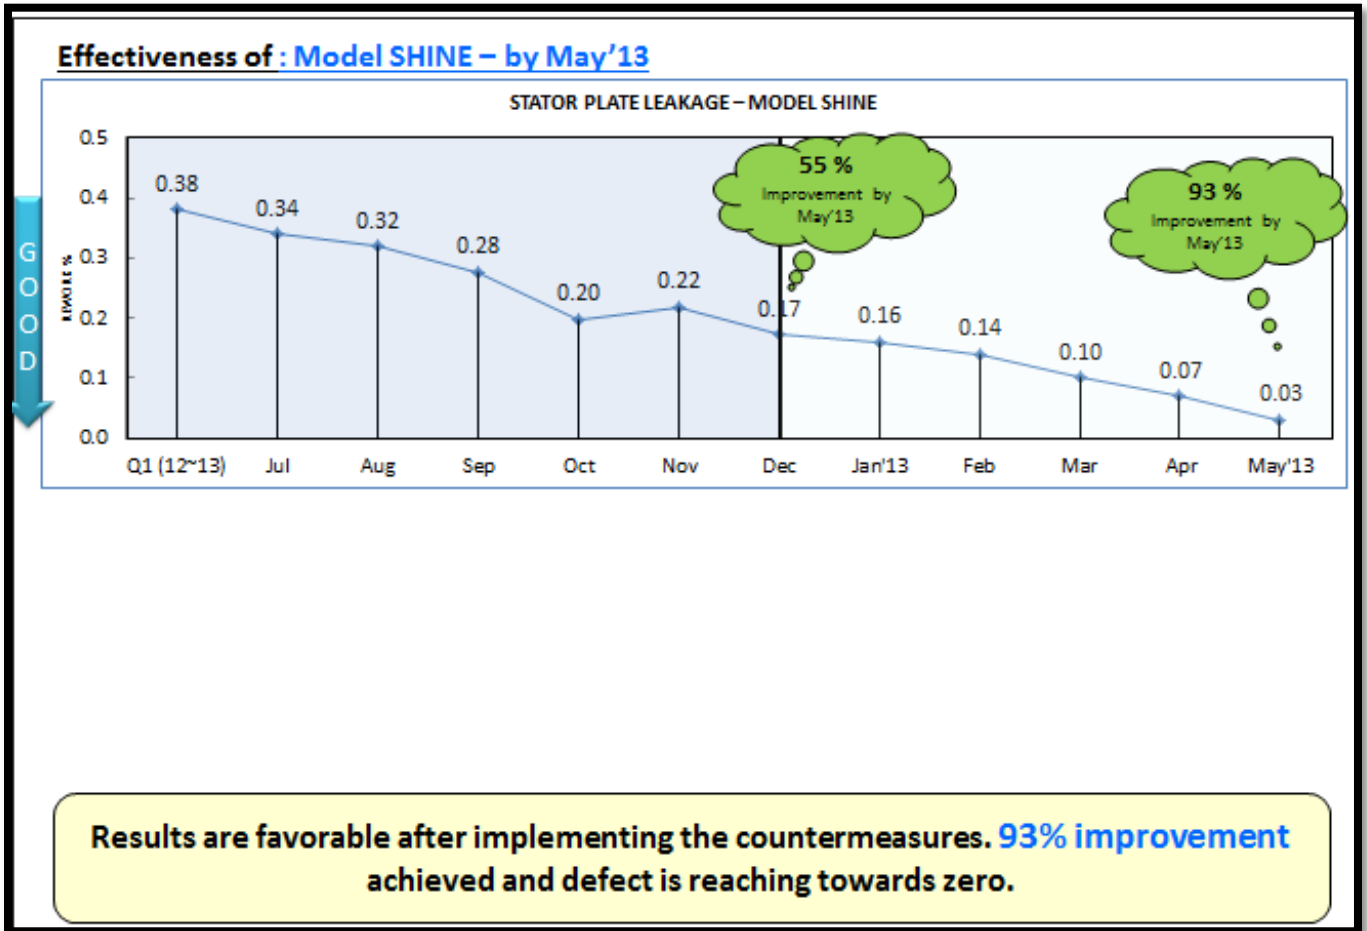
CONFIRM EFFECTIVENESS: RESULT CONFIRMATION

This trial confirms that keeping Stator Plate O ring groove dia(d) at upper side (between mean and USL) confirms maximum sealing in engine from stator plate area.
