STUDY ON RESPONSE OF CONCRETE BRIDGE DUE TO CONSTRUCTION DEFECTS

A DISSERTATION

In this study, the field survey has been done to identify the defects and elaborate on the codal provisions. The method used for assessing the behaviour of the structure due to defect is modelling and analysis of the bridge in STAAD pro software. With the consideration of defect, additional unexpected moments are generated in the girder and diaphragm for which the structure was not originally designed. In general, steel reinforcement is provided for required moments in the structures. If additional unexpected moments are generated, then damage can occur in the structure and affect the service life of the structure. The present study highlights that the collection of data can provide information about the possible defects with their causes for a meaningful conclusion about the service life of the structure.

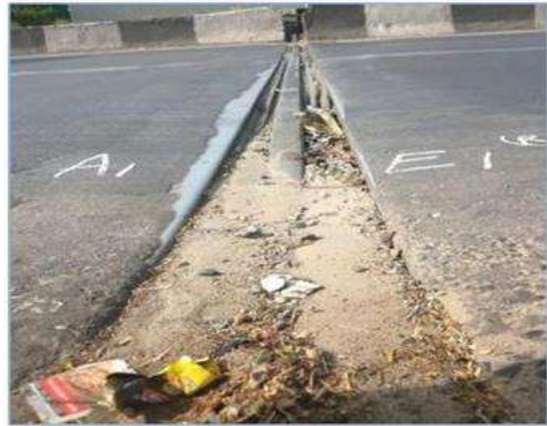
Expansion joints are provided in the bridge to permit the movement of the span. It should offer good riding comfort to road users. Expansion joints should be free from water leakage or watertight and be capable of expelling debris without clogging [1]. In the field, it was observed that at most of the locations debris was accumulated in the expansion joint (refer Fig 3.7 to 3.8). This may be happened due to the improper periodic inspection or cleaning. In the strip seal type expansion joint, neoprene seal was damaged/missing at most of the locations as seen in Fig 3.9 to 3.10. Due to this seepage observed at pier cap level and lead to corrosion initiation in the reinforcement.

Fig 3.8 Debris accumulated in expansion Joint

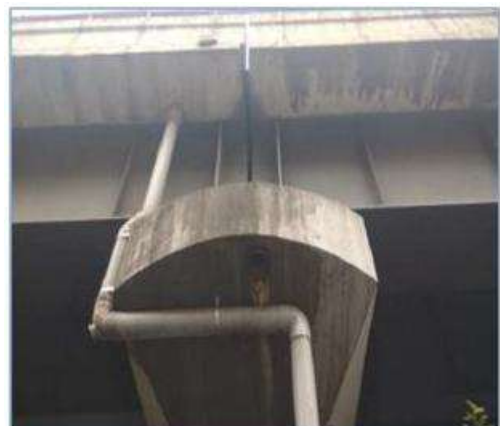
Pier cap is a horizontal component over the pier which transfers the superstructure load to the substructure. Dampness is major problem which has been observed at many locations during the field observations. One of the main reasons of dampness was due to poor installation practice & maintenance of expansion joint which leads to leakage from the expansion joint (refer Fig 3.18 to 3.19). If the dampness continues then the chances of reinforcement corrosion increase and the structure begin to corrode severely. Another common defect observed in the field is the vegetation growth over the pier cap (refer Fig 3.20 to 3.21) Due to the vegetation growth cracks are initiated in individual component. Debris accumulation over the pier cap (Fig 3.22 to 3.23). It is also observed that hardened concrete was accumulated around the bearing at pier cap which was a sign of poor workmanship negligence (Fig 3.24 to 3.25).

Fig 3.19 Seepage on pier cap

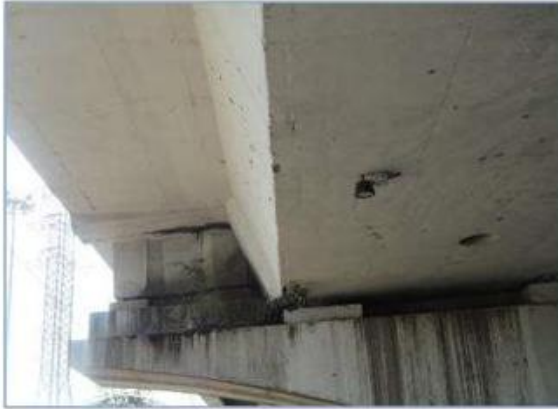
Fig 3.20 Vegetation growth on pier cap

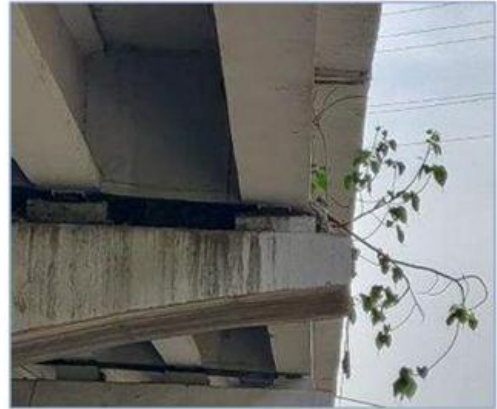
Fig 3.21 Vegetation growth on pier cap

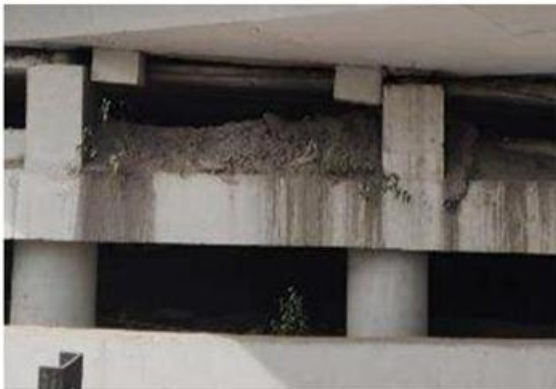
Fig 3.22 Debris accumulated over the pier cap

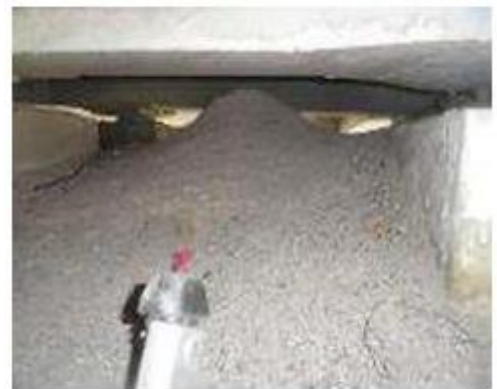
Fig 3.23 Debris accumulated over the pier cap

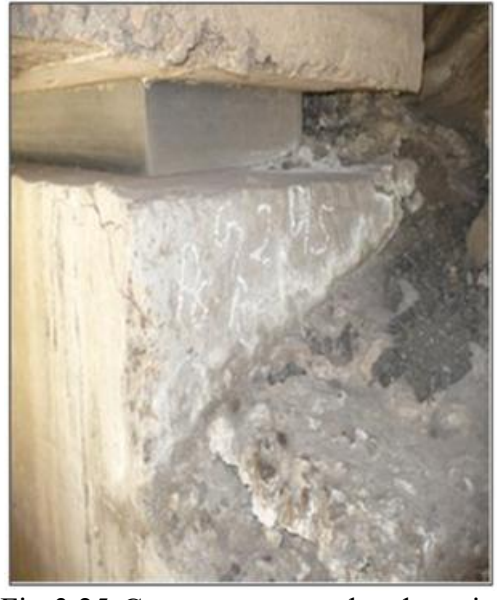
Fig 3.25 Concrete accumulated at pier cap due to negligence during the construction

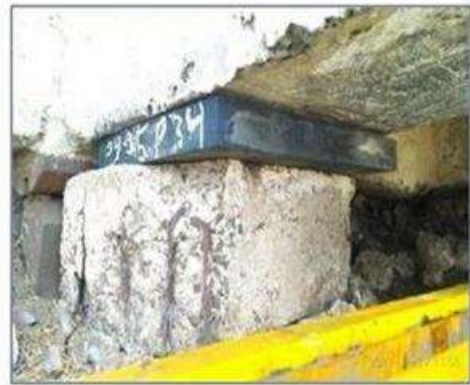
In the field, it is observed that elastomeric bearings are not placed properly as seen in Fig 3.26 to 3.27. The surface on which elastomeric bearing are placed shall be accurately level but at many locations ignored often. In the steel bearings, it has been observed that bolts were not properly tight and even missing at few locations. Bolts for fixing bearing shall be checked carefully by not doing so, performance of bearings can be affected (refer Fig 3.28 to 3.30). Bearing plates also got damaged at several locations as shown in Fig 3.31.

Fig 3.27 Bearings not placed properly

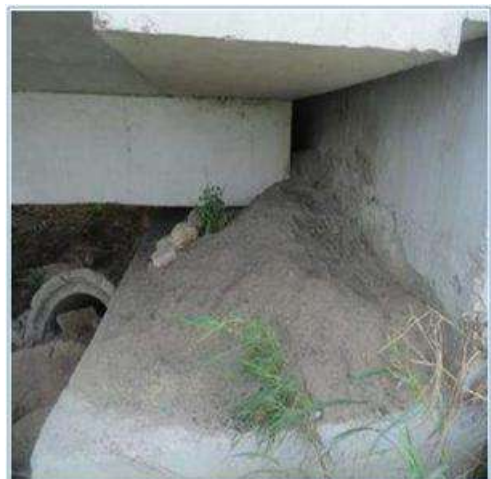
Fig 3.35 Debris accumulated around the bearing, affected the performance of bearings.

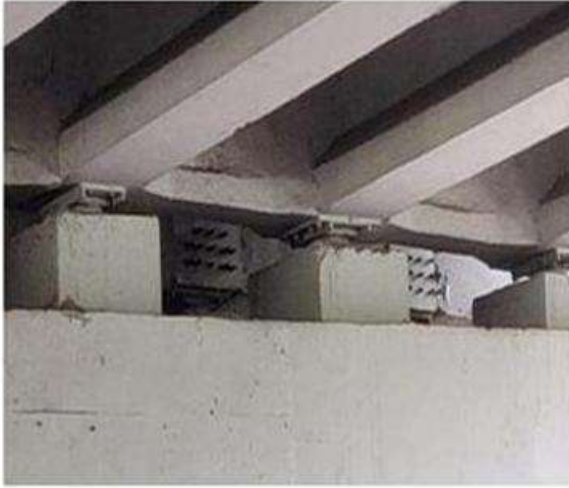
Fig 3.39 Prestressing cables exposed at end girder

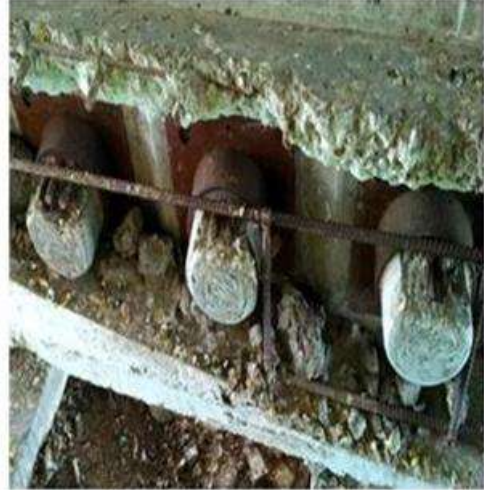
Fig 3.40 Prestressing cables exposed at end girder

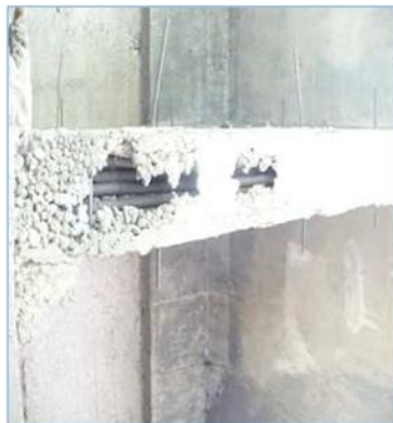
Diaphragm is a structural part of the bridge and it resists the lateral load in bridge. A general view of the arrangement of diaphragm shown in Fig 3.59. A cavity was observed at the bottom of diaphragm as shown in Fig 3.60. Honeycombing and exposed reinforcement also observed in diaphragm (refer Fig 3.61). Cracks also observed at the bottom face of diaphragm as shown in Fig 3.62.

Fig 3.60 Exposed reinforcement at bottom of diaphragm

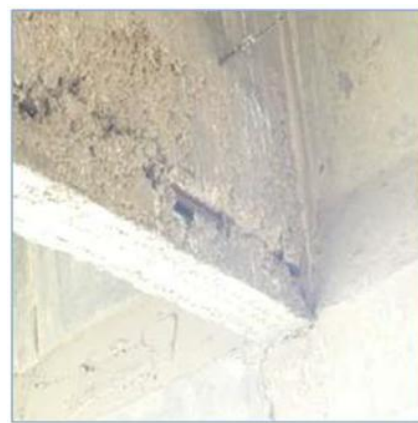
Fig 3.61 Exposed reinforcement in the face of diaphragm
