CREEP-FATIGUE ANALYSIS FOR REMAINING LIFE ASSESSMENT OF STEAM TURBINE BLADE USING NUMERICAL SIMULATION AND EXPERIMENTAL TESTING

A Thesis

DOCTOR OF PHILOSOPHY

CHAPTER 3: Investigation of the Failure of Seventh Stage Low Pressure Steam Turbine Blade and Framework for Life Assessment

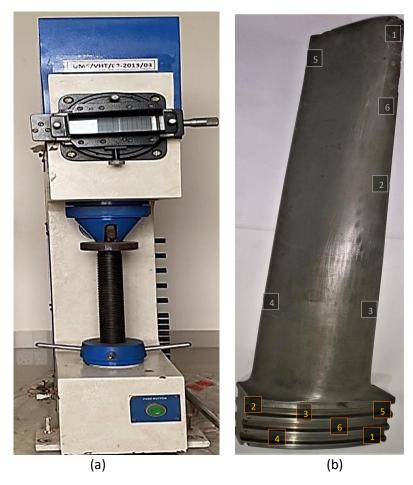
Figure. 3.10 (a) Hardness testing machine (b) blade profile and root hardness locations

The hardness test was carried out on a tube sample. Brinell hardness measurements were performed on blade materials using a universal hardness tester shown in Figure 3.10(a). The hardness values of the blade are found to be in the standard range, indicating that they had been properly tempered. Table 3.4 shows the observed values for hardness at different positions of turbine blade profile and root shown in Figure 3.10(b). Figure 3.11 shows a comparison of hardness at different locations of LP blade with the standard hardness required for LP turbine blade.

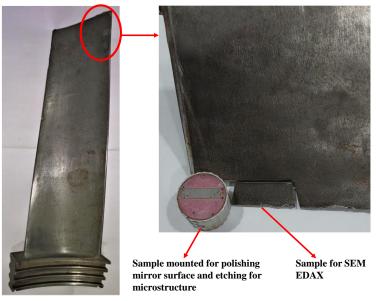
Figure 4.1 General view of the examined section of the blade

A failed blade from the L-7 row of the LP stage was taken from the unit in order to determine the root of the problem. The operating temperature of this stage of turbine was about 102.4°C. Erosion pits are observed, on the edges (as shown in Fig. 4.1). Elemental composition was determined using energy dispersive X-ray analysis of fracture surfaces (EDAX). Microscopical specimens were prepared by cutting and polishing blades according to normal metallographic procedures and by etching them. The microstructure and fracture surface

A sample is mounted for polishing the mirror surface and etching for microstructure evaluation and one sample is cut for SEM and EDX analysis as shown in figure 4.1.

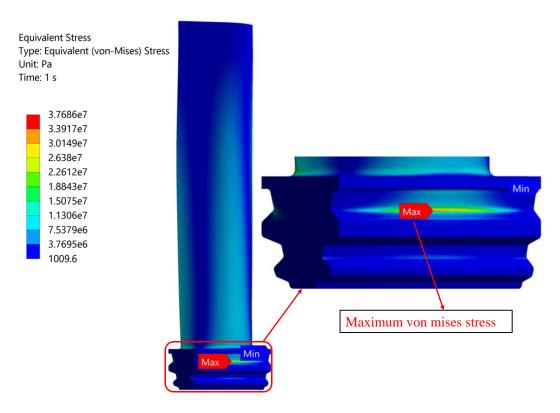
Figure 5.12 Maximum stress due to steam force

When the steam turbine functions normally, the forces exerted by the steam on the rotor blades fluctuate according to a harmonic pattern. Figure 5.12 shows the maximum stresses that occur at maximum steam loads. Maximum stresses occur close to the root of the blade. Compared to

the effect of a centrifugal load, these forces have lower stresses; yet, they can still be considered when estimating damage and usable life.

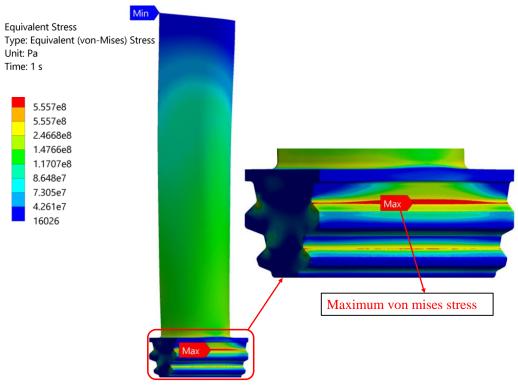
Figure 5.13 Stress due to centrifugal forces at 3000 RPM

Calculations of the centrifugal stresses at rotational speeds ranging from 500 to 3000 revolutions per minute are presented in table 5.8. Maximum centrifugal stresses were obtained at 3000 RPM under these conditions which is the operational speed of turbine. Figure 5.13

depicts the distribution of centrifugal stress within the blade. When the speed was increased to 3000 rotations per minute, the greatest centrifugal stress was found to be 555.7 MPa in the area around the fir tree roots on the suction side.
