STUDY ON RESPONSE OF CONCRETE BRIDGE DUE TO CONSTRUCTION DEFECTS

A DISSERTATION

In this study, the field survey has been done to identify the defects and elaborate on the codal provisions. The method used for assessing the behaviour of the structure due to defect is modelling and analysis of the bridge in STAAD pro software. With the consideration of defect, additional unexpected moments are generated in the girder and diaphragm for which the structure was not originally designed. In general, steel reinforcement is provided for required moments in the structures. If additional unexpected moments are generated, then damage can occur in the structure and affect the service life of the structure. The present study highlights that the collection of data can provide information about the possible defects with their causes for a meaningful conclusion about the service life of the structure.

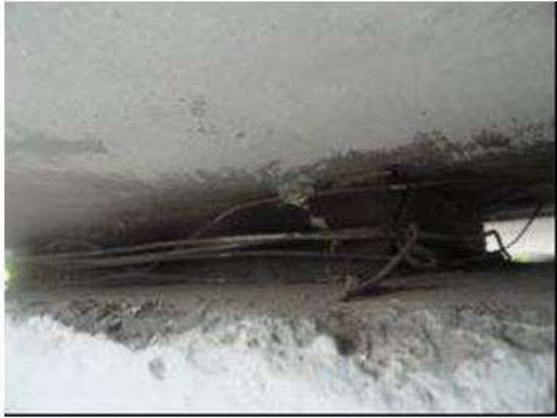
At few locations it is observed that MS binding wire is seen around the elastomeric bearing leading cuts on bearing rubber as shown in Fig 3.36 to 3.37.

Fig 3.36 MS wire binding around the bearing
